<b>Purpose:</b>	This form is used for providing a report regarding a reportable incident as required by regulation 34 (4) of the Petroleum (Environment) Regulations 2016 (NT).
<b>Reference:</b>	Petroleum (Environment) Regulations 2016 (NT)
<b>Date Submitted:</b>	23/02/2023

<b>Incident Details</b>	<b>Name of Site or Facility:</b> Maverick 1- EP 136	<b>Date:</b> 28/11/2022
<b>Initial Written Report</b>	<b>Person submitted by:</b> Matt Kerneke	<b>Date:</b> 03/12/2022
	<b>Contact Number:</b>

## Appendix A Sentinel-2 L2A Satellite Imagery Review

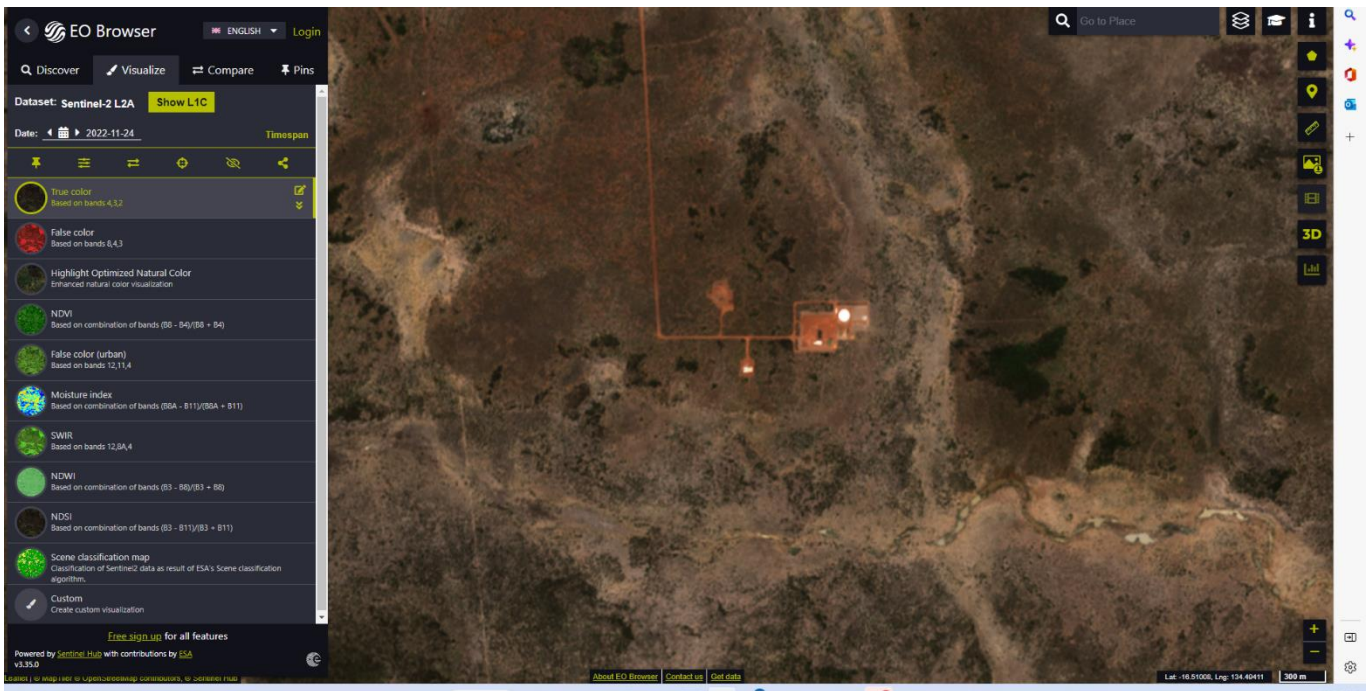
**Figure A.1** Maverick 1 site prior to the stormwater release. Note Newcastle Creek appears to have elevated turbidity levels

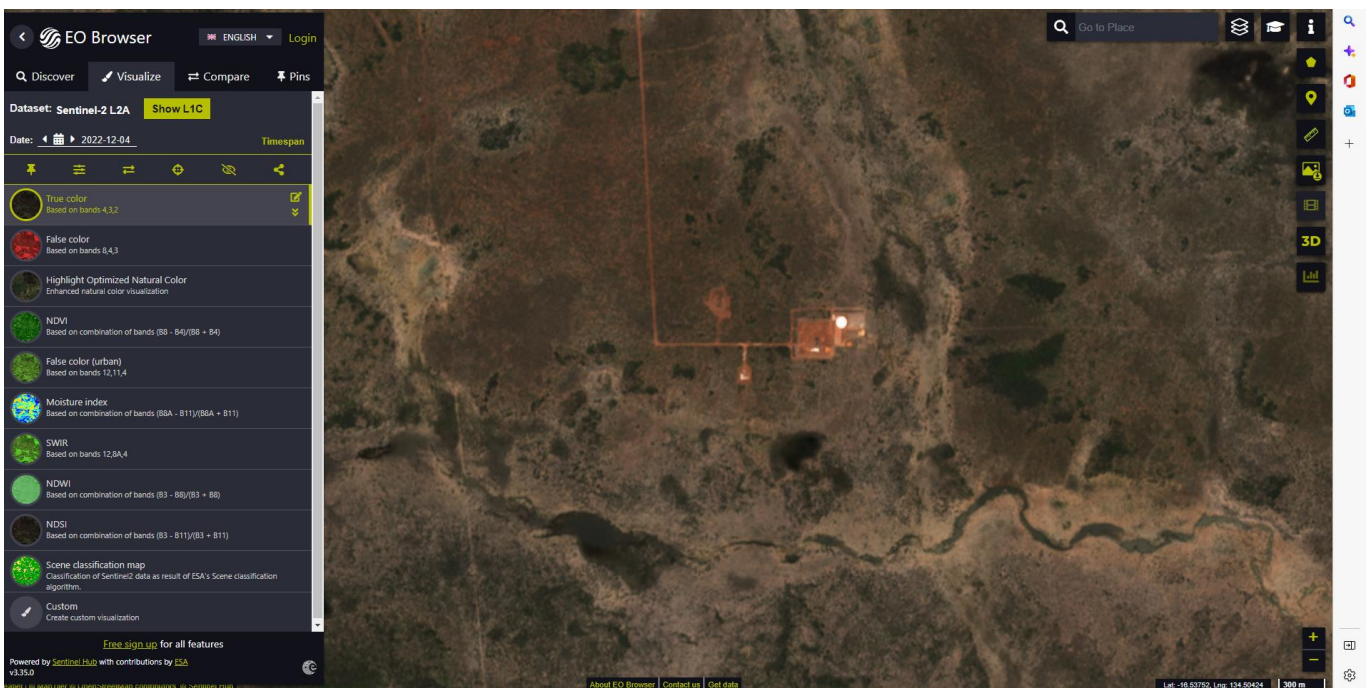
**Figure A.2** Maverick 1 site post stormwater release. Note Newcastle Creek does not appear to have elevated turbidity levels and downstream of lease appears consistent with surrounding area

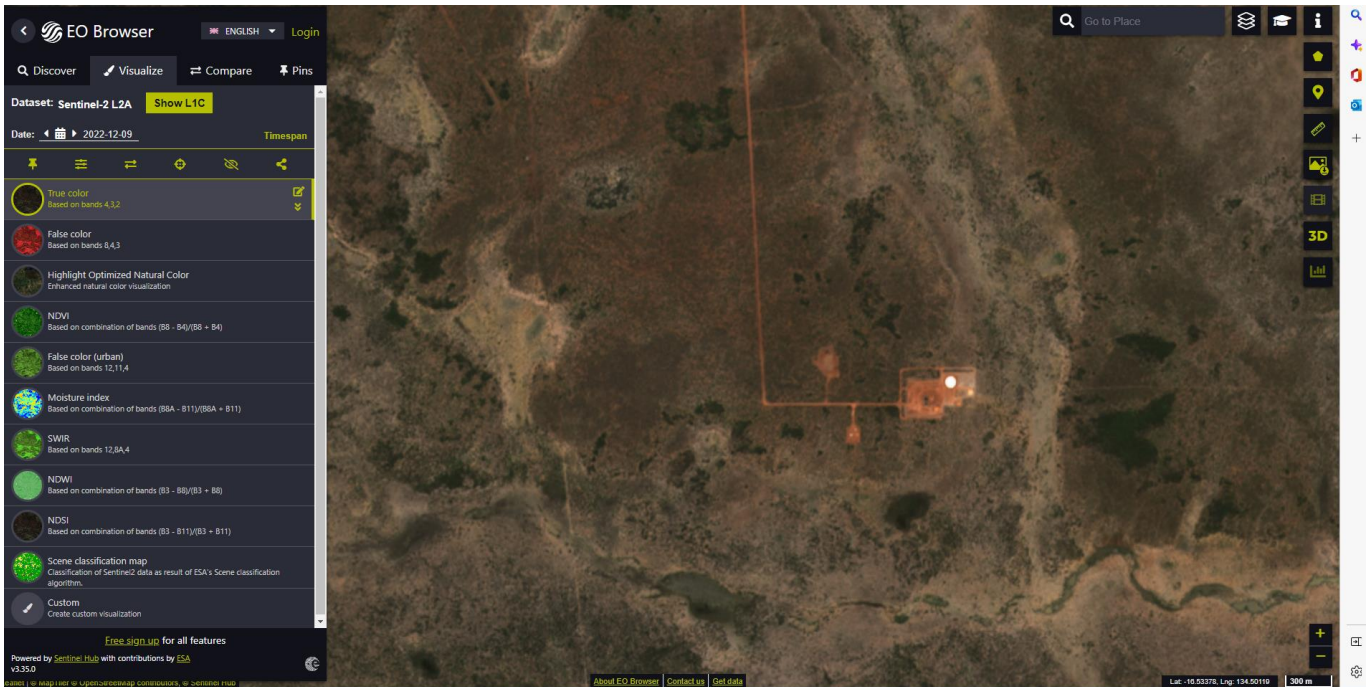
**Figure A.3** Maverick 1 site 11 days post stormwater release. Note sediment levels an downstream of lease appears consistent with surrounding area

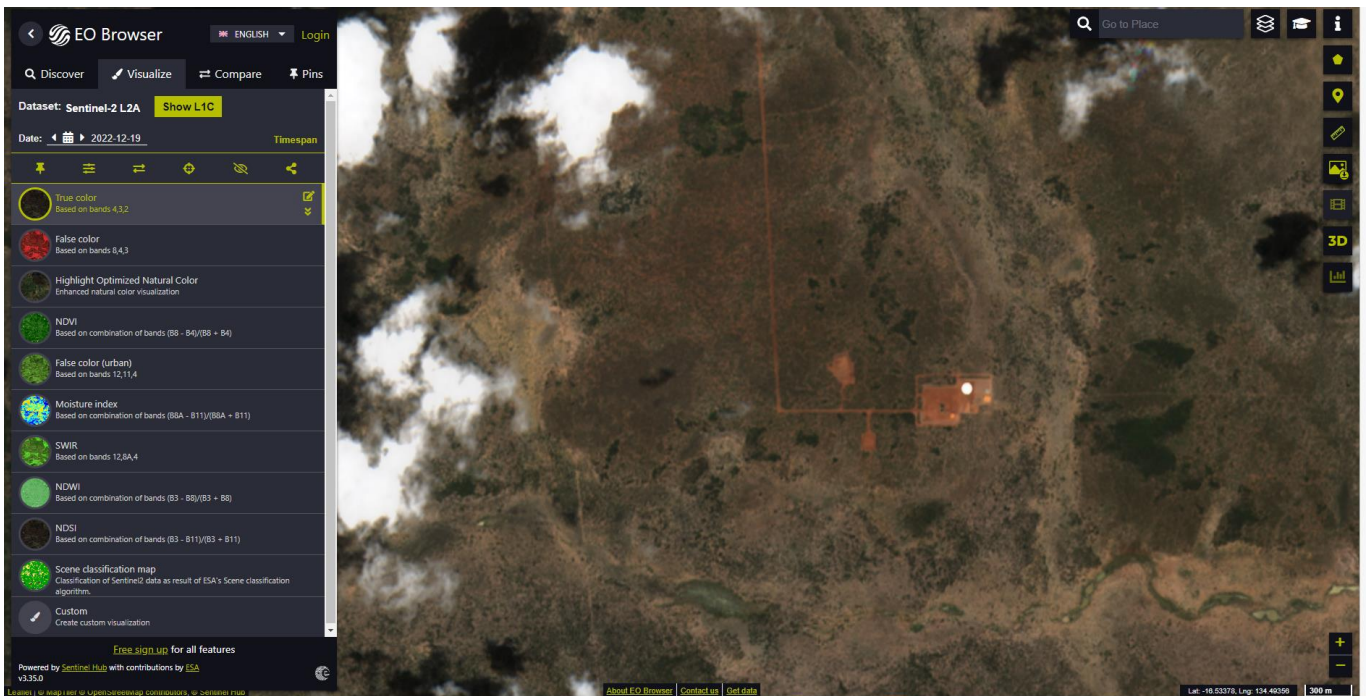
**Figure A.4** Maverick 1 site 21 days post stormwater release. Note sediment levels an downstream of lease appears consistent with surrounding area

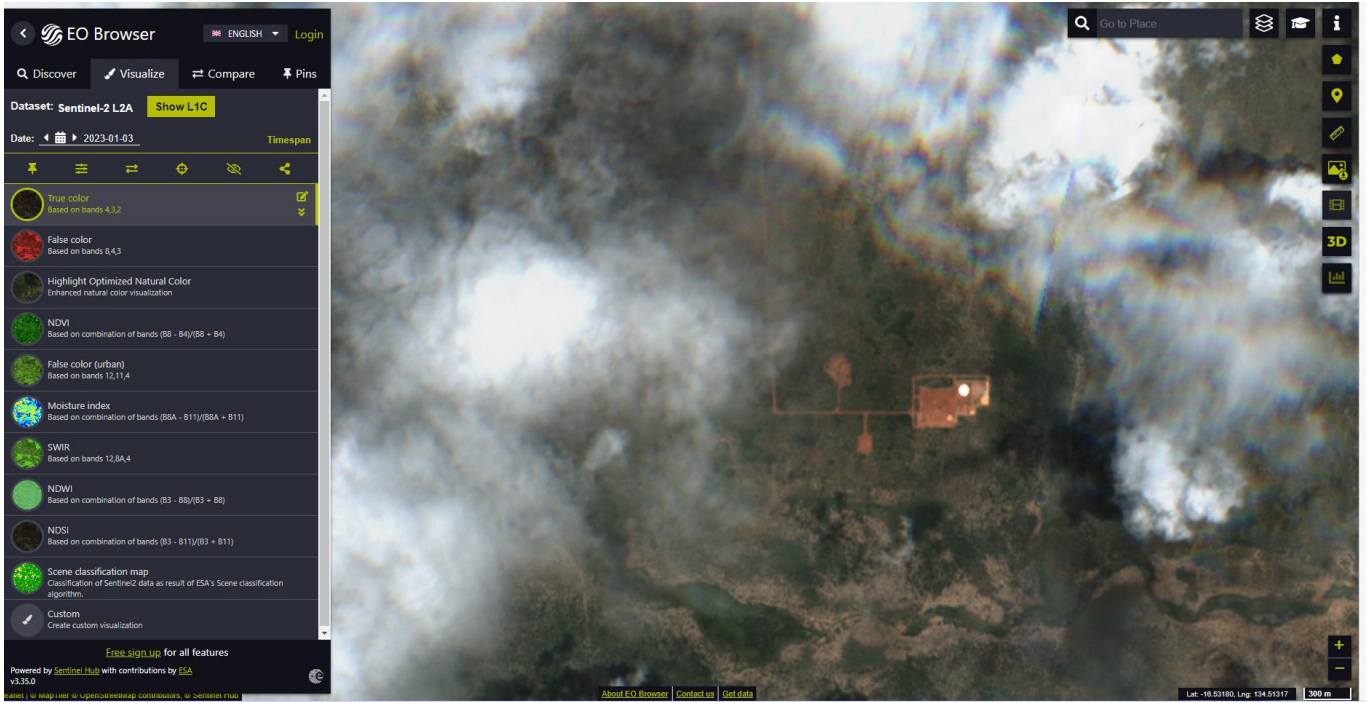
**Figure A.5 Maverick 1 site 35 days post stormwater release. Note significant vegetation growth in region with no evidence of sediment**

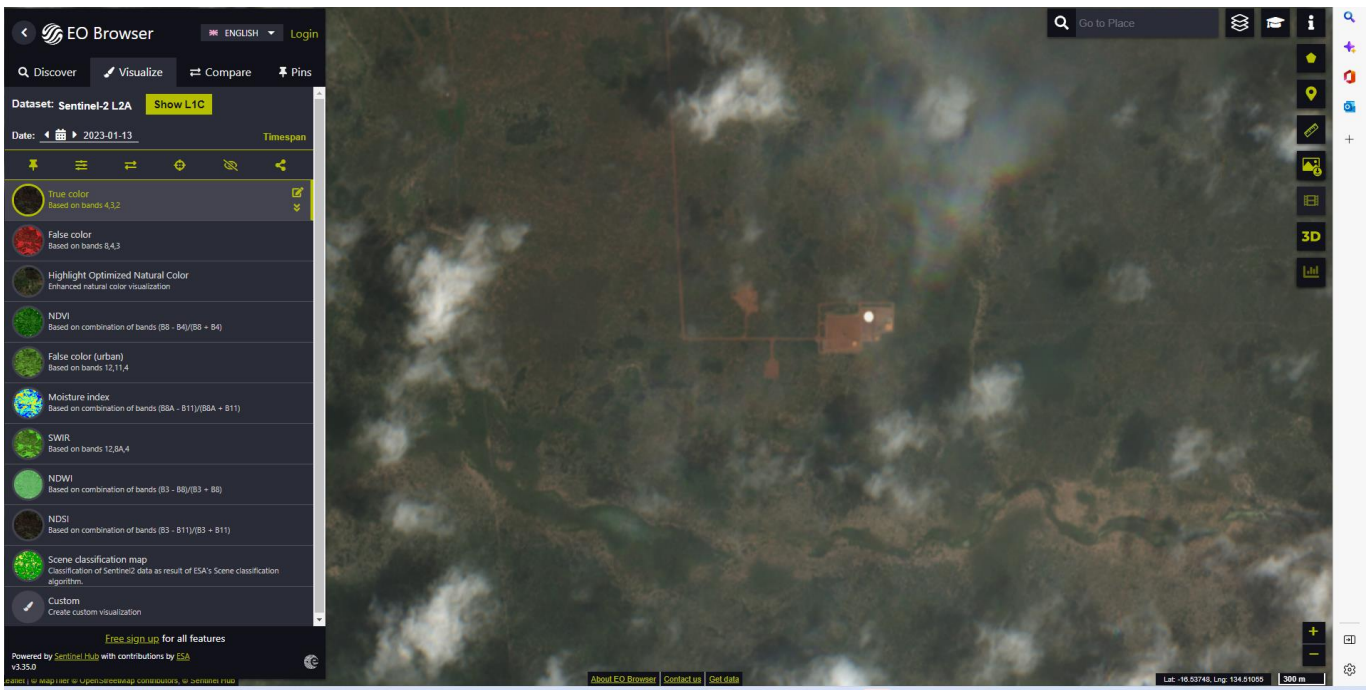
**Figure A.6 45 days post stormwater release. Note significant vegetation growth in region with no evidence of sediment**

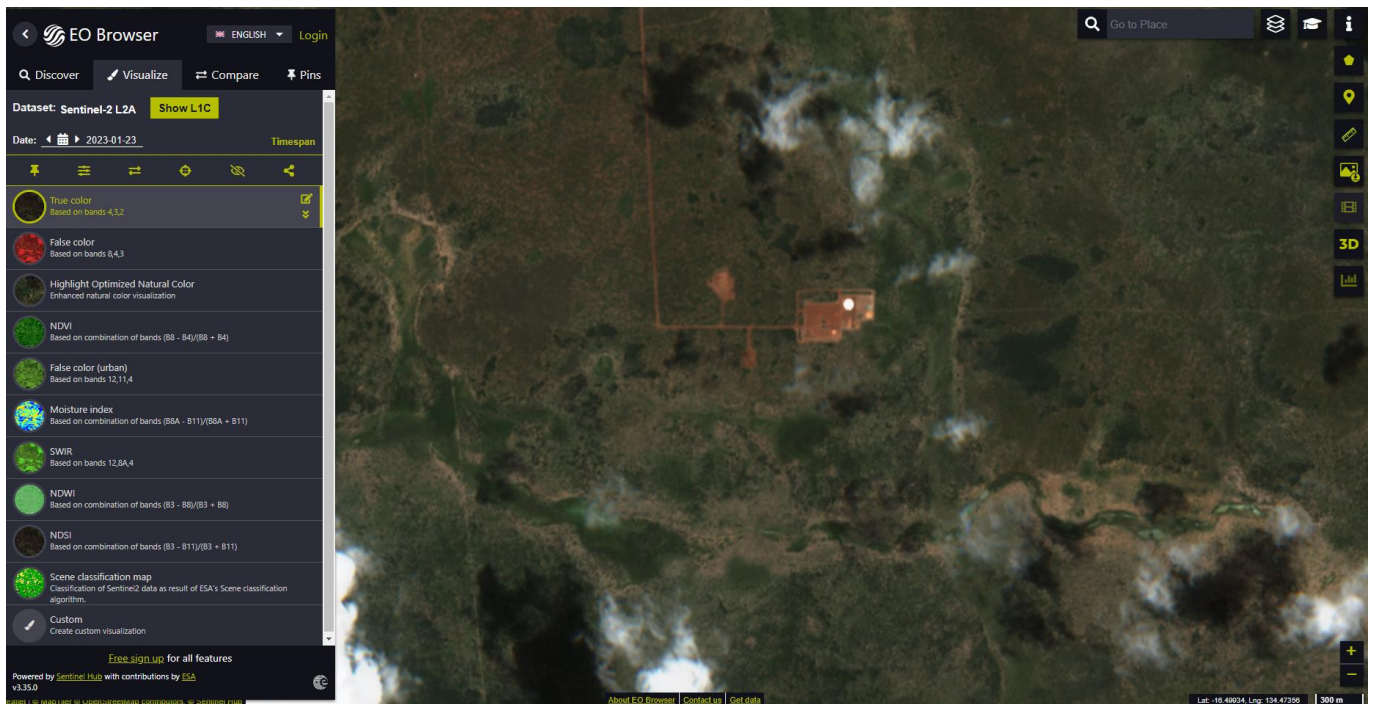
Figure A.7 55 days post stormwater release. Note significant vegetation growth in region with no evidence of sediment
