# Annual Environmental Performance Report

<b>EMP title</b>	SEISIC EXPLORATION PROGRAM EP 136 (SWP1-4)
<b>Unique EMP ID</b>	SWP1-4
<b>EMP approval date</b>	02 November 2020
<b>AEPR period</b>	03 November 2023 – 02 November 2024
<b>Petroleum title number/s</b>	EP 136

<b>Document title</b>	Annual Environmental Performance Report
-----------------------	---

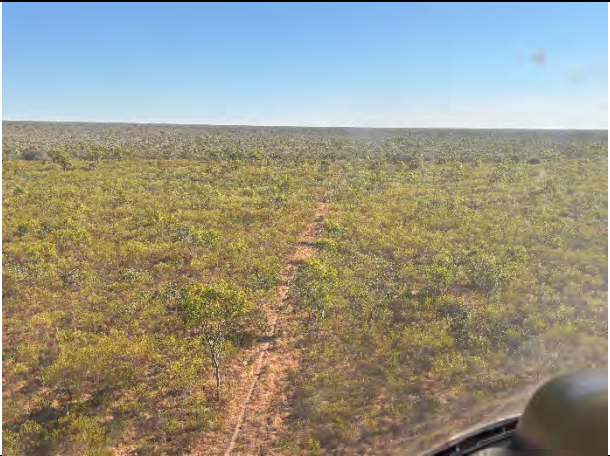
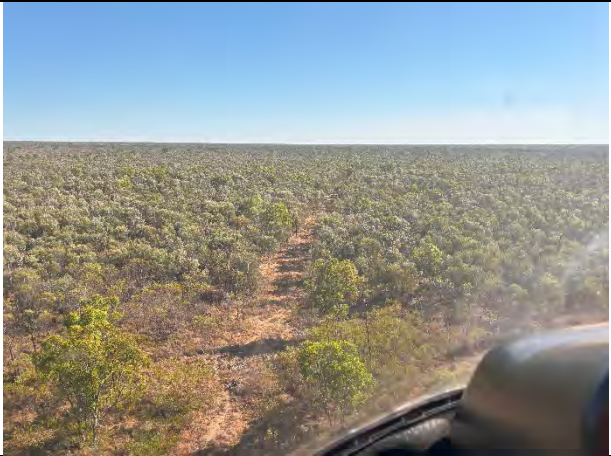
<p><b>Plate 8</b> Seismic Line 12 showing <i>Acacia lysiphloia</i> and <i>Melaleuca viridiflora</i> growth along seismic line restricting helicopter landing access. Cattle tracks evident along one side of seismic line.</p>	<p><b>Plate 9</b> Transition between the two vegetation communities shows good ground cover with some <i>Acacia shirleyi</i> regrowth visible.</p>

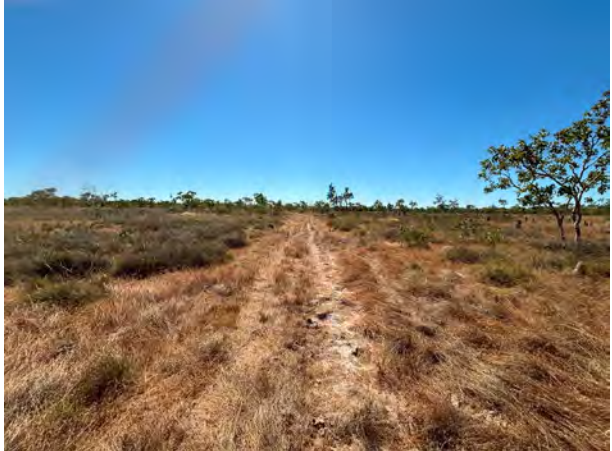
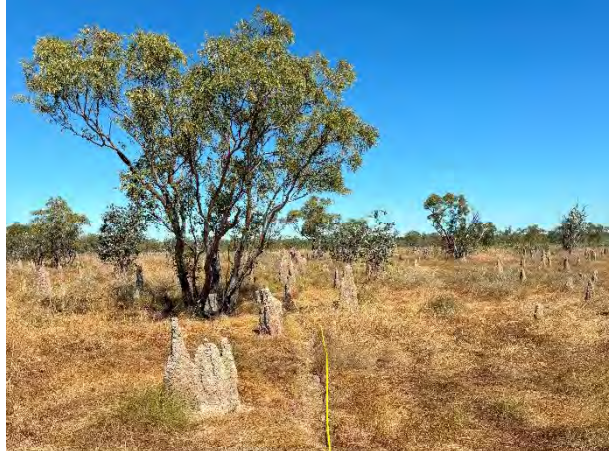
<p><b>Plate 12</b> Seismic Line 10 impact site with evidence of cattle tracks along one side, although good ground cover species are consistent with surround vegetation.</p>	<p><b>Plate 13</b> Seismic Line 10 analogue site also showing some cattle track impact.</p>

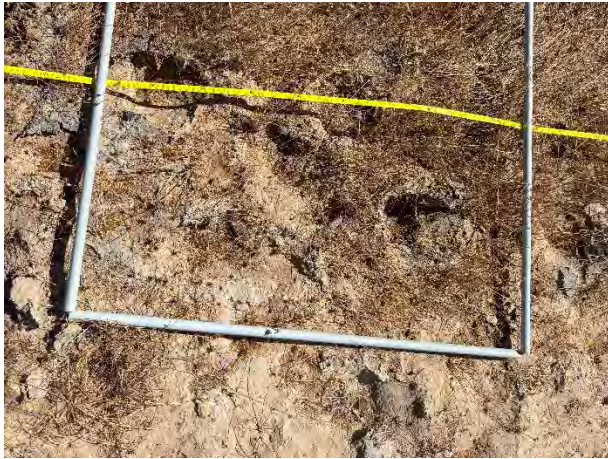
Cattle disturbance was evident at all the ground survey sites. Evidence of recent cattle movement was in the form of dried cow dung, cattle tracks and pig disturbance (Plate 16 to Plate 19). Some of these tracks were along the existing seismic lines. It is also noted that even without seismic line disturbance, cattle tracks are observable across the permit area. The recent aerial imagery available on Google Earth Maps taken in November 2023, as presented in Table 5 and Table 6 in section 4.2, clearly show the cattle tracks traversing across the landscape.

**Plate 16** Seismic line 10 impact GS Transect 5 with evidence of cattle using the old line for moving through landscape.

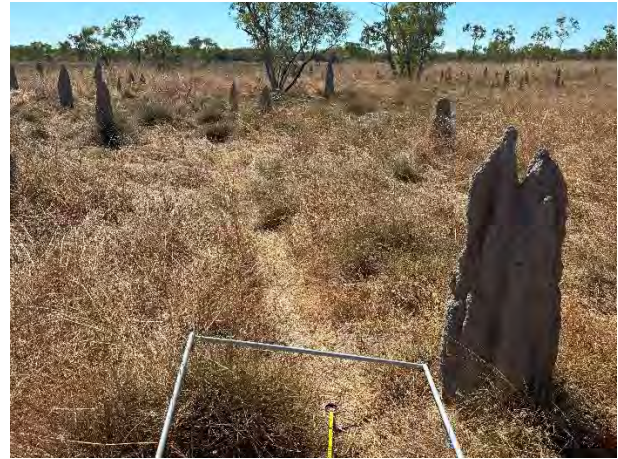
**Plate 17** Seismic line 10 analogue GS Transect 6 also presented with cattle tracks. Noted that this track was new from the September 2023 rehabilitation survey.

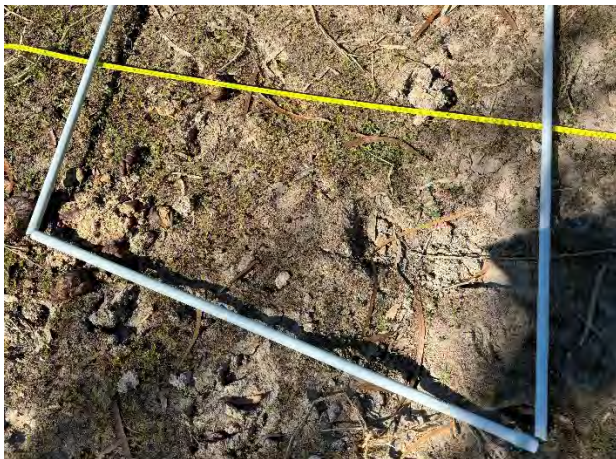
**Plate 18** GS Transect 4 analogue site with cattle footprints in the mud. This site is located in a drainage depression and likely to have held water late in the season attracting cattle to the area.

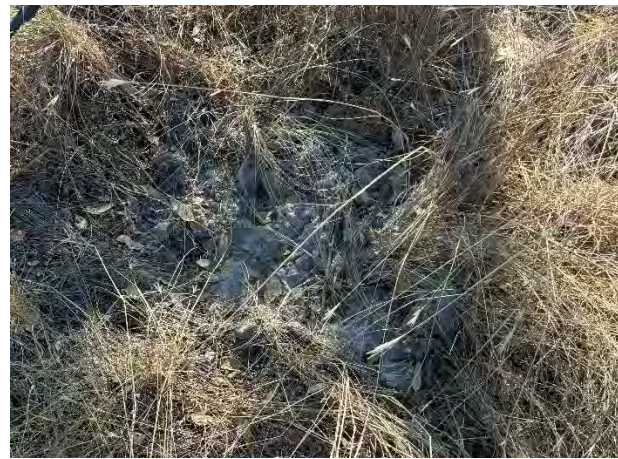
**Plate 19** Seismic Line 9 cattle/pig disturbance.

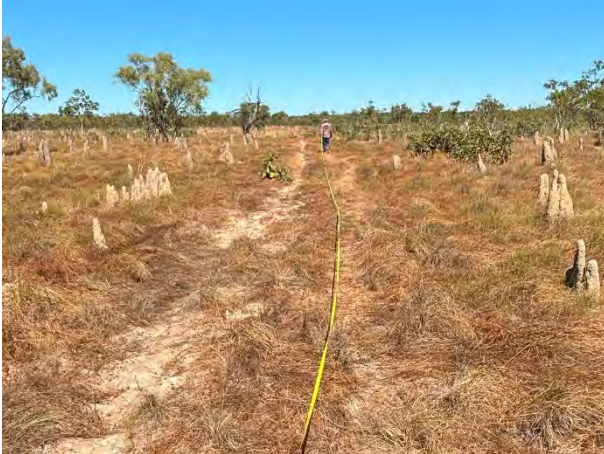
All areas surveyed on the ground did not show visible signs of erosion. All areas assessed were flat in nature, with only some compaction attributed from the seismic program and more recently cattle movement in the area (Plate 20 and Plate 21).

Plate 20 Seismic Line 5 impact site showing compaction which can be attributed to cattle traversing old line.

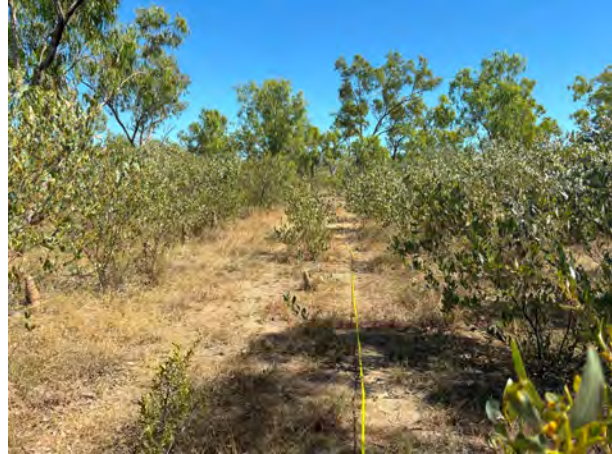
Plate 21 Seismic Line 6 impact site showing some remnant compaction.
