# Reportable Incident - Final Report

EMP Title (petroleum title/s)	2021 – 2025 EP 187 Work Program	Unique EMP ID	IMP 4-3.10	Initial report	<input type="checkbox"/> Yes <input checked="" type="checkbox"/> No
Reporting	Notification Content	Date Submitted	Recipient	Key Stakeholders	<input checked="" type="checkbox"/> Yes <input type="checkbox"/> No
Initial Report	Identified dying vegetation in surface drain discharge area.	11/01/2025	DLPE	Yes - Notified	1
Interim report	Results of site investigation and measures taken for containment, isolation and clean up.	13/03/2025	DLPE	Yes - Notified	1
Final Report	<ul style="list-style-type: none"> <li>Source, nature and extent of material released</li> <li>Potential Receptors and Pathways analysis</li> <li>Contamination assessment</li> <li>Laboratory soil results vs NEPM criteria</li> <li>Impact assessment</li> <li>Remediation and Rehabilitation</li> <li>Summary of Root Cause Analysis</li> <li>Lessons learned and Controls</li> </ul>	-	DLPE	-	1

The Reportable Incident relates to the unintended release of contaminants wastewater from Activity - Storage of potentially hazardous substances

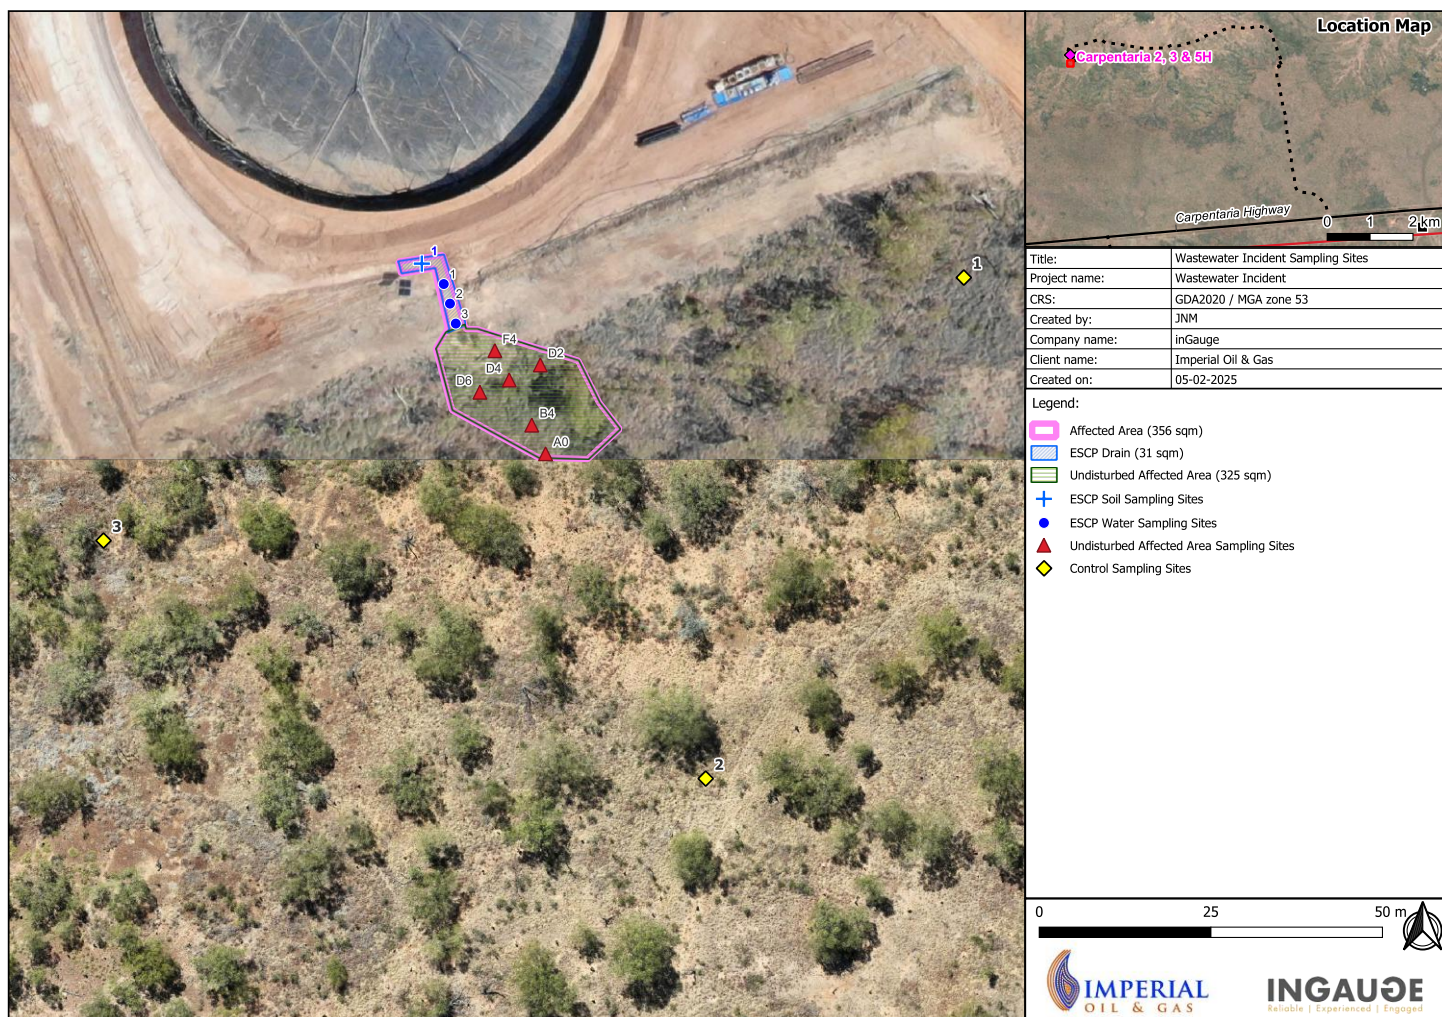
## Attachment A – Boundary of Affected Area with Soil and Water Sampling Points

- Dispersion Mechanism: Rainfall (totalling 56 mm during the incident) may have assisted the spread of the saline water over a limited area in the ESC Drain discharge, largely by overland flow across dry, low-moisture soils. No further dispersion has been observed outside of the 356 m<sup>2</sup> of affected soil area pegged out visually during the site investigation (see **Attachment C**).

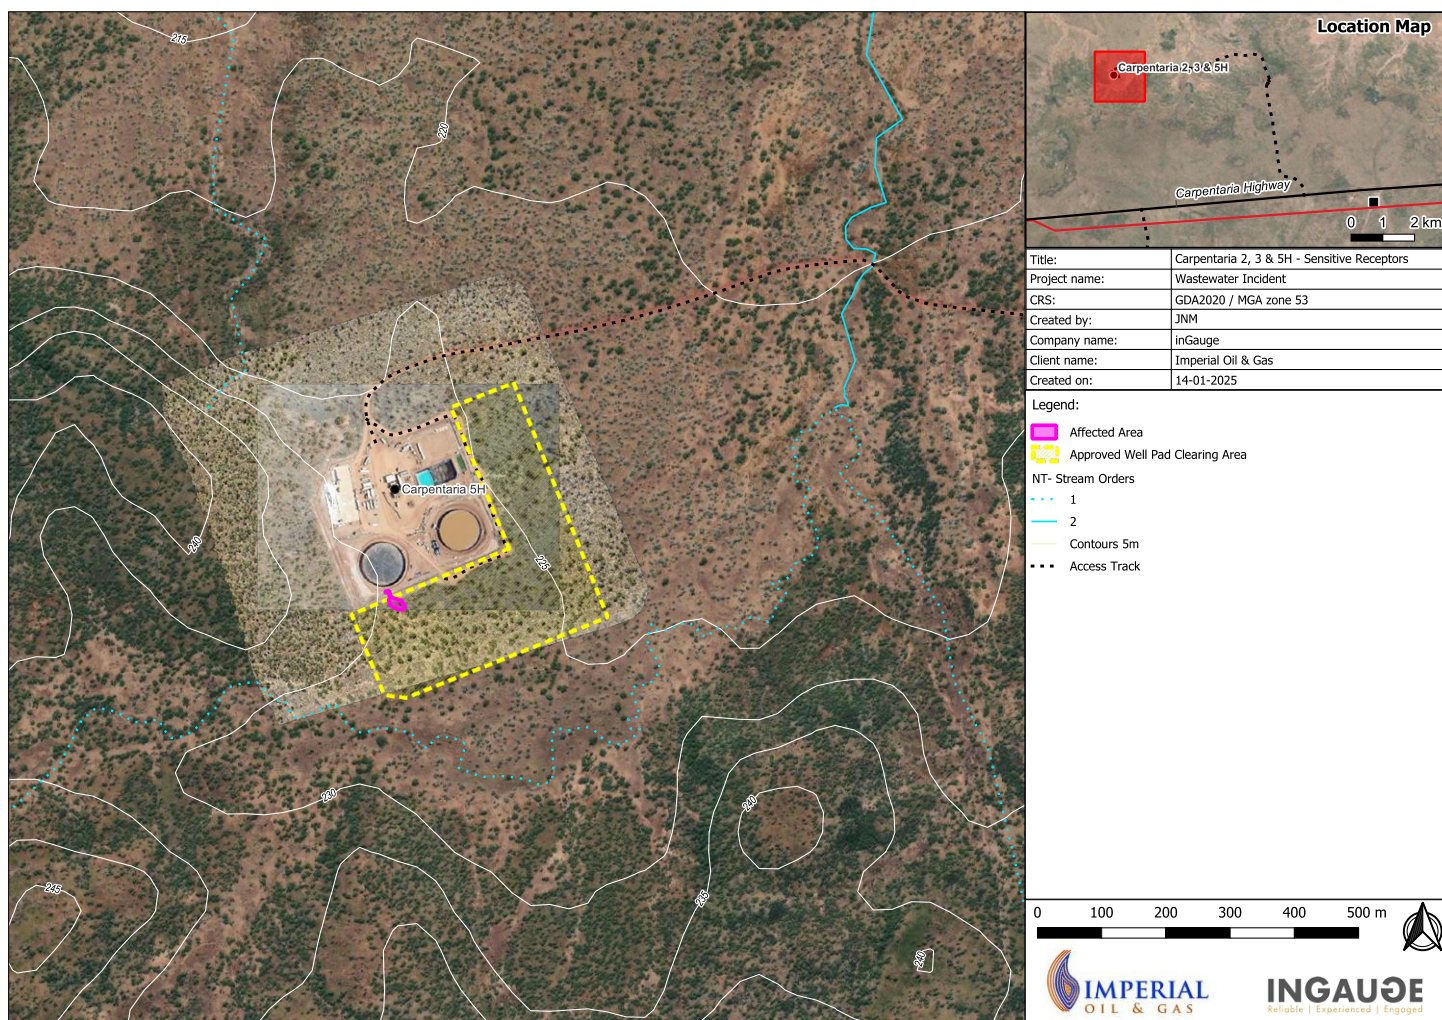
## Attachment B – Sensitive Receptors in the Vicinity of the Affected Area

- The nearest surface water receptor is an ephemeral NT Stream Order 1 drainage line, approximately 450 m down gradient from the affected area (Attachment B). Riparian vegetation for this stream order is directly on the stream bank. The stream was completely dry during the incident period (**Attachment F**).
- The closest domestic or stock bore is more than 2.7 km away.
- The nearest dwelling is about 9 km away.
- The nearest recorded cultural site is more than 10 km away.
- Protected areas (e.g., Limmen National Park, Bullwaddy Conservation Reserve) are located 40–110 km away.
  - Sensitive Flora and Fauna: The incident caused temporary chlorosis (leaf discoloration and necrosis) in affected vegetation – a direct consequence of effects of elevated chloride level

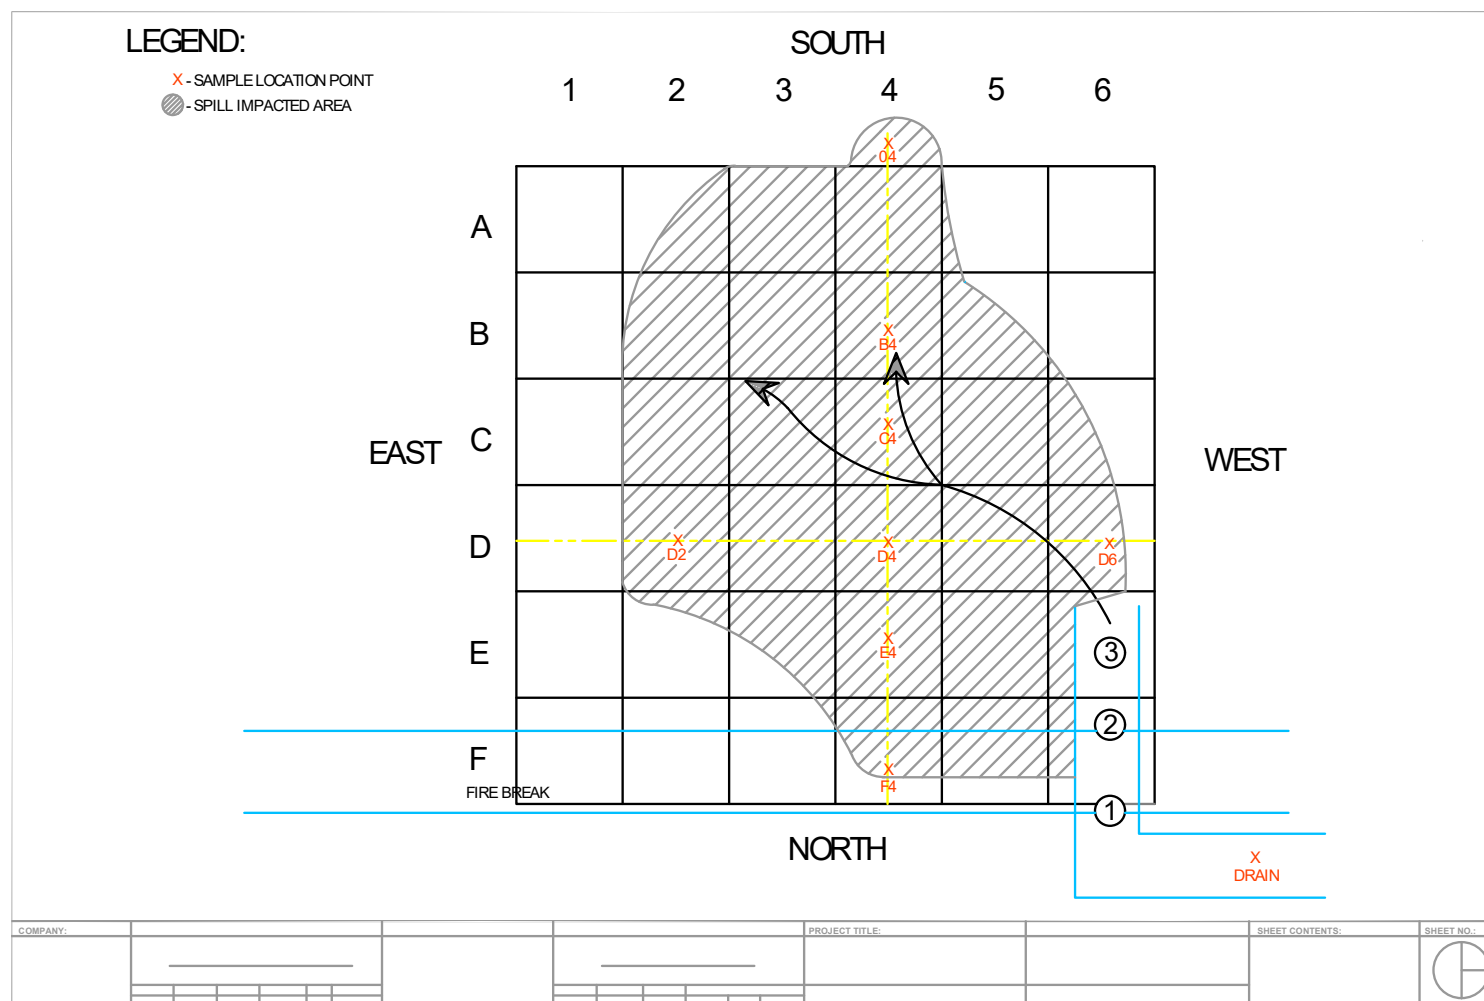
## Attachment C – Affected Area Soil Sampling Plan (5 m Grid)

The boundary of the Affected Area and the soil sampling locations are shown in Attachment C. The total area affected by the unintentional release is approximately 356 m<sup>2</sup>. The most heavily Affected Area in the ESC-Drain where affected soil was scraped up and removed is approximately 31 m<sup>2</sup> (see **Attachment F**). The Affected Area outside the present well pad boundary firebreak is approximately 325 m<sup>2</sup>.

Soil samples were taken during site investigation on 16th and 17th January 2025. Samples were collected from 8 sampling points shown in **Attachment C** and 3 sampling points approximately 50 m to the south, east and west of the boundary of the Affected Area. These baseline reference soil samples, collectively called Soil Baseline, provide a measure of the baseline chemical characteristics of the soil. At each sample point, a soil sample was taken at 0 - 10 cm depth and 10 - 30 cm depth in accordance with NEPM and AS 4482.1 [STANDARDS AUSTRALIA, 2005]. Soil samples were sent to a NATA-accredited laboratory for analysis in accordance with section C.8 of *the Code* suite of analytes.

Repeat soil sampling was undertaken on April 4, 2025, approximately 10 weeks after the incident, from the 8 sampling points shown in **Attachment C** in the affected soil area. At each sample point, a soil sample was taken at 0 - 10 cm depth and ~ 30 cm depth in accordance with NEPM and AS 4482.1

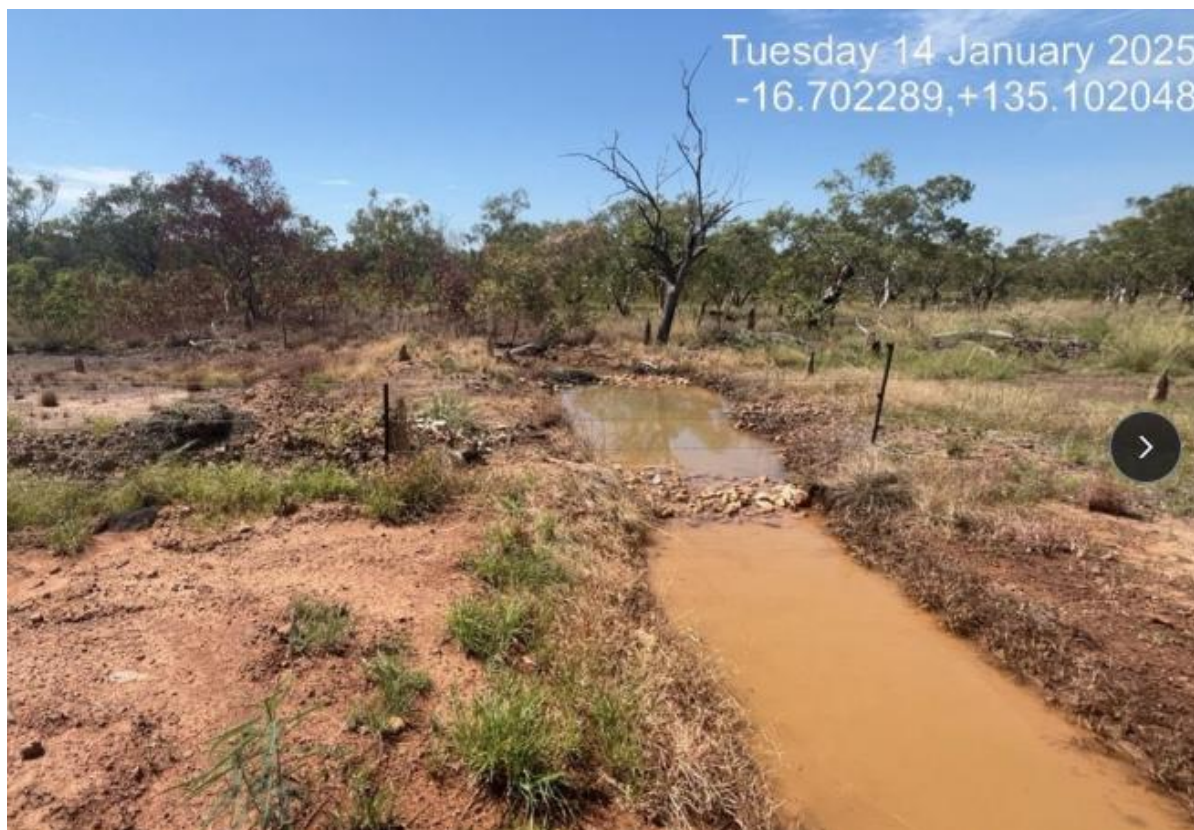
Affected Area in the ESC Drain – 14th January 2025

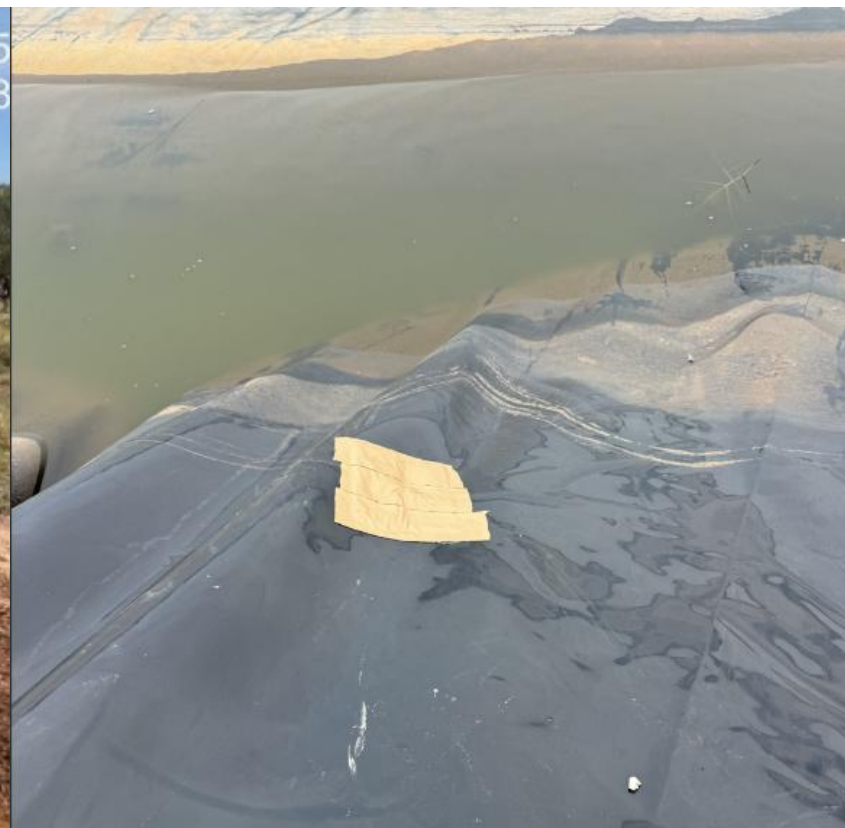
<p>release was undertaken by the original equipment manufacturer for the wastewater tank system. The investigation revealed failure in the integrity of the tank cover resulted in loss of containment due to a puncture hole, likely caused during field maintenance work on the rainwater solar pump on December 24, 2024. This puncture allowed saline wastewater stored in the tank to seep upwards through the tank cover, due to differences in salt concentration gradient (ionic diffusion), increasing the salinity of the accumulated rainwater on top of the tank cover.</p> <p>To ensure proper functionality, accumulated rainwater must be periodically pumped off the tank cover. Site investigations determined that from December 25, 2024, to January 8, 2025, approximately 5,700 L of brackish (half the salinity of seawater) affected rainwater was slowly pumped off the Tank Cover unintentionally, following rain events, into the surface water erosion sediment control (ESC) drain exiting from the well pad.</p> <p>Rainwater pumping from the tank cover was stopped immediately when vegetation near the ESC drain discharge area adjacent to the well pad southern area boundary was noted to be stressed on January 8, 2025. Affected rainwater that was pooled in the ESC drain was pumped back into the wastewater tank to mitigate further salt contamination. The most salt affected soil area (31 m<sup>2</sup>) in the ESC-Drain was scraped up and removed.</p>

Cause of Affected Rainwater on Mandatory Tank Cover (tear now covered by patch)

- The pump's poor placement (opposite the viewing platform) and inadequate liner material or padding around pump / hoses led to undetected damage.
- Going forward:
  - Redesign pump setup to prevent liner stress.
  - Conduct pre-deployment durability testing for new tank systems (liners, pumps).

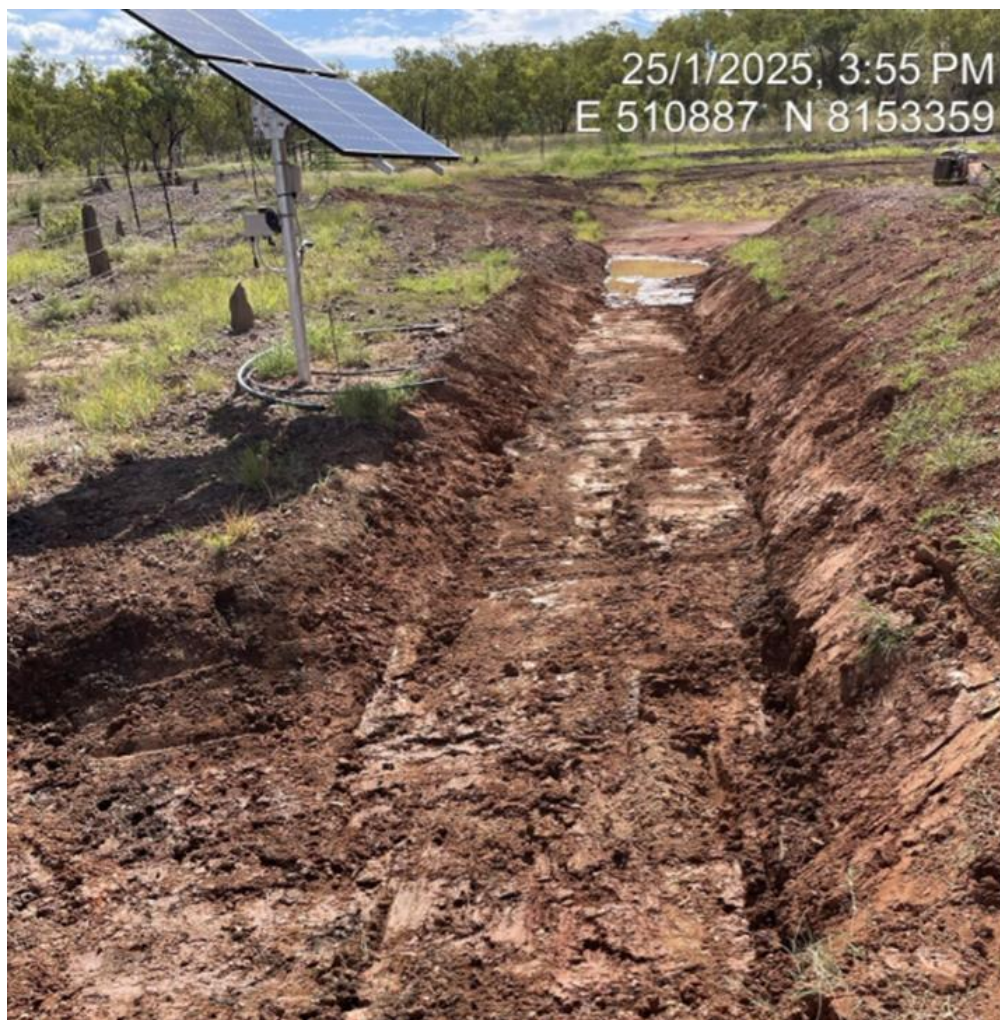
Salt Affected Soil Removed from ESC Drain – 25th January 2025

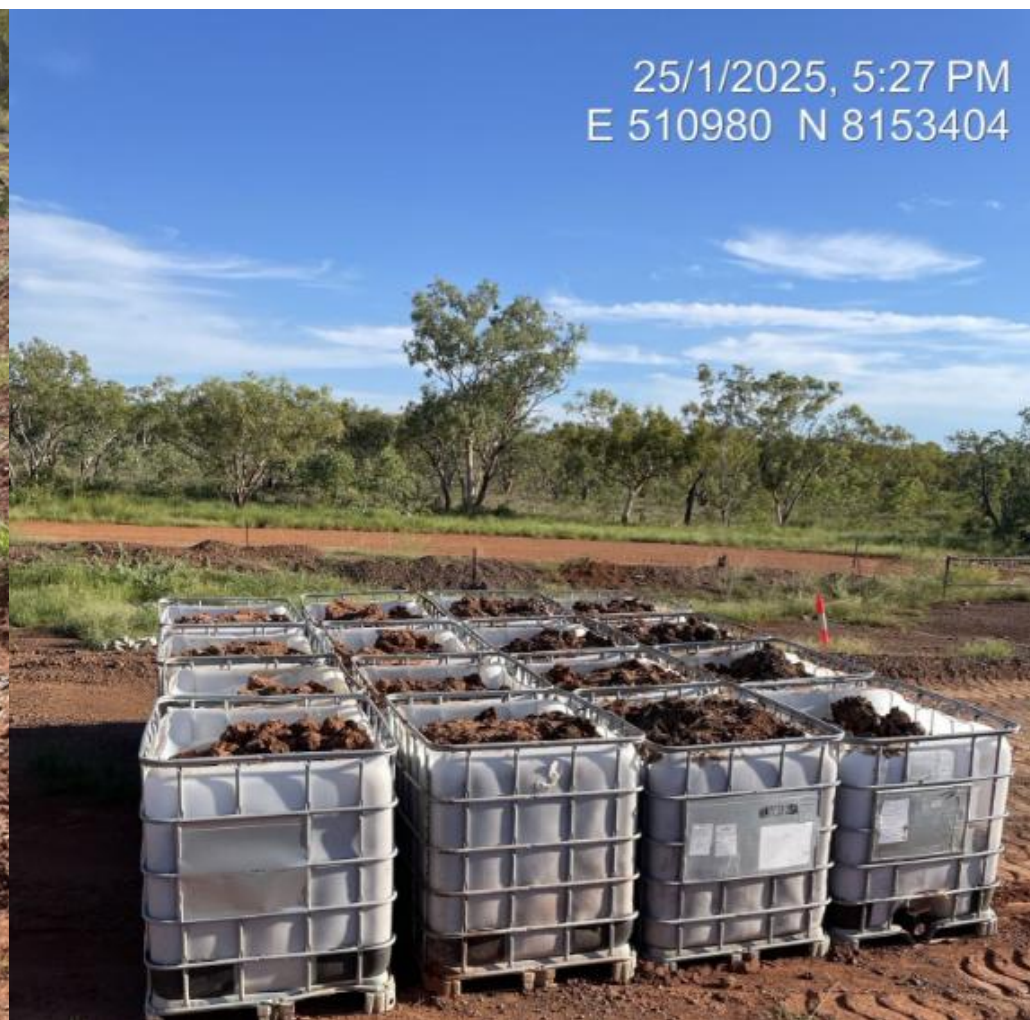
Soil Affected Soil Stockpiled from ESC Drain

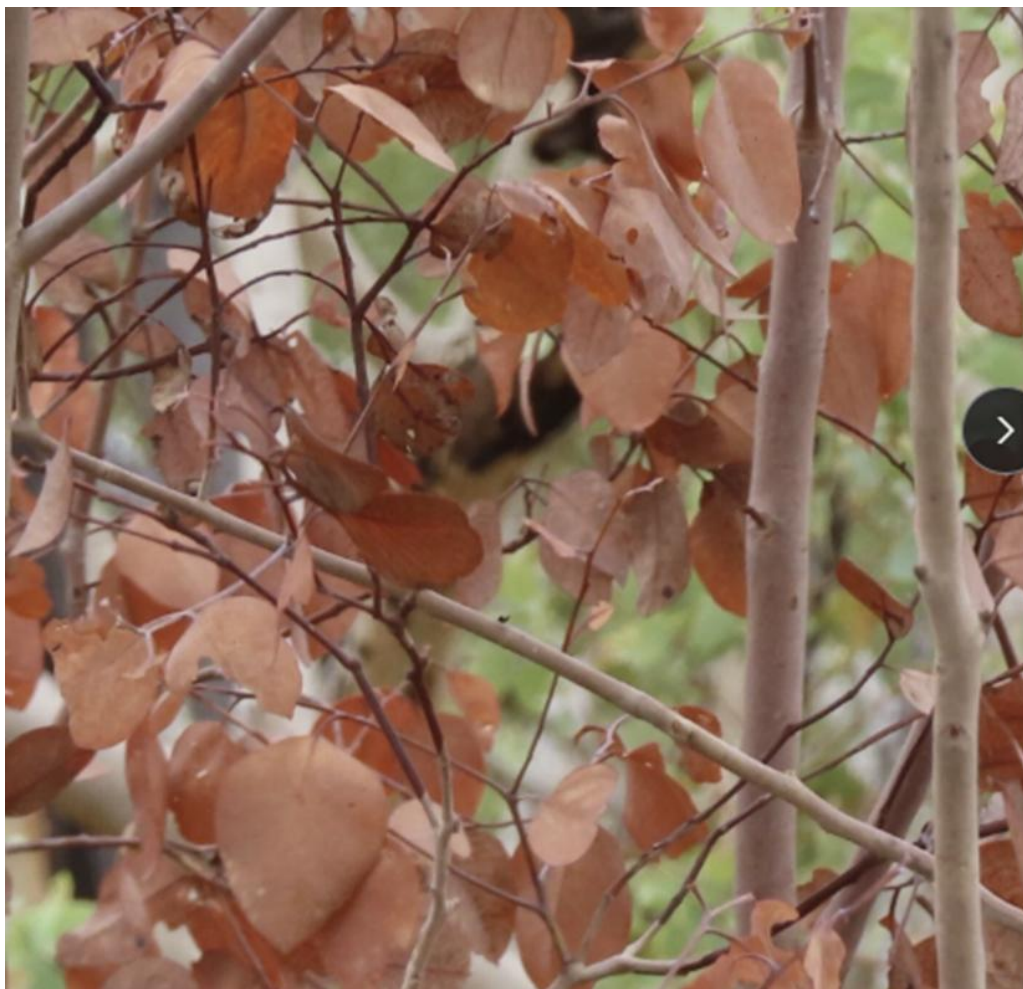
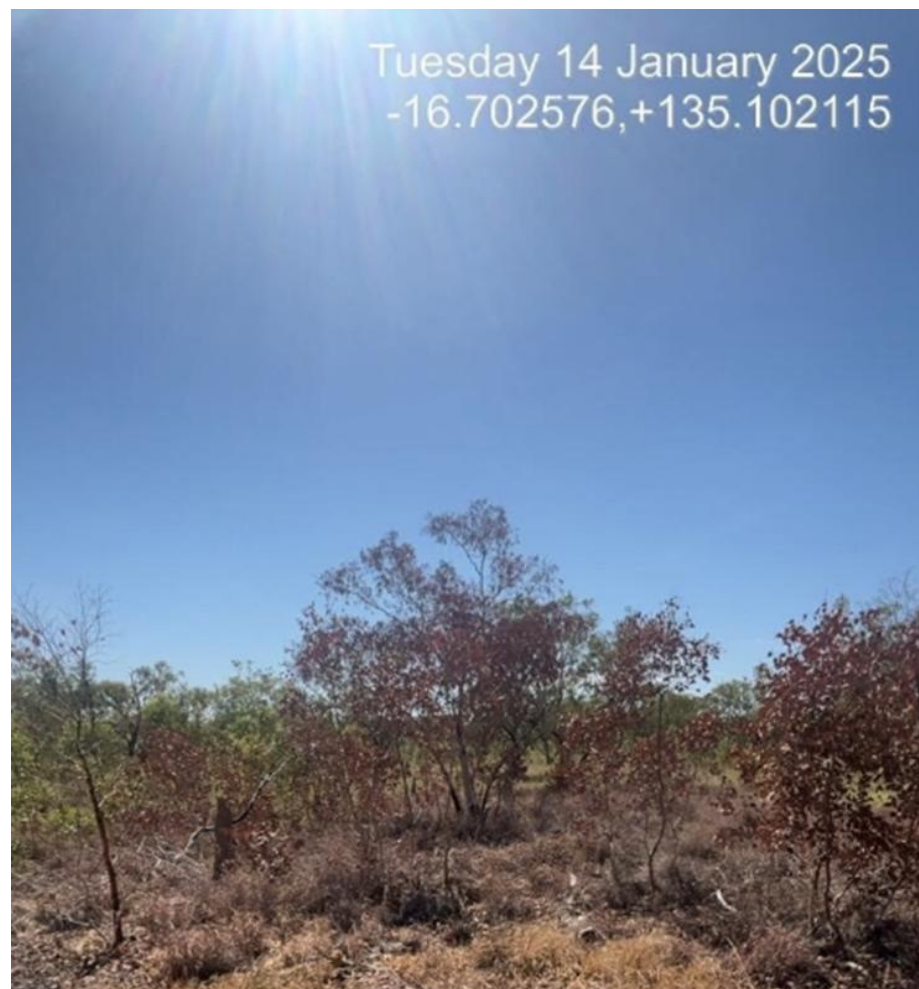
The brackish rainwater caused chlorosis in the leaves of affected vegetation, leaf browning and leaf drop, as shown in **Appendix F** at the time of the incident. Vegetation recovery in the affected area has shown leaf chlorosis effects on vegetation are temporary in the affected area following seasonal rains which has reduced the salinity of the affected soil in the root zone. There are strong signs of vegetation recovery 1 month after the incident with new leaf and bud growth visible on snappy gum and recovery of tussock grasses in the affected area (**Attachment F**). Imagery of the affected soil area

Leaf Chlorosis during January 2025 Incident

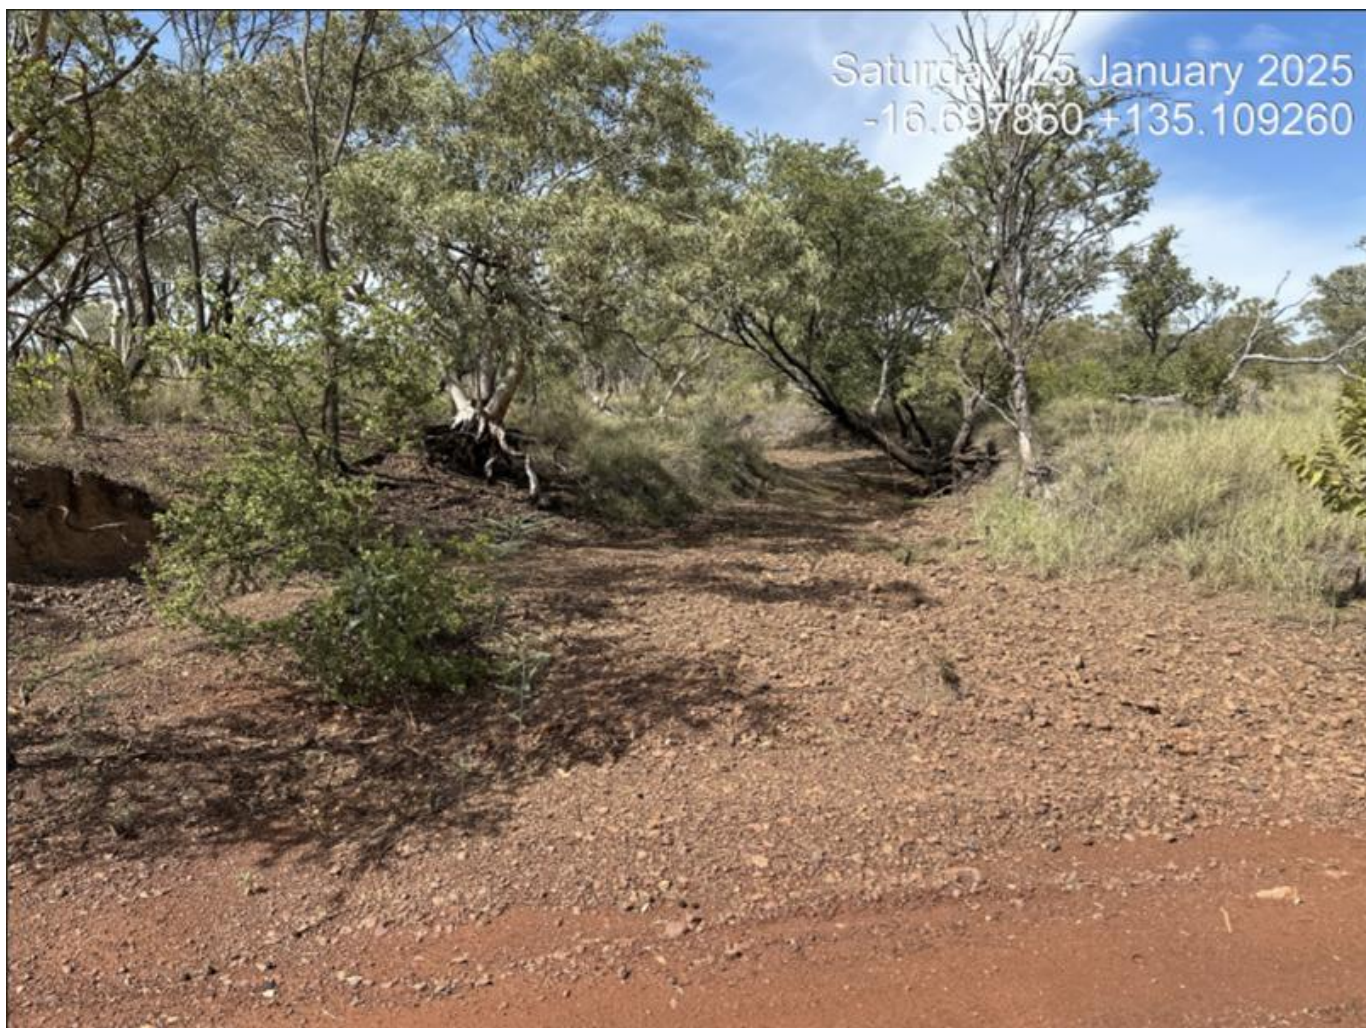
Stream Order 2 Creek Crossing 1.6 km Downstream from the Affected Area

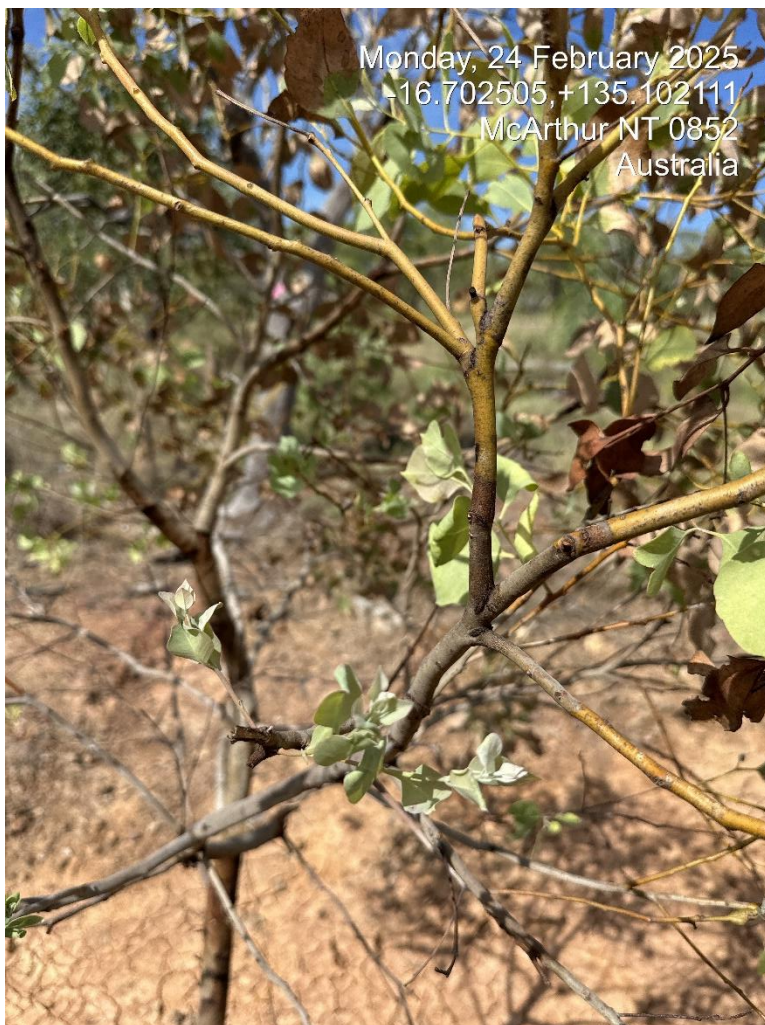
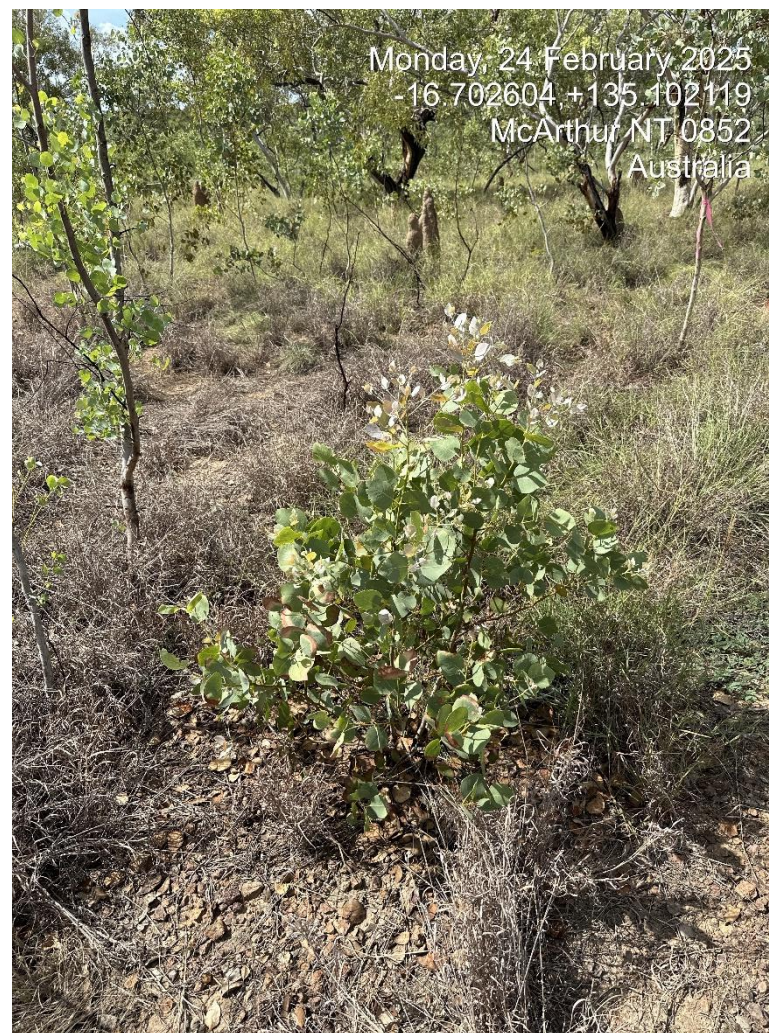
Leaf Recovery 1 Month after Incident

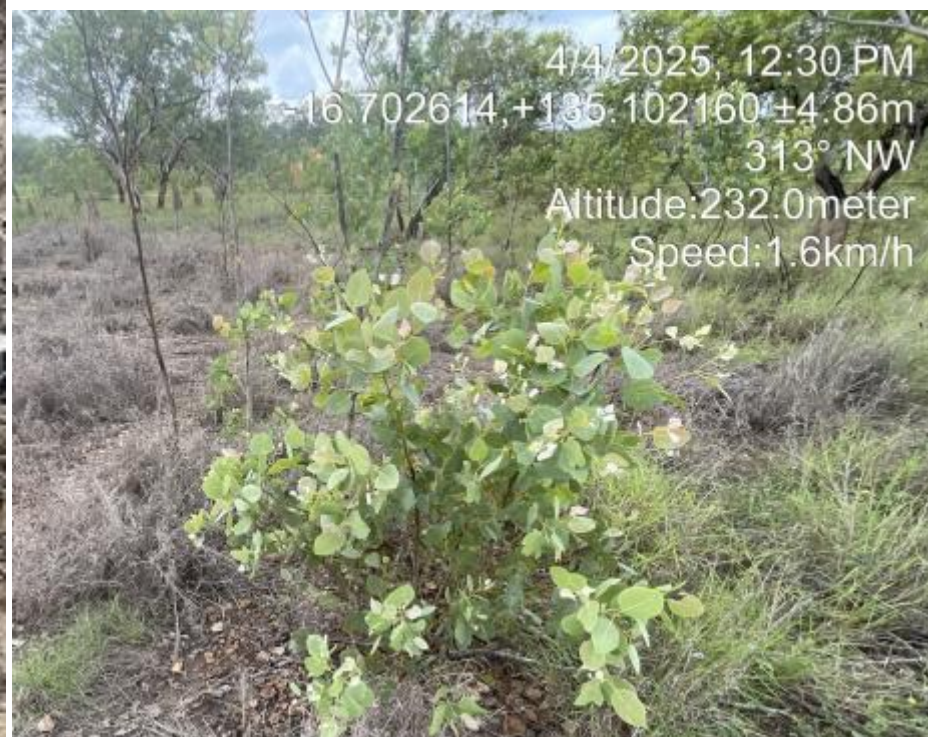
Vegetation Recovery 70 days after Incident
