# Quarterly Recordable Incident Report

Section 2 – Recordable Incident Report Details							
<b>EMP title (petroleum title/s)</b>	Beetaloo Basin Shenandoah South E&A Program Environment Management Plan (TAM1-3) EP 117 and EP 98	<b>Unique EMP ID</b>	TAM1-3	<b>Date Submitted</b>	15 April 2025	<b>Nil report?</b>	<input type="checkbox"/> Yes <input checked="" type="checkbox"/> No
<b>Activity type</b>	Petroleum Exploration and Appraisal program including civil construction, well drilling, hydraulic fracture stimulation.	<b>Reporting Period<sup>1</sup></b>	Quarter:	1	Year:	2025

## SUPPORTING DOCUMENTS

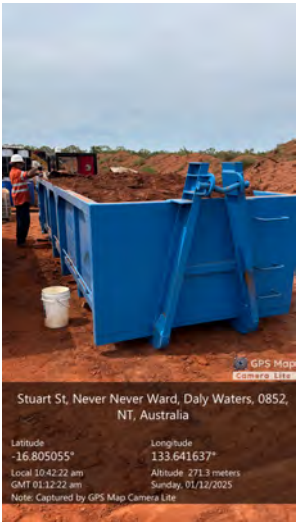
SS2-contaminated soil recovered from under drill rig2.JPG

Spill from rig being pressure washed after drilling operations completed.

The fluid that went to the drill pad was bore water mixed with residual non-hazardous drilling mud that had dried on equipment. An area of 25 m3 of hardstand was removed into 2 x skip bins. Soil was excavated to 10 cm during the clean-up process. All fluid was retained on the SS2 well pad that is bunded and contained in the operational area. No offsite release occurred.

1. Drilling operations were completed for the campaign and the rig was being washed down prior to stacking. H&P are required to wash the rig package prior to stacking to ensure residual drilling mud is removed to prevent corrosion/rust AND
2. The bunding underneath was insufficient to contain wash water.

The bunding sustained damage when moving/skidding equipment between wells. The bunding was in multiple small pieces which had shifted and allowed water to seep between and under each individual piece. AND as bore water being used for the washing process, the holes in the bunding were not recognised by the rig crew as a potential contaminant/hazard.

1. The bunding was not sufficient to hold all of the wash-water. It had sustained damage when skidding equipment between the two wells.
2. The bunding was made up of multiple separate bunds which was sufficient for the drilling operations however, the size was unsuitable for washing and this allowed water to seep between and underneath the pieces of bunding during the wash down.

1. Impacted soil was cleaned up, stockpiled in skip bins and sampled.
2. Wash-down of rig and equipment to be included in planning for CY25 drilling campaign
3. Review and revise bunding requirements and strategy in conjunction with H&P. Review to include size, shape and material to ensure suitability of the rig to skid without damaging.
4. Environmental toolboxes talk and daily pre-start discussions to cover off on environmental obligations, hazards and stop the job expectations in respect to spills and releases.

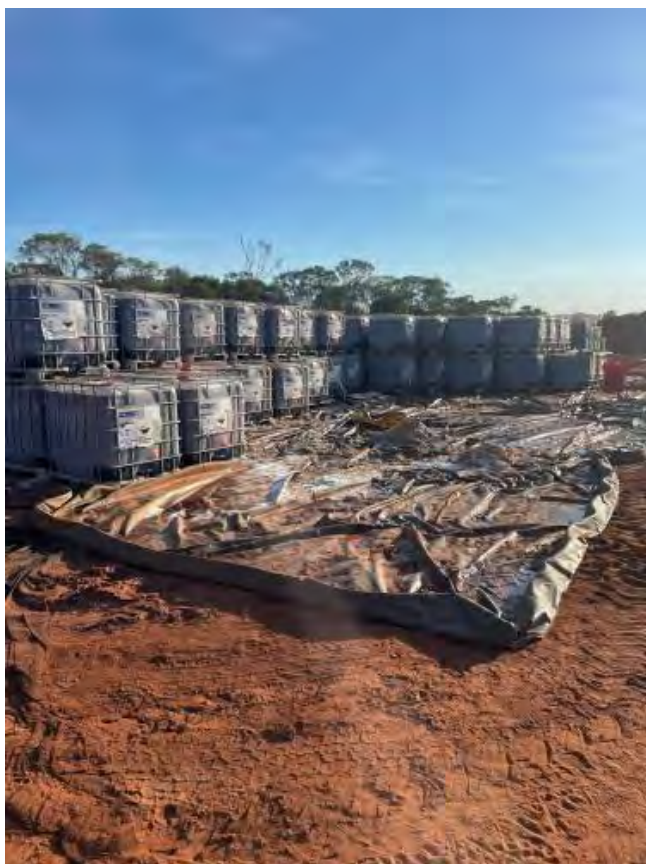
Acid 1.jpg

During pumping operations, the telehandler operator was attempting to pick up an IBC of hydrochloric acid (HCl) to lift into the acid storage tank when he inadvertently pierced the IBC, causing 387 litres (100 gallons) to spill onto the bunding.

EC 28/1: chemical spill was fully contained on bunding and cleaned up using soda ash. Nil spill to grade.

The chemical bunding had shifted and was bunched up in front of the IBC blocking the operators view of the IBC AND a spotter was not used.

- A spotter was not used.
- The operator did not stop the job and ask for help
- Spill response was enacted quickly which ensured the whole tote of acid was not spilt.

- Ensure a spotter is used when shifting all chemical totes.
- Review lighting at the chemical storage area to confirm that is sufficient for nighttime operations.
