Darwin-Palmerston and Estuary

Summary

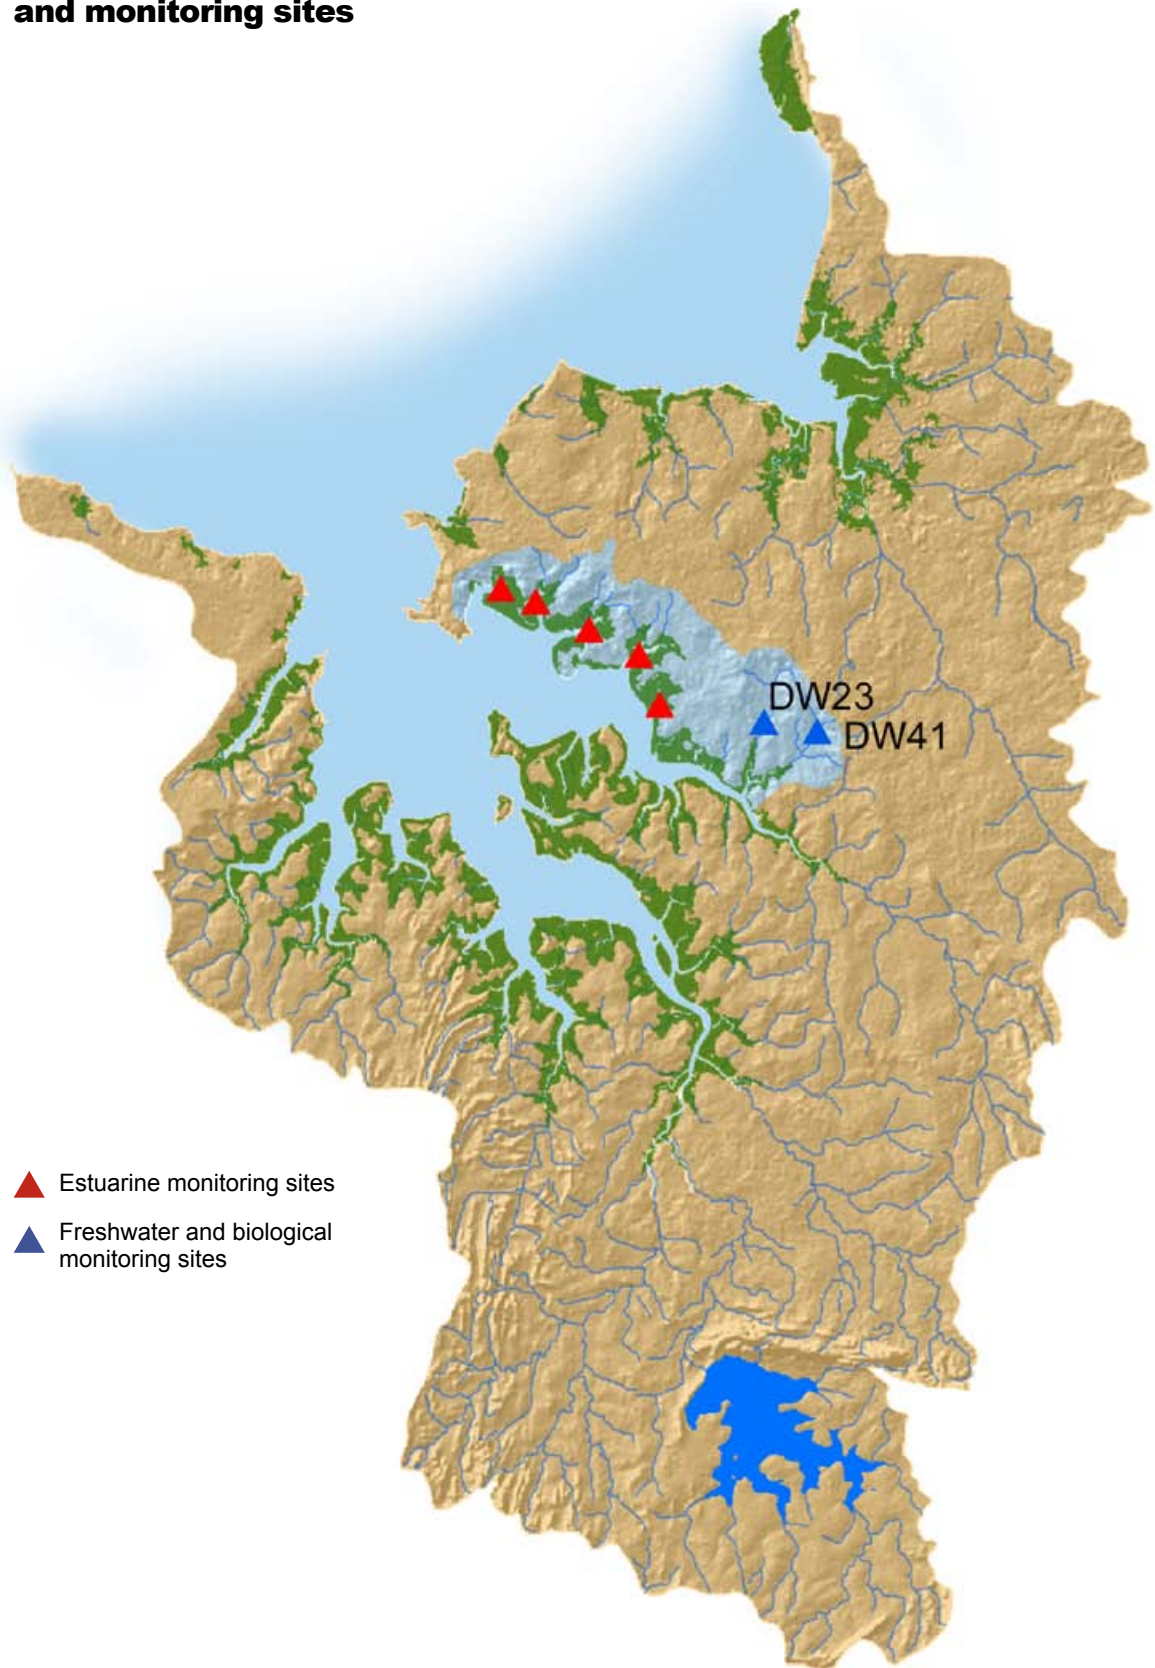
Darwin-Palmerston area catchment showing rivers and monitoring sites

Estuarine monitoring sites
-

Freshwater and biological monitoring sites

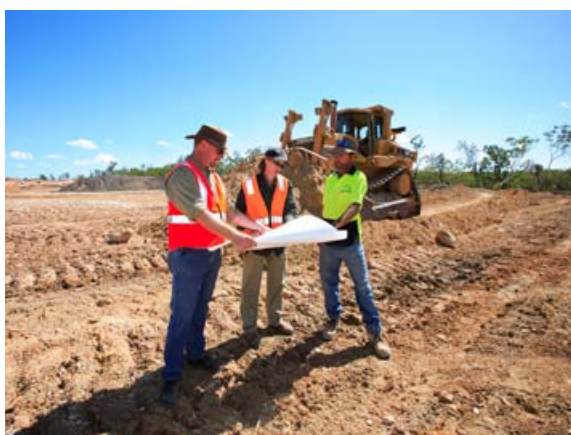
‘Water sensitive urban design’ (WSUD) features that are being planned in Johnston and Bellamack will help improve stormwater quality draining from new urban areas to Mitchell Creek.

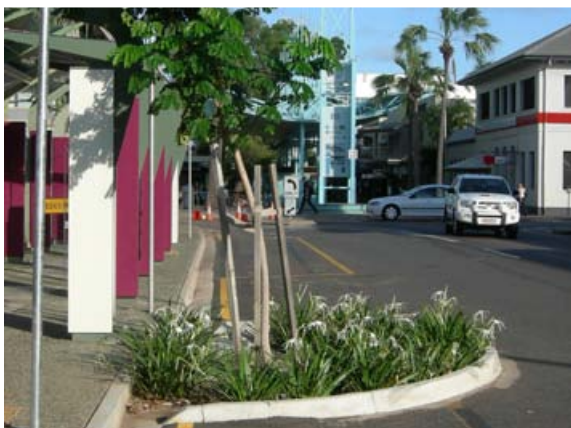
Darwin City Council has installed raingardens to treat road runoff from Mitchell St. Water flows into the street raingarden and slowly filters through the soil. Photo: Equatica.
