Regulatory Statement: Imperial Oil and Gas Pty Ltd compliance with 2021-2025 EP187 Work Program EMP

Detection of non-compliance

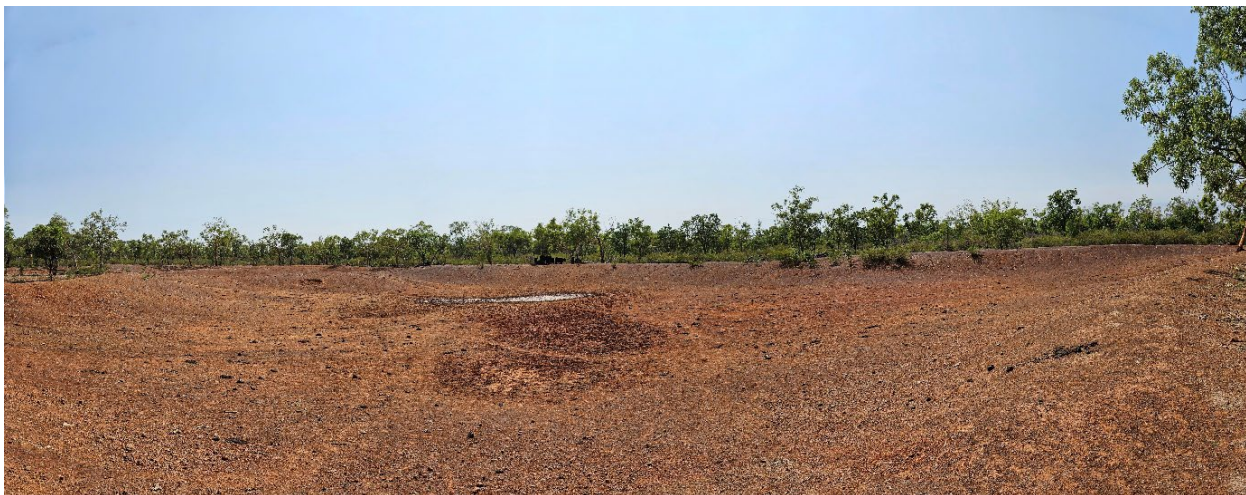
- A 1 hectare gravel pit (Figure 1) constructed North of the Carpentaria-4 well pad outside the areas identified in the EMP, as recorded in the [recordable incident report](#).
- A small corner portion (0.4 hectare) of the cleared Carpenaria-4 well pad (3 hectares) breaching the 100-metre riparian zone buffer of Relief Creek (Figure 2).

Figure 1: Image of Gravel Pit taken November 2024 during a site inspection

The Department confirmed the unauthorised clearing against drone imagery and GPS data and sent correspondence to Imperial, noting the observations. As a result, Imperial ceased use of the gravel pit and proposed rehabilitation measures for the well pad.

In 2024, Imperial submitted a new EMP ([Carpentaria Pilot Project](#)) which included the unauthorised gravel pit area. The plan was reviewed by NTG agencies and advice was received that the gravel pit was not located in a sensitive environment (e.g. high-value vegetation for threatened species, or areas with many hollow-bearing trees).

Approval of an EMP will only be granted if risks are demonstrated to be as low as reasonably practicable and reduced to acceptable levels. The EMP was approved on 12 November 2024 and no further action was taken by the Department for this incident.

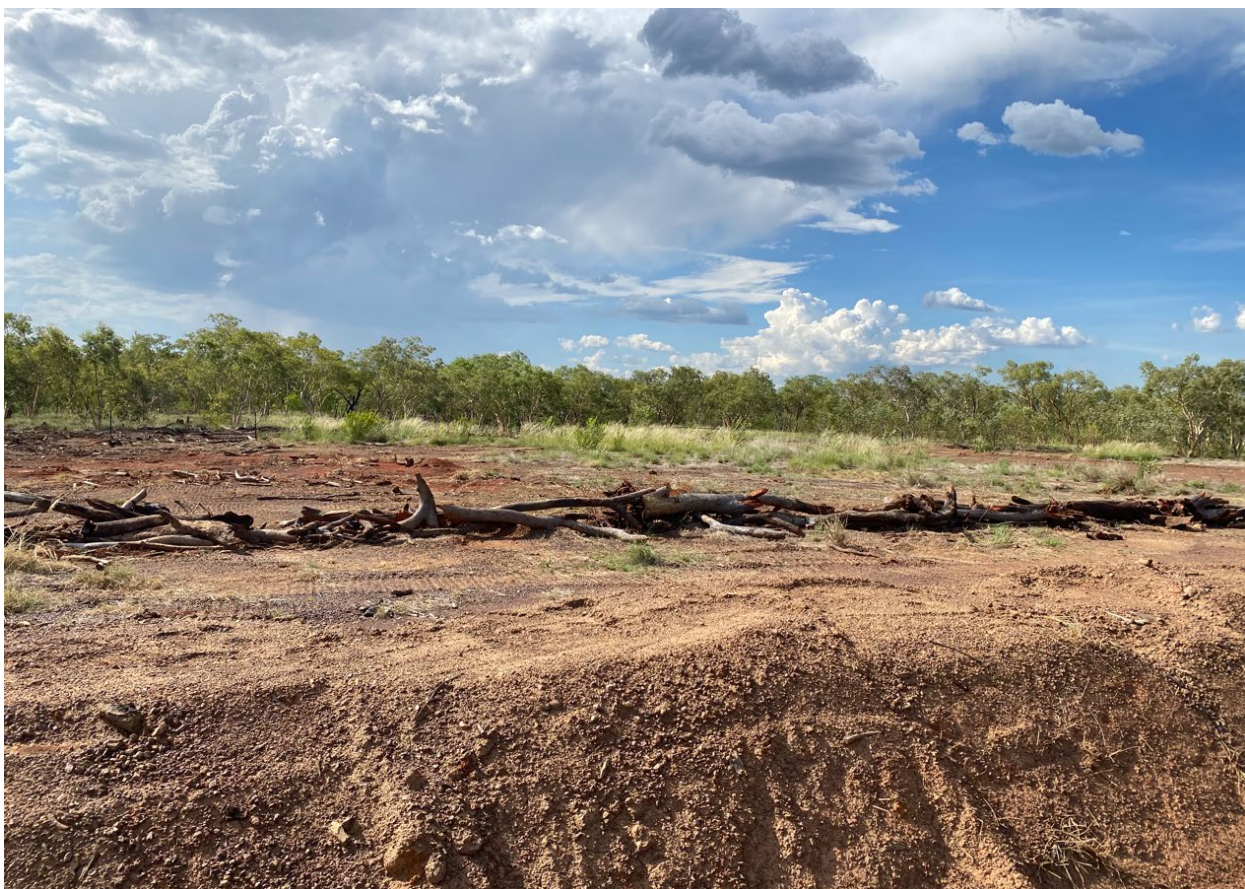
Figure 3: Image of Carpentaria-4 well pad rehabilitation area taken December 2024

This included reviews of submitted Rehabilitation Plans and follow-up site inspections that confirmed Imperial had commenced rehabilitation of the section of the well pad (Figure 2 & 3).

The Department is and will continue to monitor the rehabilitation of the well pad area through site inspections and drone imagery.
