**ALICE SPRINGS HOSPITAL AMBULATORY CARE UNIT, RENAL DIALYSIS UNIT TRANSPORT
IMPACT ASSESSMENT**

Appendix B AS Constructed Drawings Multi level Car Park Lot 4579
June 25, 2024

Alice Springs Hospital-Ambulatory Care unit, Renal Dialysis Centre - Road Safety Inspection: Corrective Action Report

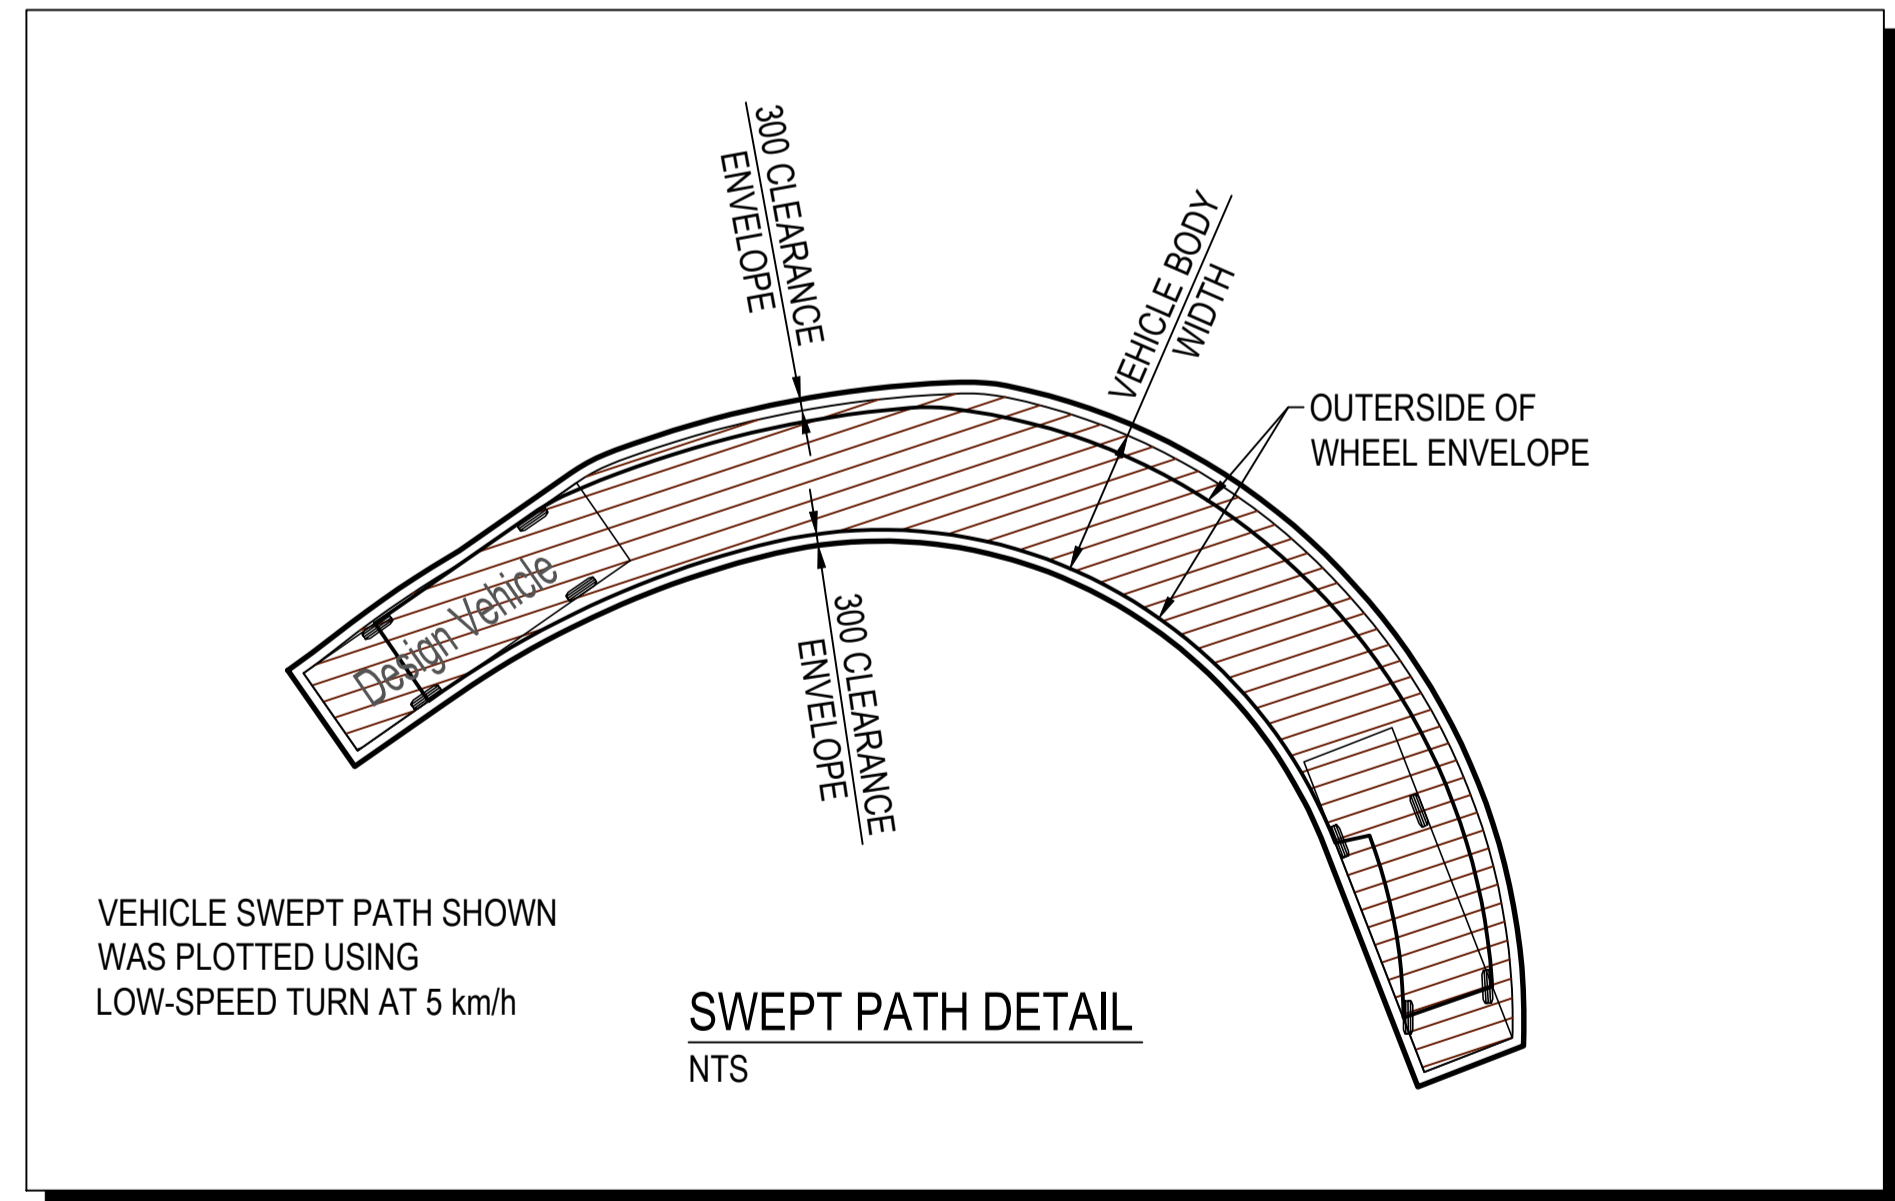
SWEPT PATH DESIGN VEHICLE
 NTS

Service Vehicle (8.8 m)
 Overall Length 8.800m
 Overall Width 2.500m
 Overall Body Height 4.300m
 Min Body Ground Clearance 0.427m
 Track Width 2.500m
 Lock-to-lock time 4.00s
 Curb to Curb Turning Radius 12.500m

ALICE SPRINGS REGION GAP ROAD, ALICE SPRINGS, NT 0870 AMBULATORY CARE DIALYSIS UNIT DROP-OFF AREA - RIGHT IN SWEPT PATH - 8.8m SERVICE VEHICLE (AUSTRADS)			
NTG Project No. -	NTG Asset No. -	Sheet Reference SK023 OF -	NTG Drawing No. Amendment DZ2114-SK-023 A A1

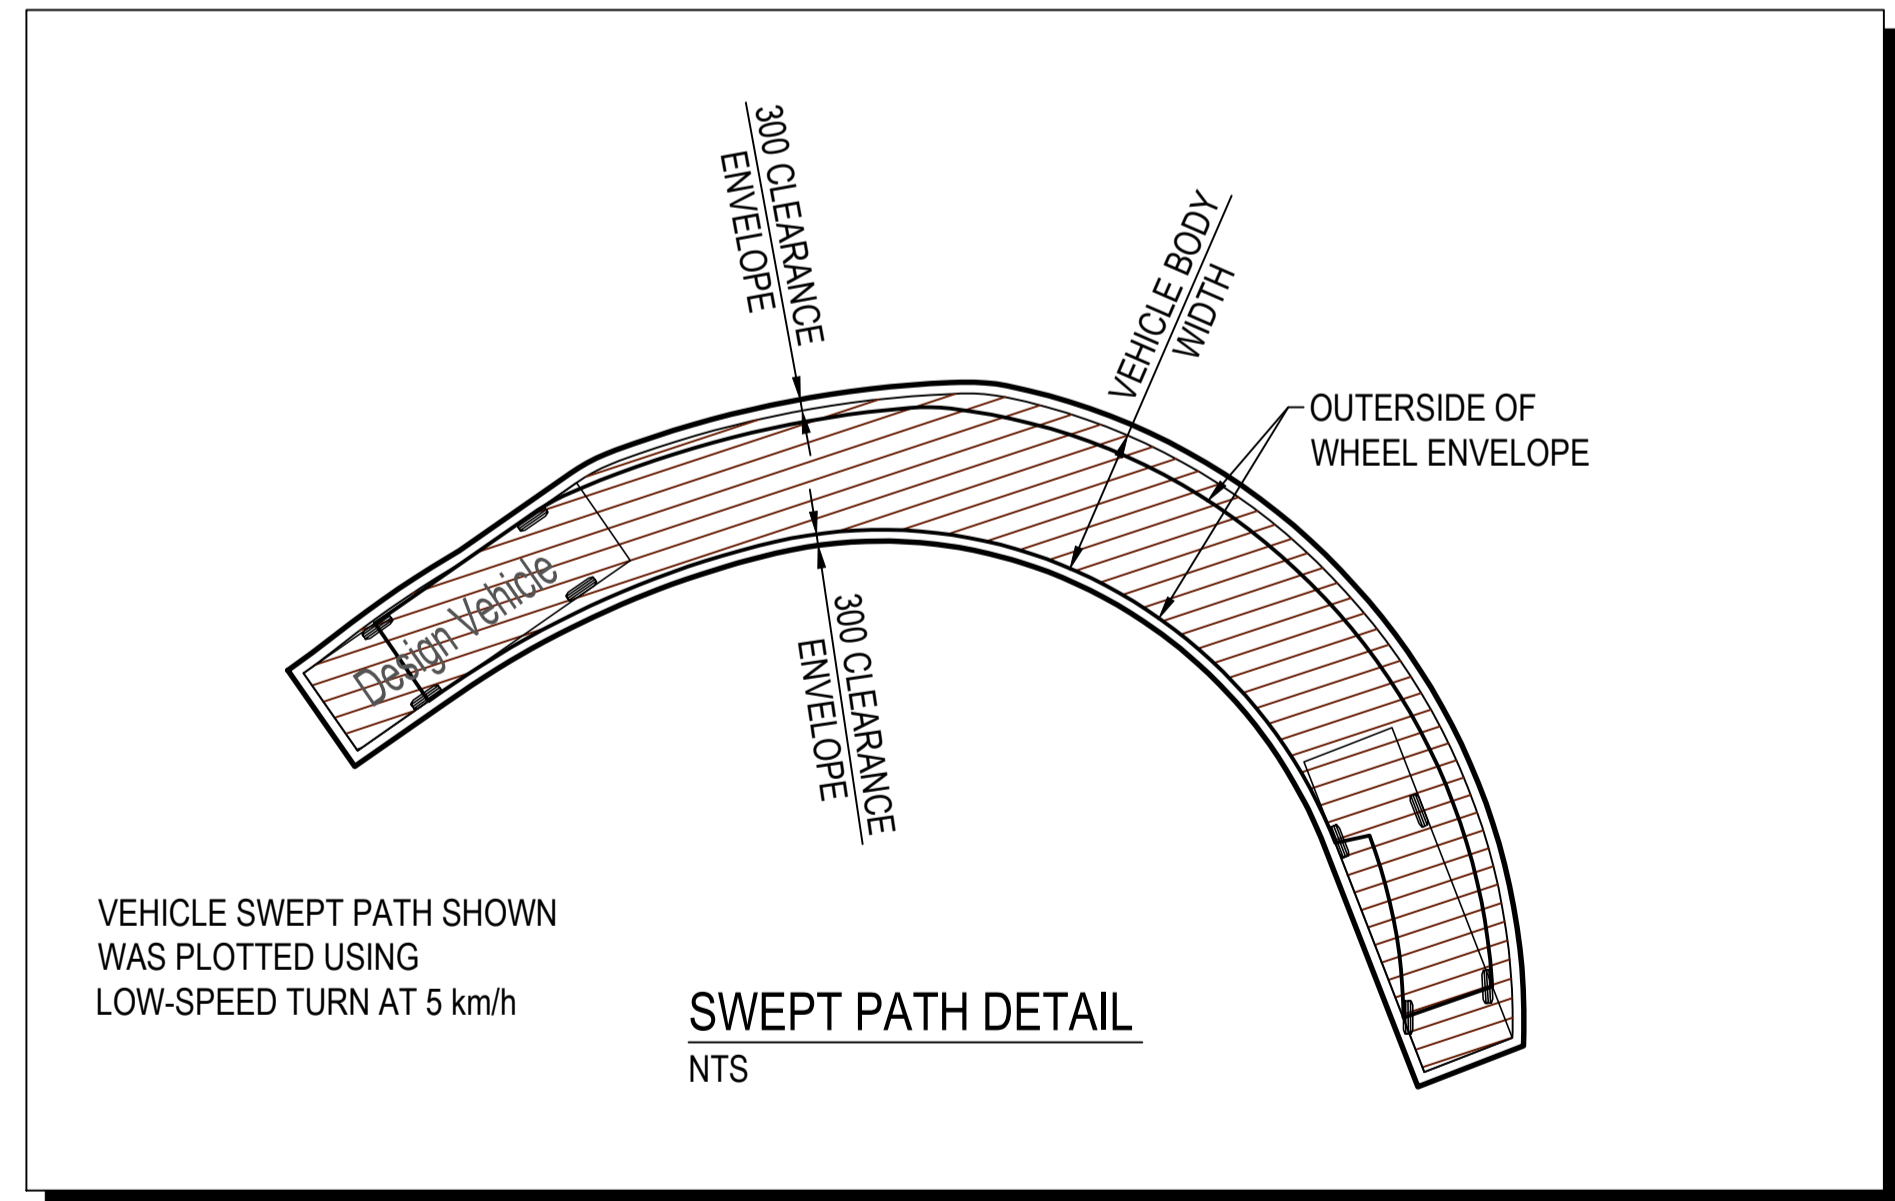
SWEPT PATH DESIGN VEHICLE
 NTS

FIRE TRUCK 8.2m (Scania P320 DB 4X2 HNA)
 Overall Length 8.200m
 Overall Width 2.500m
 Overall Body Height 3.100m
 Min Body Ground Clearance 0.427m
 Track Width 2.500m
 Lock-to-lock time 4.00s
 Curb to Curb Turning Radius 9.250m

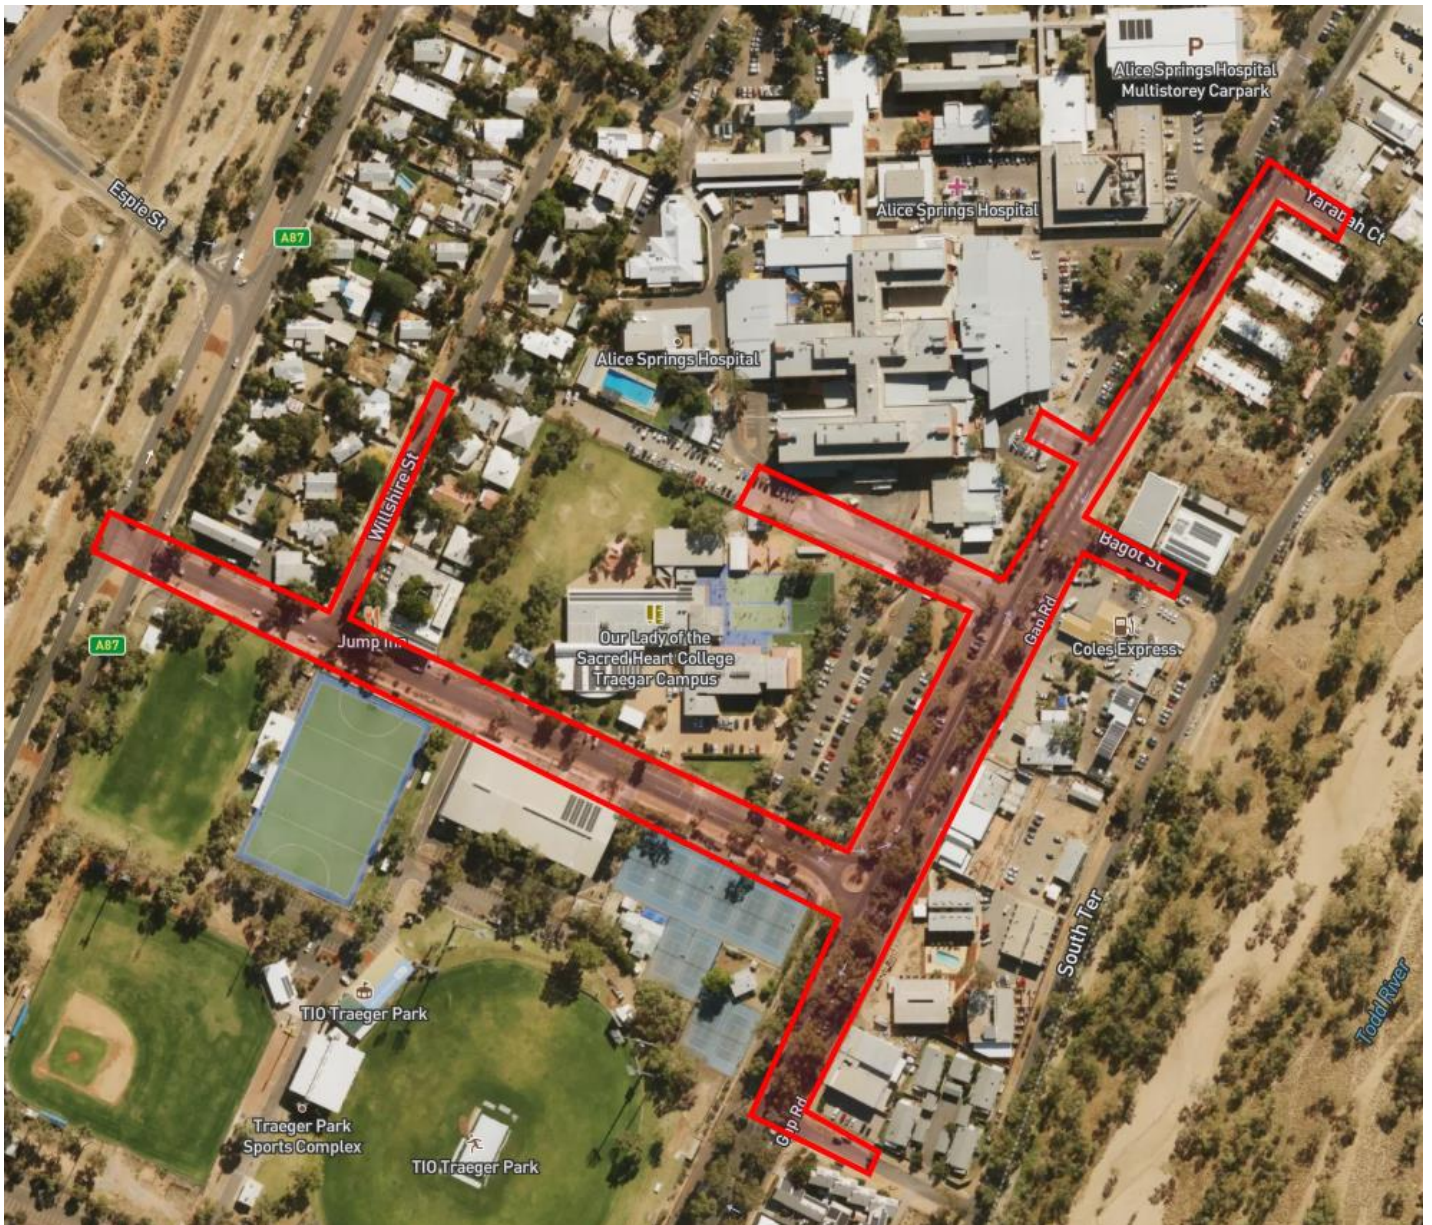
Figure 3-3 Crash data area

The crash history for site was provided by Road Safety NT and includes the reported crash data for the previous 10 years. As shown below in **Figure 3-3**, the road sections which the crash data was assessed for are:

A review of the crash data provided showed that between 2013 and 2023, 54 incidents were recorded and 96 people involved.

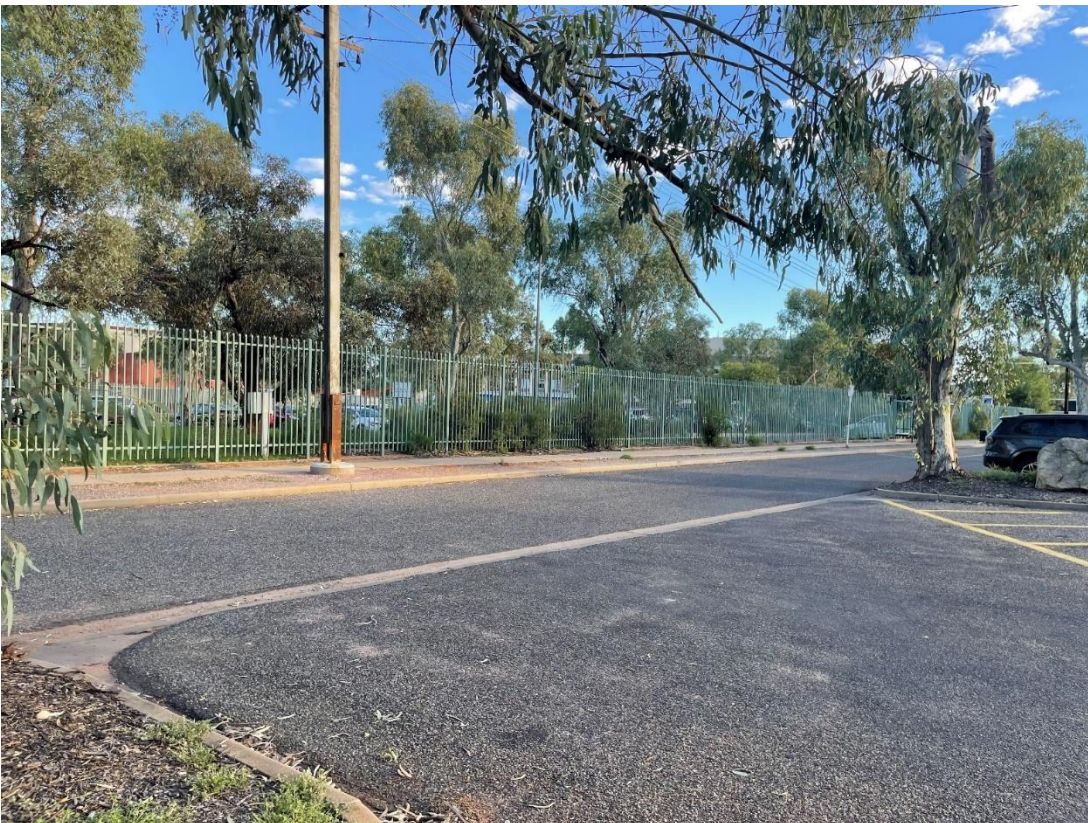
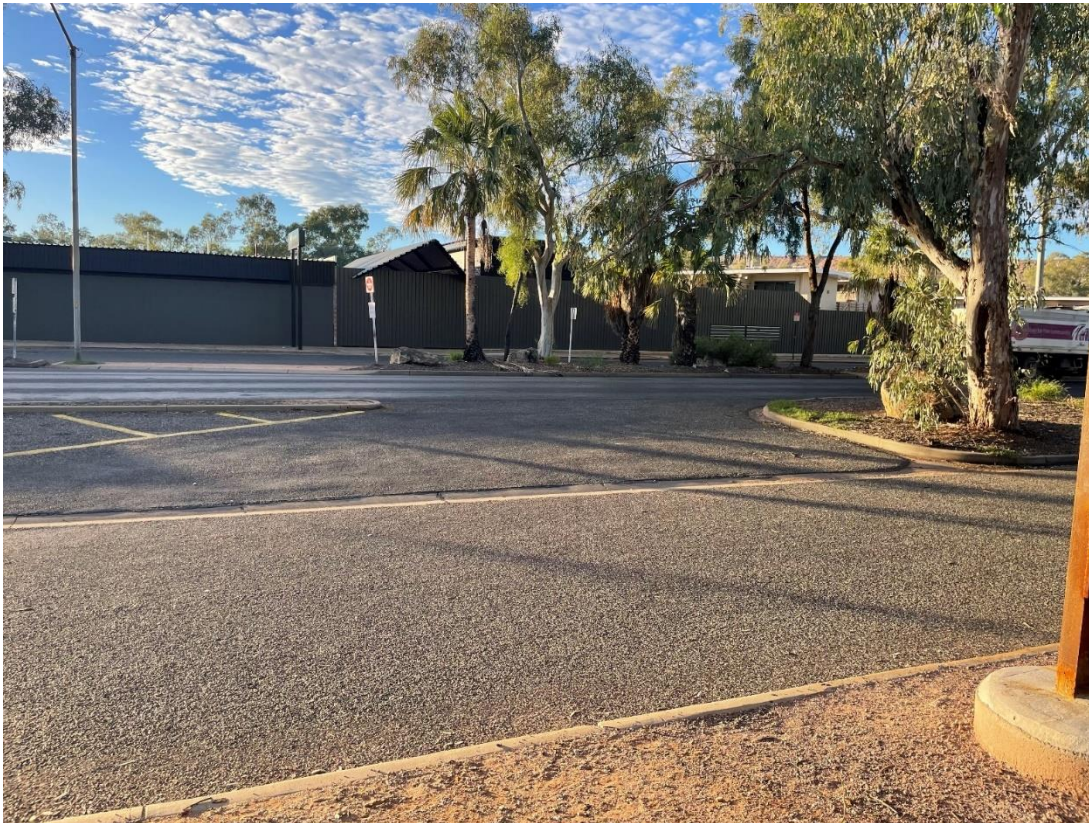
Figure A 2 Power pole close to proposed access point

2	<p>Power pole close to the access point –Service road</p> <p>During the site visit it was noted that the power pole is located in close proximity to the access point. Sufficient clearance should be provided between the pole and the access point to remove the potential for ‘hit object’ type crashes.</p> <p>Refer to Figure A 2 and Figure A 3.</p>	<p>Recommendation</p> <p>Provide sufficient clearance between the access point and the power pole and provide swept path analysis to demonstrate that the location of the power pole won’t interfere with vehicles accessing the site.</p>	Important		
3	<p>Parking bays located opposite of the bus stop bay</p> <p>It was observed that there are parking bays located opposite to the bus stop bay. There is the potential for vehicles accessing / egressing these bays to cause ‘side impact’ crashes where buses are using the bus stop as the effective carriage width will be significantly reduced.</p> <p>Refer to Figure A 4 and Figure A 5</p>	<p>Recommendation</p> <p>If the bus stop is used by buses for long waits, it is recommended for the parking bays to be removed, otherwise no modifications are required as the risk is minimal.</p>	Comment

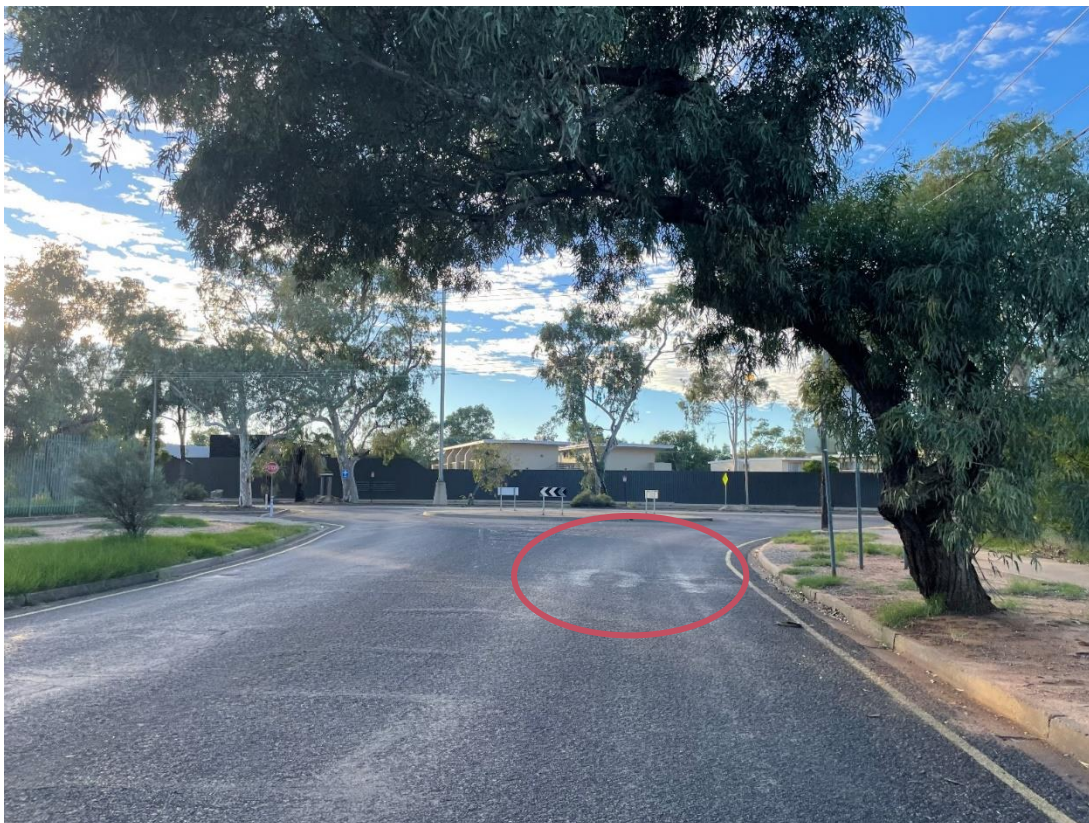
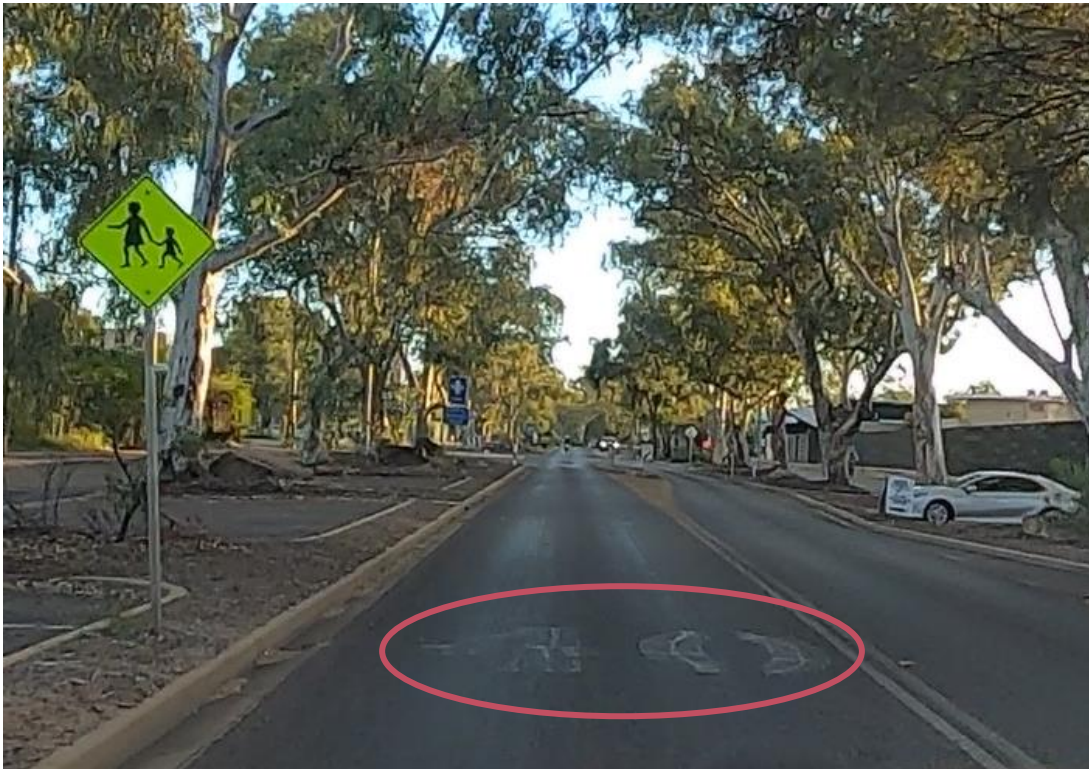
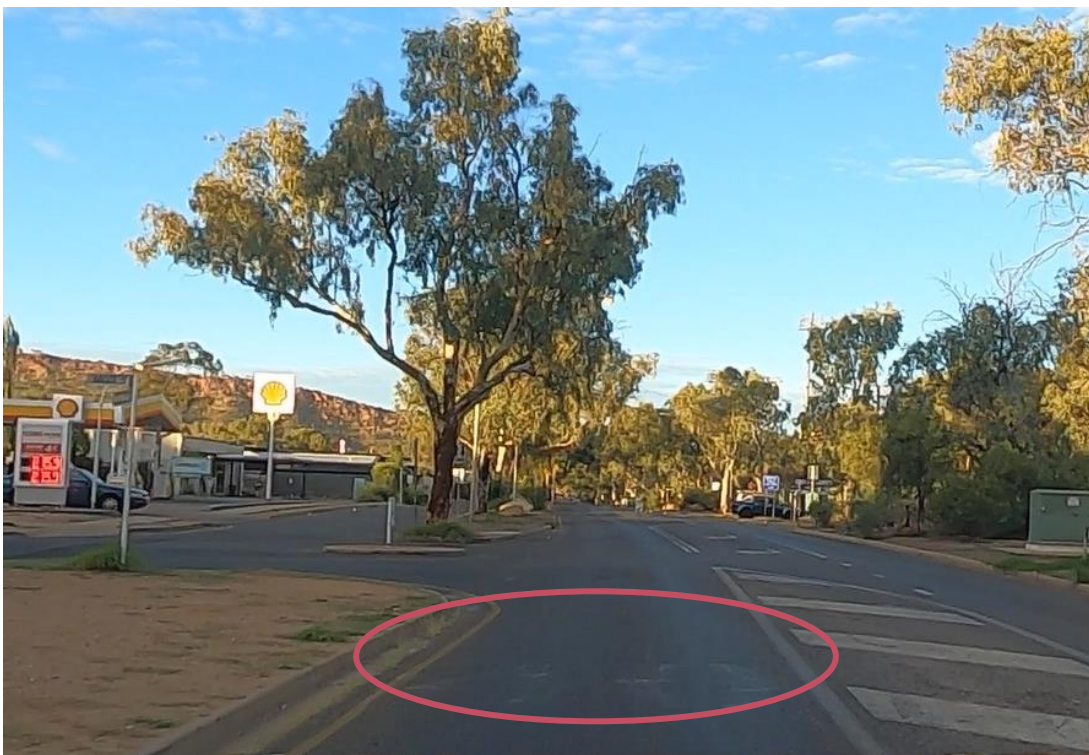
Figure A 6 Faded 40km/h speed limit pavement marking

4	<p>Faded 40km/h speed limit pavement marking within the area</p> <p>The 40km/h speed limit pavement markings along Gap Road and Traeger Avenue were observed to be faded and generally indistinguishable.</p> <p>Worn or faded pavement markings may result in poor execution of required speed reductions / adherence to speed limits. Drivers may not be able to see the pavement markings resulting in speeding behaviours in a school and hospital zone.</p> <p>Refer to Figure A 6, Figure A 7, and Figure A 8</p>	<p>Recommendation</p> <p>Reinstate 40km/h pavement markings</p>	Moderate		
5	<p>Lack of shared path connection between Bus stop and existing path</p> <p>There is a lack of shared path connection between the bus stop 1071 (southbound) located on Gap Road and the existing path and pedestrian crossing located south of the bus stop.</p> <p>Due to the lack of shared paths, pedestrians are more likely to walk within the road carriageway increasing the risk of collisions with vehicles.</p> <p>Chances of survival for a hit pedestrian type of crash diminish rapidly at impact speeds above 30km/h.</p> <p>Refer to Figure A 9.</p>	<p>Recommendation</p> <p>Provide shared path to connect the bus stop with the existing shared path and pedestrian crossing facilities. Path to be provided to minimise total road crossing points for pedestrians thus minimising pedestrian/ vehicle interactions.</p>	Moderate

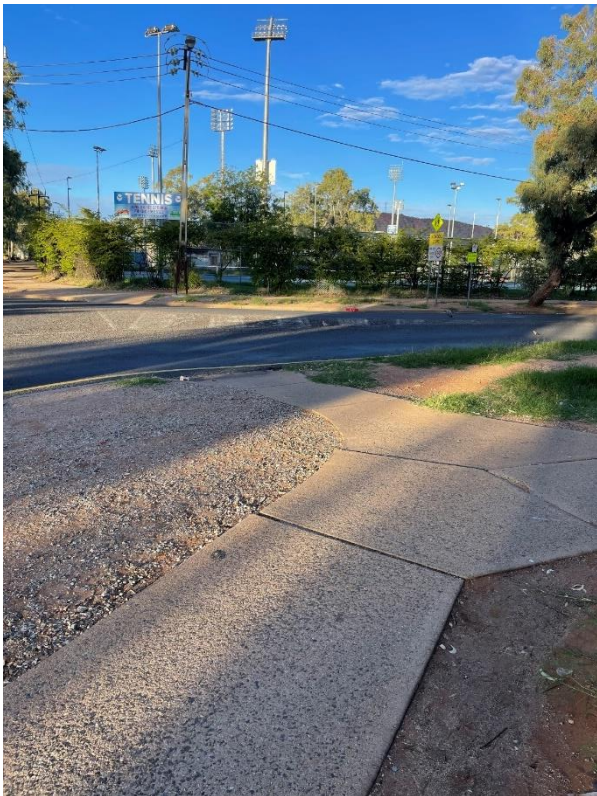
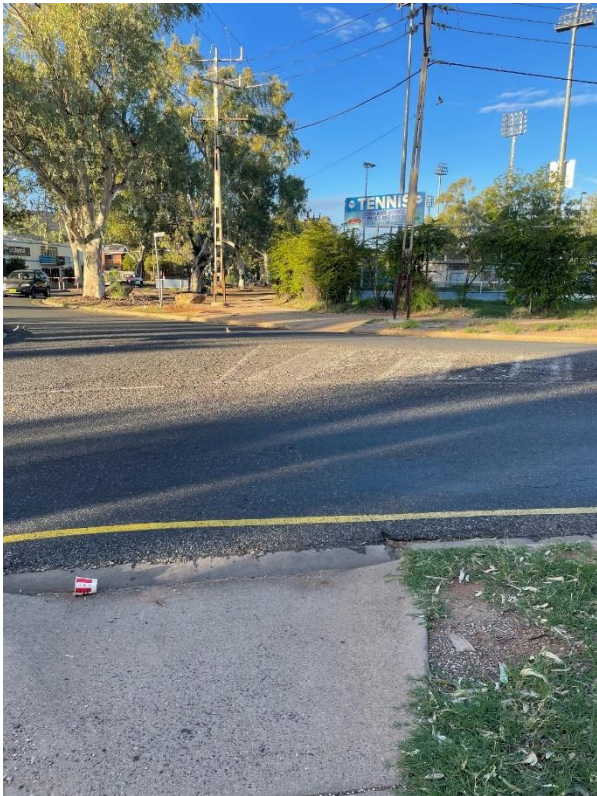
Figure A 10 Misaligned Pram ramps and long crossing distance

6	<p>Misaligned Pram ramps and long crossing distance with no median Traeger Avenue</p> <p>The pedestrian crossing at Traeger Avenue has misaligned Kerb ramps and long crossing distance.</p> <p>Misaligned kerb ramps at pedestrian crossings could inadvertently lead visually impaired persons towards kerbing,</p>	<p>Recommendation</p> <p>Realign kerb ramps and reduce the effective crossing distance by installing a median (refuge) with cut-through for pedestrians to allow for crossing in two movements.</p>	Critical

<p>creating a potential trip hazard or lead them towards traffic increasing the risk of pedestrian related crashes.</p> <p>Long pedestrian crossing distance increase pedestrian's exposure, especially for elderly or pedestrians with movement impairment which often travel at a slower speed.</p> <p>Refer to Figure A 10 and Figure A 11</p>				
7	<p>Non-compliant 'No Stopping' sign R5-35</p> <p>There are non-compliant 'No-stopping' signs R5-35 along Traeger Avenue. The size and position are difficult to be seen by motorists.</p> <p>The existing size and location of the signs may result in poor execution of the instruction of the sign resulting in vehicles stopping along this road increasing the risk of a wide range of collisions.</p> <p>As per AS1742.10 section 6.4, the section of road adjacent to a pedestrian crossing where stopping of vehicles is prohibited shall be indicated either by the no stopping sign R5-35 or by pavement marking.</p> <p>Refer to Figure A 12</p>	<p>Recommendation</p> <p>Replace the existing No Stopping signs and install them as per AS1742.10 Figure 1</p>	Moderate

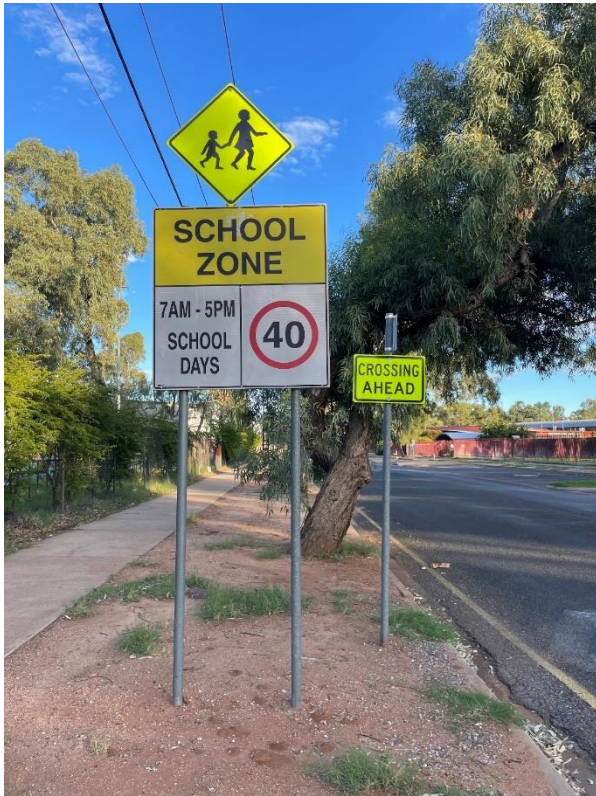
Figure A 13 Non-compliant school zone signs

8	<p>Non-compliant 'Crossing Ahead' supplementary plate W8-22 and school zone signs</p> <p>The 'Crossing Ahead' supplementary plate installed on Traeger Avenue is non-compliant. AS1742.10 section 11.2 states that the crossing ahead W8-22 sign shall not be used without the Children W6-3 sign. The 'Crossing Ahead' supplementary plate may be used in advance of a mid-block crossing.</p>	<p>Recommendation</p> <p>Provide children crossing signs at Gap Road and Traeger Avenue as per AS 1742.10 section 7.2 and Figure 3 and school zone signs as per the approved signs for the Northern Territory (Refer to Figure A 14.)</p>	Moderate

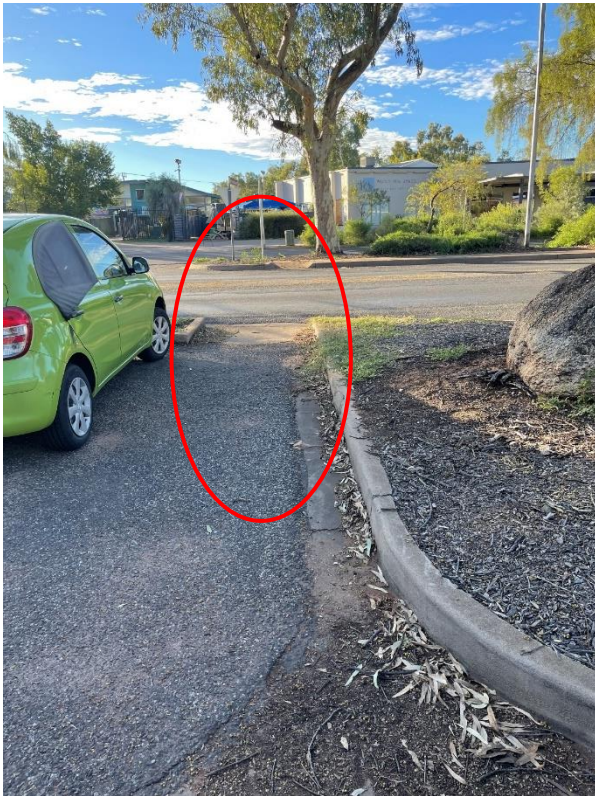
Figure A 21 Pedestrian crossing on Gap Road south of Hospital Access Road

12	<p>Pedestrian crossings in poor condition</p> <p>There are seven (7) pedestrian crossings within the study area located as follow</p> <p>-Pedestrian crossing on Gap Road south of Traeger Avenue</p>	<p>Recommendation</p> <p>Improve the general condition of the pedestrian crossing points, including width, aligned pram</p>	Moderate

<ul style="list-style-type: none"> -Pedestrian crossing on Gap Road north of Traeger Avenue -Pedestrian crossing on Gap Road south of Hospital Access Road -Pedestrian crossing on The Hospital access road close to Gap Road -Pedestrian crossing on The Hospital access road midblock -Pedestrian crossing on Traeger Avenue close to Gap Road -Pedestrian crossing on Traeger Avenue midblock <p>The crossing points are generally in poor condition, with a lack of TGSIs, narrow paths, misaligned kerb ramps, non-compliant steps at the transition to/from the roadway, etc.</p> <p>Due to the crossings being located close to hospital, medical facilities and a school, it is expected pedestrians using the crossing points will include vulnerable road users such as children, elderly, and people with disabilities. Narrow shared paths and pram ramps do not provide the conditions for wheelchairs, cyclists, or other active transport modes to use the path.</p> <p>Pedestrian crossings in poor condition and with restricted visibility to motorists increase the risk of collision between vehicles and pedestrians. The chances of survival of a hit pedestrian crash decreases rapidly above 30km/h speed environment. The area has a speed limit of 40km/h.</p> <p>A lack of TGSIs increase the risk of vision-impaired users being able to safely assess the location and direction of the crossing. According to AS1428.4.1, TGSIs provide cues which when combined with other environmental information, assist people who are blind or vision-impaired with their orientation.</p>	<p>ramps, TGSIs, and signs as per Australian Standards.</p>

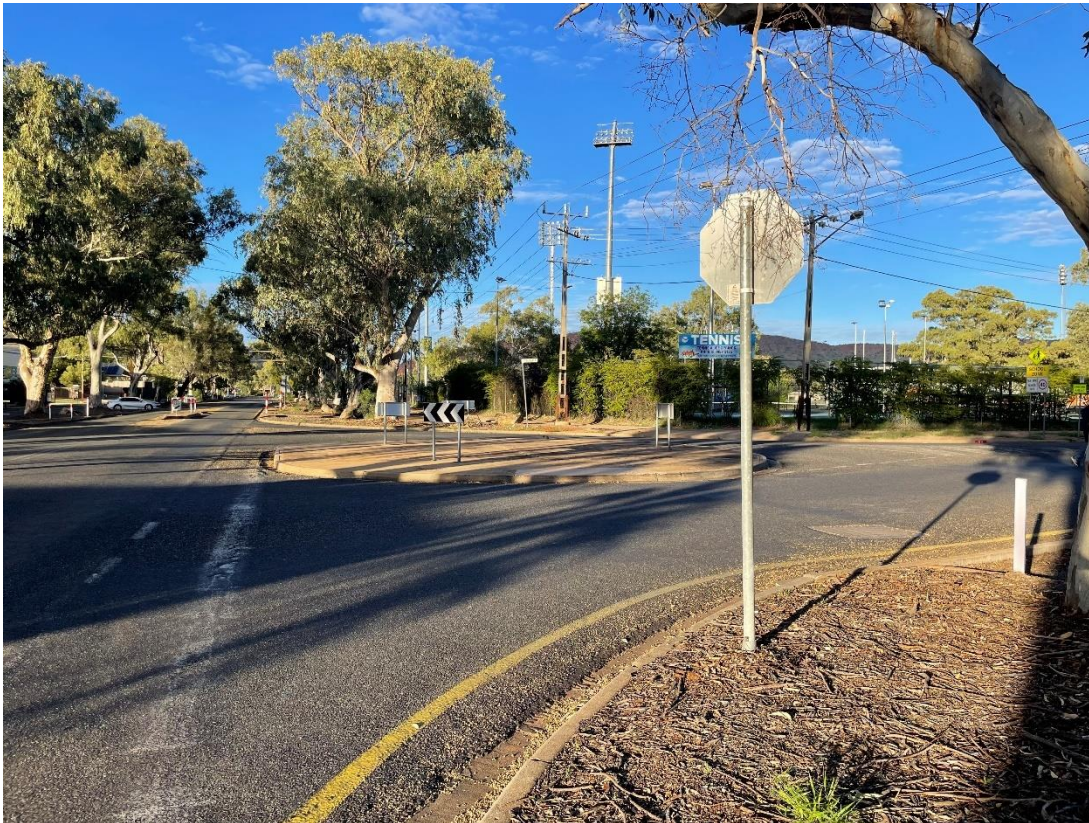
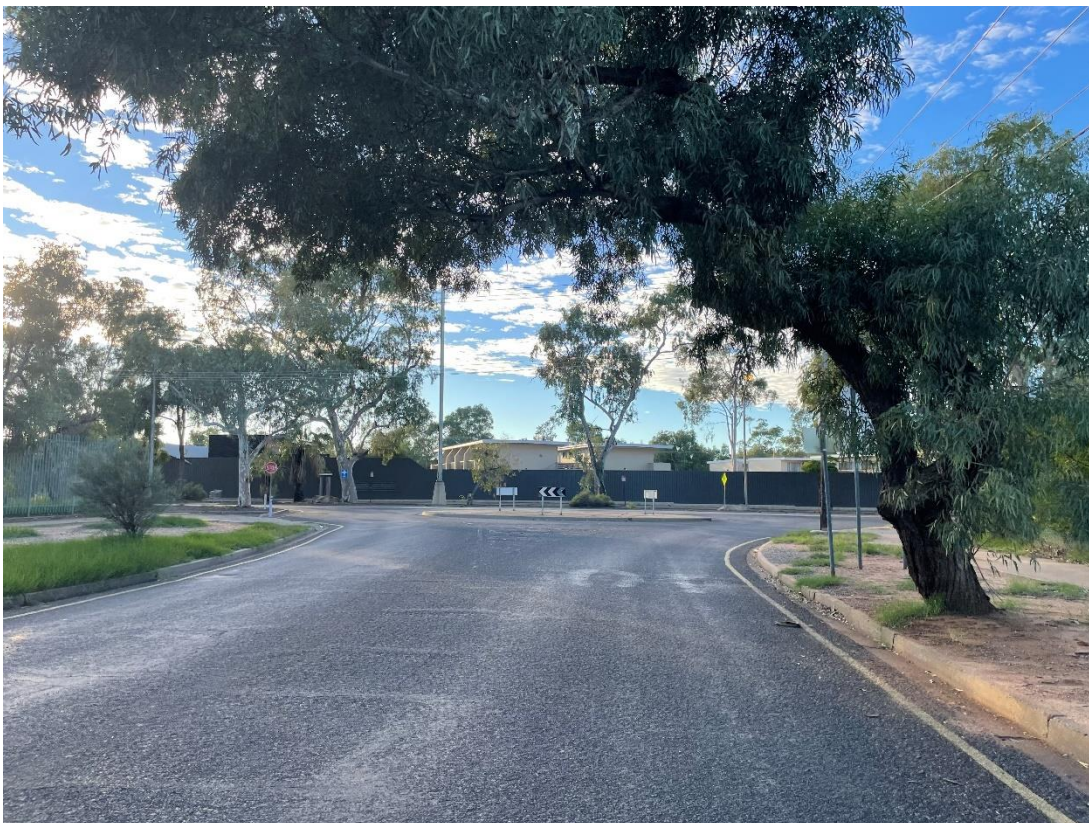
Figure A 29 Traffic island rounded shape

15	<p>Traffic island rounded shape at Traeger Avenue / Gap Road intersection</p> <p>The traffic island at the Traeger Avenue / Gap Road intersection has a rounded shape (resembling a roundabout). In its current arrangement, there is the potential for motorists travelling along Traeger Road to misinterpret the function of this island as a round-a-bout and enter the Gap Road traffic stream thinking they have right of way.</p> <p>It has been noted that the traffic count surveys recorded some traffic volumes as U turn manoeuvres.</p> <p>Refer to Figure A 29, and Figure A 30</p>	<p>Recommendation</p> <p>Remove the round shaped island and construct a traffic island as per Australian Guidelines.</p>	Important		
16	<p>Road restriction due to R-Turn vehicles into the proposed site</p> <p>The project design drawings do not show any modifications to Gap Road to provide a turning pocket for motorists entering the Renal Dialysis site. There is the potential for vehicles waiting to turn Right into the site preventing through movements for other vehicles travelling South, including emergency vehicles.</p>	<p>Recommendation</p> <p>For instances there is a queue of vehicles waiting to access the proposed site, ambulances travelling southbound from the Hospital, have two opportunities to access the service road before reaching any queue. Which would allow them to bypass any short-term blockage. No action required.</p>	Comment

The upgrade of the roundabout at the corner of Gap Road and Traeger Avenue to an island, including associated upgrades to road reserves (kerb crossovers and driveways, pedestrian and bike access, sightlines, and works within verges and carriageways) as recommended in the Road safety inspection: corrective action report, must be completed prior to the occupation of the development or in accordance with a staged program approved to the satisfaction of the Director Technical Services, Alice Springs Town Council, at no cost to the Council.

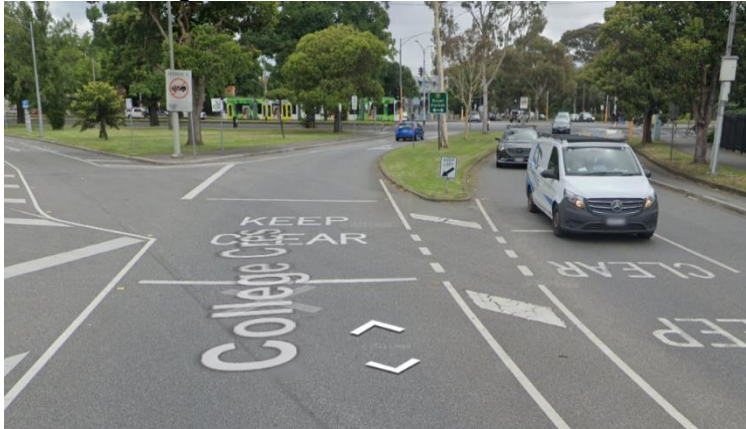
A similar example is presented below (from Victoria) where the continuous lanes have been modified to allow vehicles to turn right.
