Attachment 1: EcOz 12-month sampling report

PV 12 Drilling Operation Overspray from Flare Pit Annual Monitoring Report, July 2023

EcOz Environmental Consultants (EcOz) was engaged by Central Petroleum (CTP) to conduct annual sampling of a flare pit overspray incident at the PV12 drill site that occurred in June 2022. Sampling was conducted by [REDACTED] (EcOz), with assistance from [REDACTED] (Central) on the 20 July 2023, and is the second sampling event to monitor this incident.

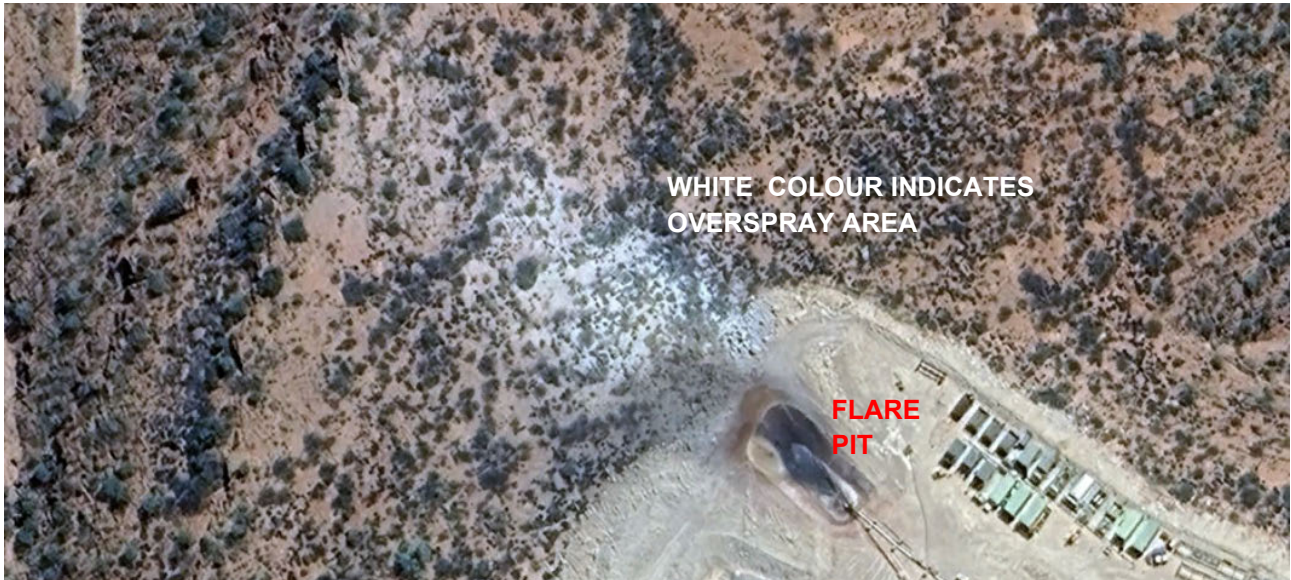
Figure 2: Google earth image of flare pit overspray (imagery date: 10 December 2022)

Following identification, and when it was safe to do so, samples of the residue were collected at five locations by the on-site Mud Engineer on the 9 November 2022 (sites locations shown in Figure 1). Analysis of the samples identified that the white residue was salt associated with evaporated salts from formation water, with concentrations decreasing further from the flare location (this was confirmed by sampling four background sample sites around the lease outside of the affected area - shown in Figure 1). Preliminary mapping of the deposition area indicates approximately 0.29 ha (approx. 30x65m) has been covered in varying levels of the residue (shown in Figure 1; the overspray area is visible on Google Earth imagery – Figure 2; photographs provided in Figure 3 and Figure 4).

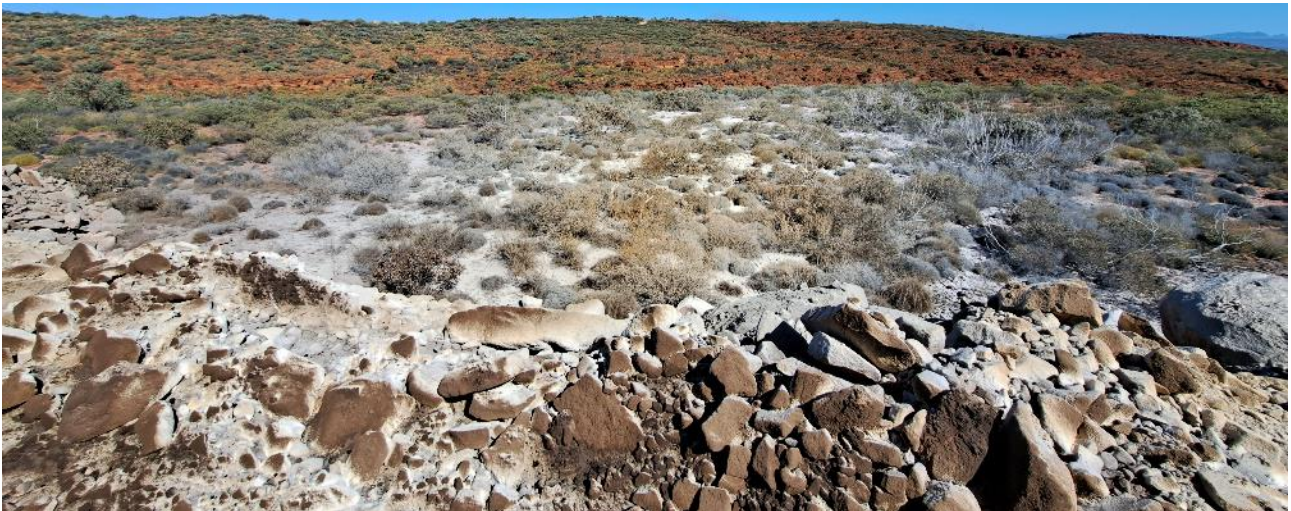
Figure 3: Photograph of flare pit overspray – view from drill pad (9 October 2022)

During a routine inspection on the 10 October 2022 on the PV12 well lease and surrounding area by the On-site Company Representative (OCR), an area was identified to the north-west of the PV-12 well lease where white residue was visible on the ground and vegetation.

Review of activities identified that this salt deposition may have arisen from an unexpected contact / intersection with a formation water zone during drilling of the well. Pre-planning did not anticipate formation water at this location in the well.

Once the subsurface team identified the location of the formation water, CTP ran an inflatable production packer in hole to isolate the water production zone from the gas producing zone. This packer was set and verified with a tag and overpull. This packer is designed to prevent formation water flowing into the well while allowing the gas zone above it to flow gas.

After initial assessment of the incident, sampling results and topography of the receiving environment, Central and specialist third party subject matter experts determined that a lesser impact would result from leaving the soil to naturally leach the salts than engage machinery or personnel into the environment and disturb the limited soil resource. This is aligned with the Key Principles for Remediation and Management of Contaminated Sites developed by the National Environment Protection Council, which details that if a contaminated site management strategy is likely to create a greater adverse effect than leaving the site undisturbed, clean up should not proceed.

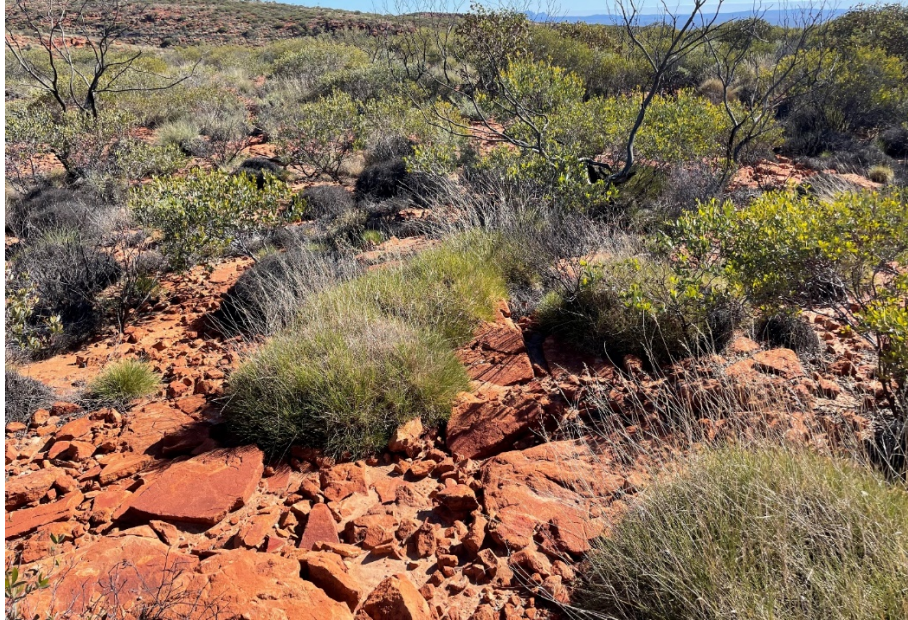
Figure 7: Photographs of the overspray area – 20 July 2023

There were no notable or obvious impacts from salt toxicity to vegetation health or condition within the affected area (refer to photographs in Figure 7). There was a small area of vegetation death / senescence close to the edge of the lease area (approximately 10m from edge) – however, this is assumed to be a result of heat damage from the flare rather than impacts from the overspray (in the future flare pit berms will be built higher and further away from vegetation to avoid vegetation impacts from heat from flare).

Vegetation within the affected area is in good condition, with the exception of the small area on the edge of flare (see below)

Concentrations are below NEPM (2013) health and ecological screening levels (where applicable) and there are currently no observable impacts to vegetation condition at the site given the senescence close to flare pit boundary is attributed to the heat from flare during the incident. Consequently, no further sampling of the overspray site is recommended and the site is considered remediated.

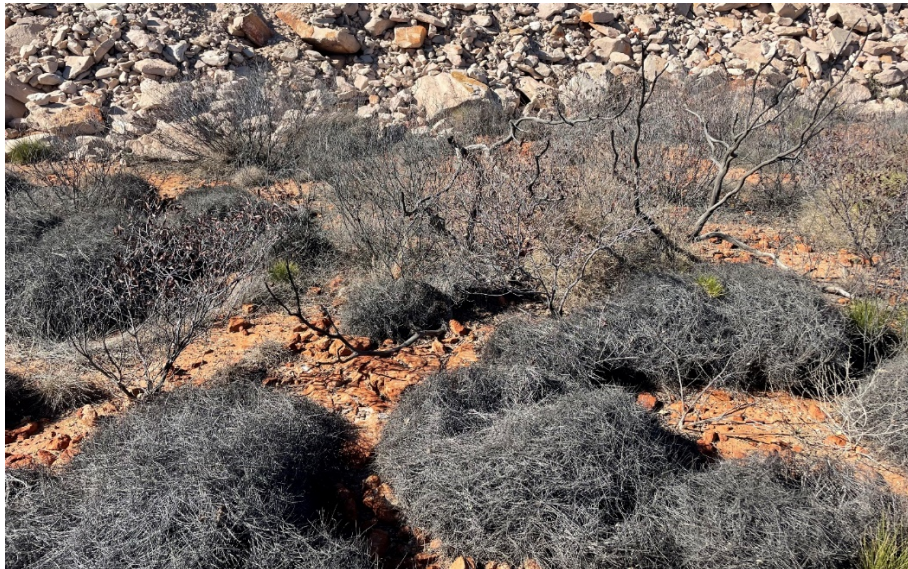
Localised area of dead or senesced vegetation close to edge of flare as a result of heat impacts from flare rather than salt toxicity

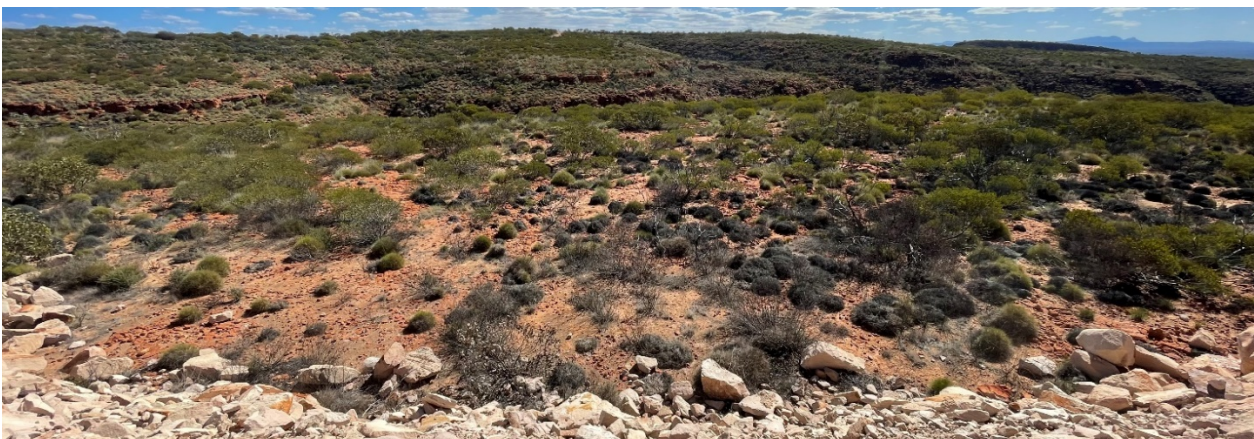
White staining or salt crusting was not observed on the soil surface or vegetation, and is expected to have dissolved after several high rainfall events over the past 12 months.

View from flare pit edge – note that white residue is no longer visible on soil surface or vegetation
