PV-12 Drilling Operation

Flare pit drilling fluid release incident

12-month monitoring report, July 2023

CENTRAL PETROLEUM

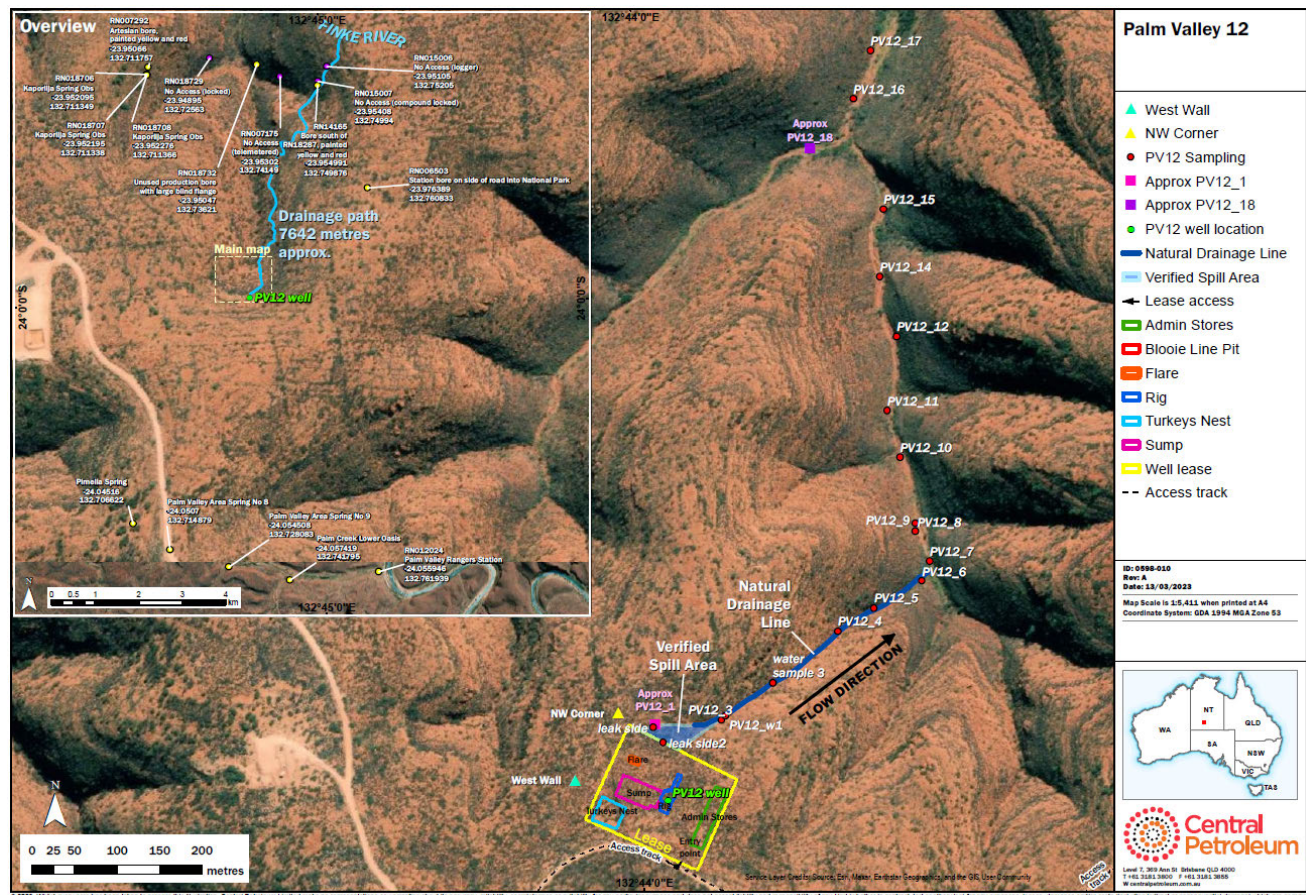
Figure 1: Map of spill site and initial sample sites in July 2022

Central engaged Low Ecological Services (LES) to assess the impact and recommend suitable remediation. A site visit was conducted on the 20 July 2022 to visually inspect the affected areas (i.e. one month after the drilling fluid spill, and a few days following the hydrotest potable water spill), and collect samples from downstream soil/sediments and fluid held in rock pools. White / grey staining of rocks was observed along much of the rocky creek bed, some associated with the spill and some associated with a natural complex of calcium carbonate. The inspection followed the drainage gullies for about 1.2km, to at which point there was no sign of spill impact. LES reported that evidence of the spill extended approximately 800m down the adjacent rocky gullies.

LES collected 18 soil samples along the affected drainage gully (sites PV12-1 to PV12-18), and two water samples from rock pools (site names PV12-W1 and PV12-W3) (refer to Figure 2). The water clearly contained flare pit fluids (i.e. brown coloration, with some viscosity and foam). Several soil samples were combined to

Results indicated the spill impact area is restricted to an area on the rocky plateau adjacent to the drill pad and the downstream rock drainage line, with potential detections for approximately 400m. Contamination impacts are low with minor elevated detections of hydrocarbons within water samples collected and slightly elevated salinity within soil samples approximately 400m beyond the release site. All other analytes were either within NEPM levels or levels seen in background soil chemistry.

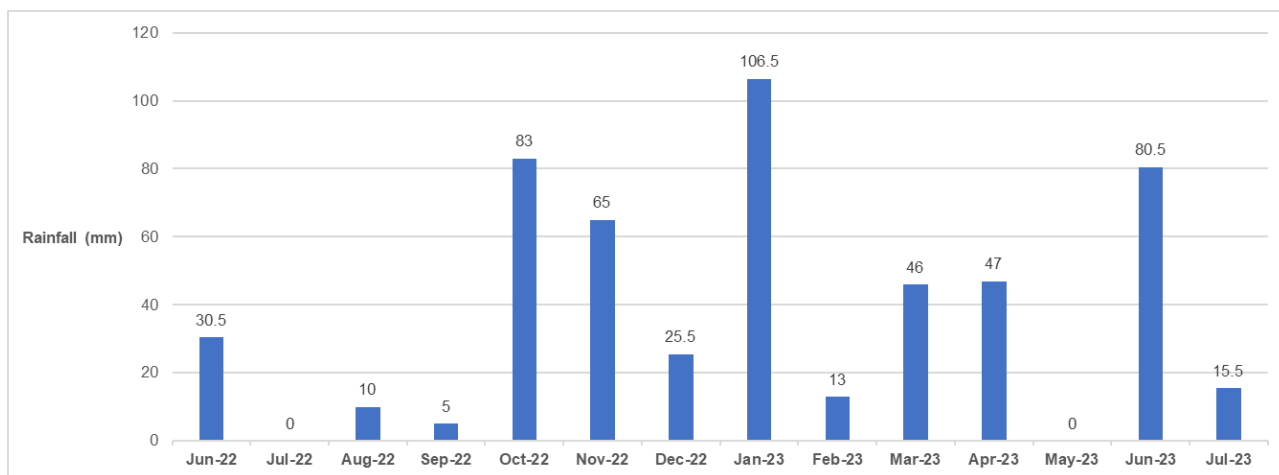
Figure 3: Graph of monthly rainfall since the leak incident

A total of 527.5 mm of rainfall has been recorded at PVGF since the incident and initial sampling event in July 2022 (data provided in Figure 3). This volume of rainfall is expected to have provided significant dilution levels within the affected drainage gully and spill impact area.

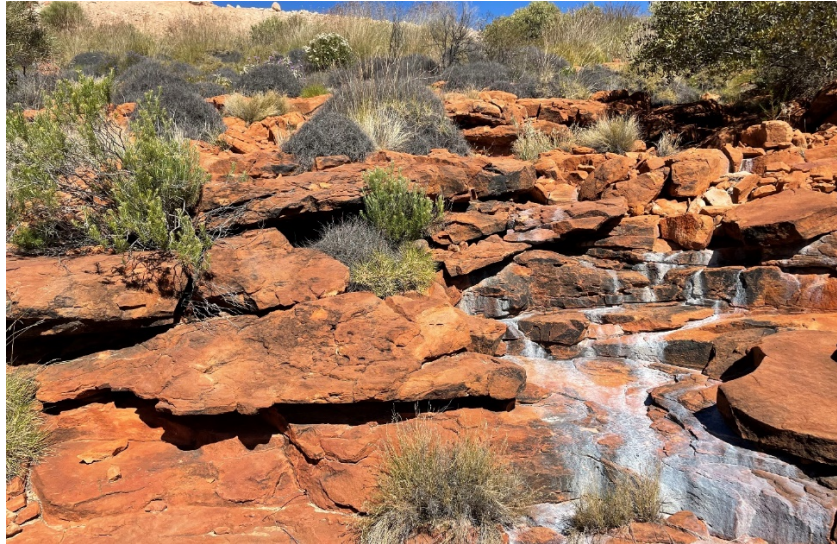
Figure 4: Photograph of current staining from the incident (head of gully adjacent to release point)

White-grey staining from drilling fluid was still present in the upper reaches of the rocky drainage; however, staining has reduced since previous monitoring in July 2022 (see comparison photographs in Figure 6). White-grey staining from the incident was evident for a maximum of 100m from the release point, it is now limited to the rocky plateau and the upper reaches of the upper gully. There is a darker staining on the sandstone rocks in the flow path of the rocky gully (where the white staining occurred); this may be related to the drilling fluids – however dark staining is also naturally occurring in adjacent gullies and is considered unlikely to be a significant issue. Refer to Figure 5 for comparison photographs at Site S3 within the upper gully (approximately 80m from the release point), and Figure 6 for comparison photographs approximately 1000m downstream of the release site. The previous monitoring recorded staining for at least 1000m. It is assumed to have been dissolved from rainfall flush/flow events since the previous monitoring event – and the dilution factor involved is unlikely to have resulted in further downstream staining.

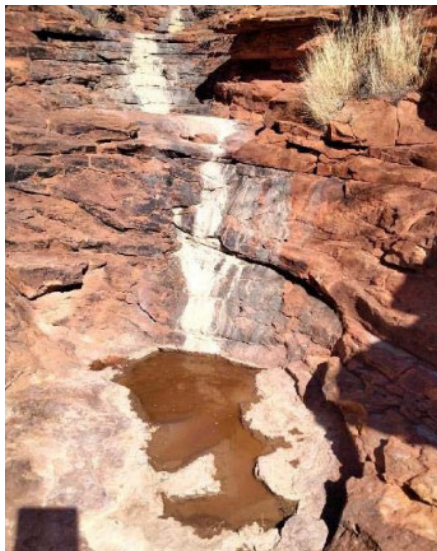
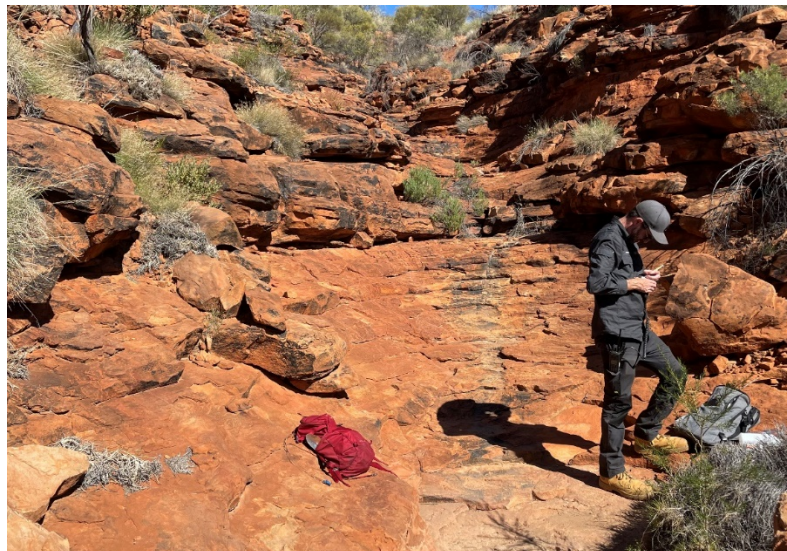
Figure 5: Photograph mid-way down the upper gully (approx. 100m downstream of release point)

Previous event – July 2022 (LES)

Current event – Site S3 – 80m from release point – July 2023 (EcOz)

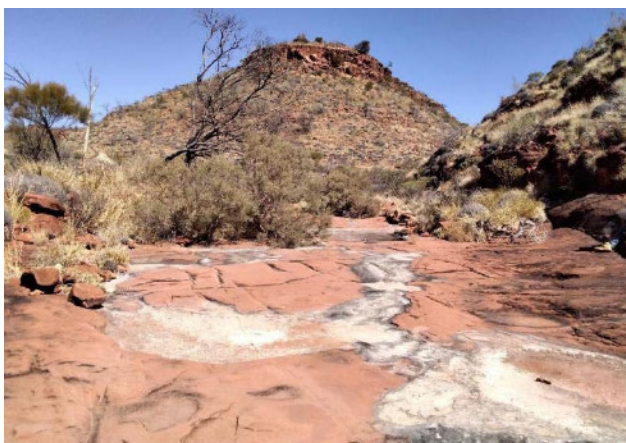
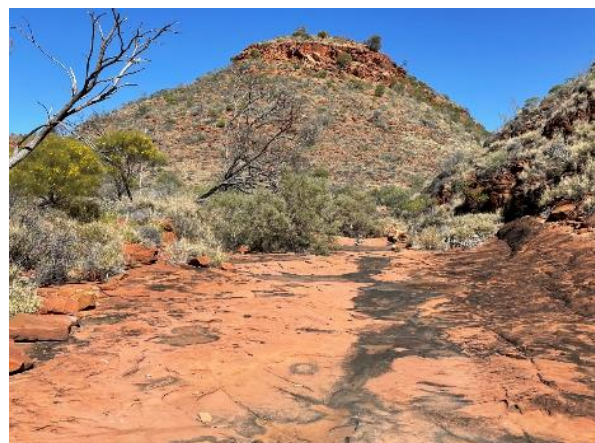
Figure 6: Photograph approximately 1000 m (near site W2 and S10) downstream of release site from this monitoring event (July 2023) and the previous monitoring event (July 2023)

Previous event – July 2022 (LES)

Current event – July 2023 (EcOz)

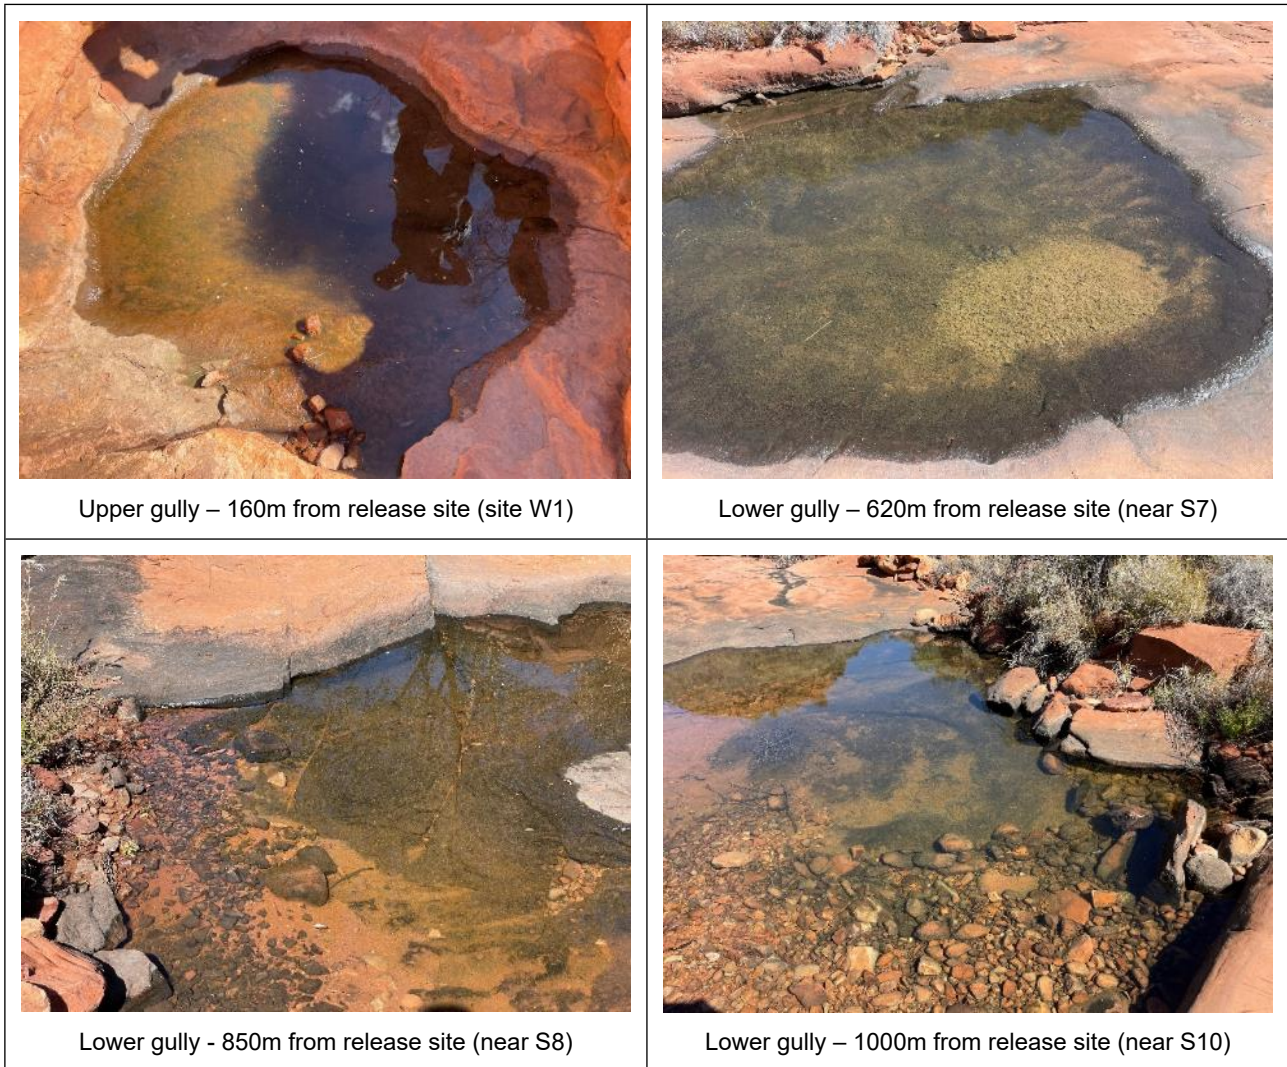
Figure 7. Photograph of rock pools present during the current monitoring event (July 2023)

Numerous small and shallow rock pools were present at the time of monitoring. In all cases, water was clear/clean and had no sign of hydrocarbon sheen, nor did sediments have hydrocarbon odour (representative photographs provide in Figure 7). The sediment within the rock pools was biologically active (natural) and in good condition with algae and insect life present, as well as birds drinking from the pools. None of the pools has any sign of drilling mud/foam, such as those observed directly following the incident in July 2022 (see comparison photograph from previous event and the current event in Figure 8).

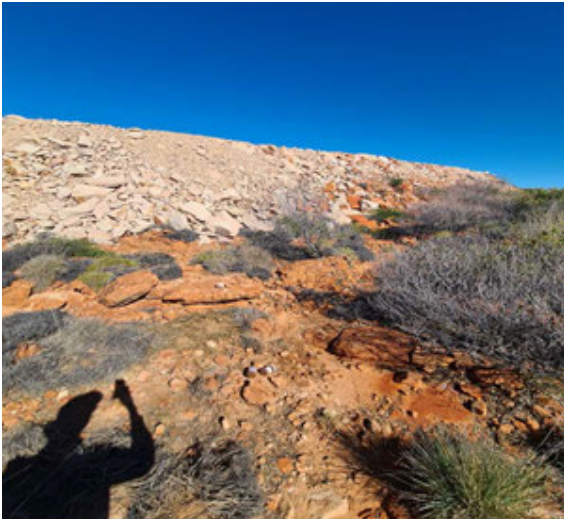
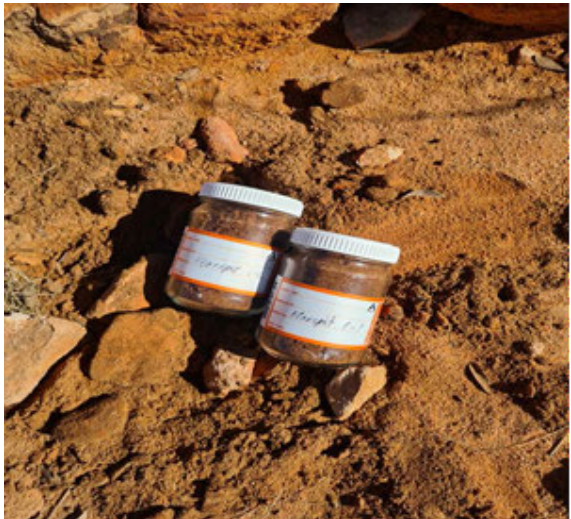
Site	General site	Sample point
S1

- **Acid (pH).** Marginal acidic conditions were recorded at site S1 (4.5 pH) (plateau adjacent to flare pit release point). All other sites recorded values around neutral (7.0 pH), including sites within the gully and background / reference sites. Previous monitoring did not detect acidic conditions (LES 2022). Inspection vegetation condition at this location did not indicate any issues with plant health that would indicate acidic toxicity.

- Elevated **Electrical Conductivity** and **Chloride** was recorded at site S1 (plateau adjacent to flare pit release point), with EC concentrations ranging from 1140 uS/cm to 1250 uS/cm, and Chloride concentrations ranging from 1870 mg/kg to 2050 mg/kg. These measurements are higher than the previous sampling event (EC – 667 uS/cm; Chloride – 1100 mg/kg). However, results indicate that higher readings are localised to a small area and not detected in the receiving rocky gully. Inspection vegetation condition at this location did not indicate any issues with plant health that would indicate salinity toxicity.

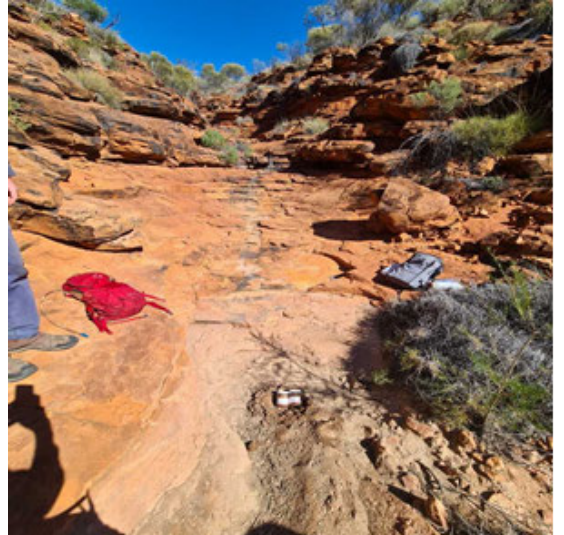
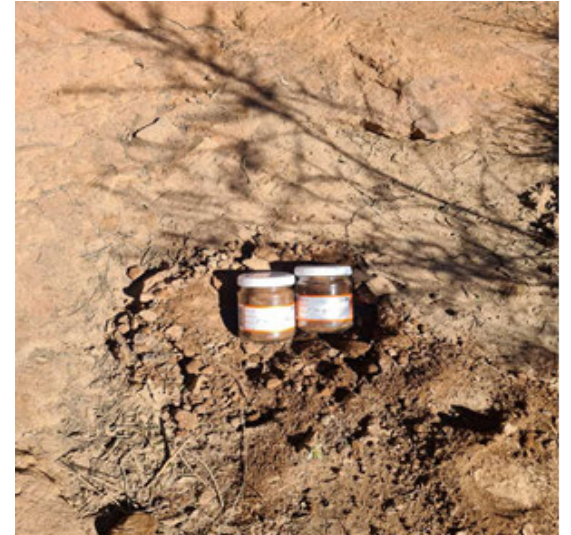
- **Copper** concentrations marginally elevated within the upper gully sites S3 and S4 (4.6 – 6.7 mg/kg compared with other sites around 1 mg/kg). Although Copper concentrations are elevated at S3 and S4 are likely a result of the drilling fluid release, concentrations are still at low levels and there is no current observable impacts to the environment.

- Very low concentrations **Total Recoverable Hydrocarbons** were detected at sites S3 and S4 (110 to 140mg/kg, respectively) – within the upper gully approximately 80m to 260m from release point. No other hydrocarbon detections occurred. No BTEXN detections occurred.
