APPENDIX K: REHABILITATION MANAGEMENT PLAN

April 2026

Rehabilitation Plan - EP 161 Newcastle South

Rehabilitation Plan - EP 161 Jibera South

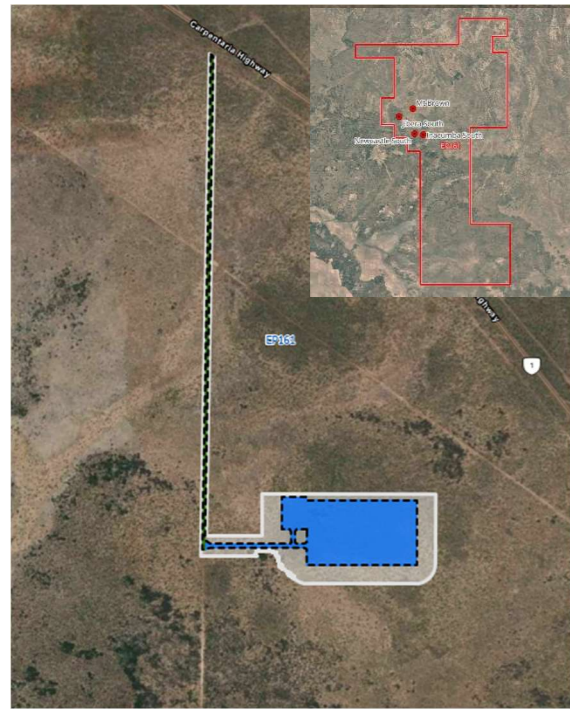
- Legend**
- Disturbance Footprint
 - Project Area
 - EP161
 - Disturbance Footprint by Impact**
 - Maintenance only
 - Clearing
 - Clearing - rehabilitation

Zone	Size (ha)	Land system(s) (refer to ecological report for details)
Newcastle South	23.06 ha	<ul style="list-style-type: none"> Land system – Beetaloo – on plains and rises associated with deeply weathered profiles (laterite) including sand sheets and other depositional products; sandy and earth soils. <p>Eight vegetation communities have been identified on site (see figure below and refer to ecological report). The main vegetation communities planned for clearing are:</p> <ul style="list-style-type: none"> 1a & 1b - <i>Corymbia dichromophloia</i>, <i>Eucalyptus leucophloia</i>, <i>Erythrophleum chlorostachys</i>, mid high open woodland

Component (sites)	Rehabilitation actions
Main access track	<ul style="list-style-type: none"> Removal of imported road base material (gravel etc), re-shaping the landform to blend the bare soil with the surrounding areas, stockpiled vegetation and topsoil re-spread, lightly scarify and shallow ripping to ensure the heavily compacted areas are loosened, suitable for vegetation growth.
Well pad and infrastructure	<ul style="list-style-type: none"> Remove all infrastructure Re-shaping the landform, re-spread topsoil over area, lightly scarify and rip. Small pad to be retained around well pad for ongoing inspection requirements
Borrow pits	<ul style="list-style-type: none"> Stabilise pit edges Re-spread stockpiled topsoil over area, lightly scarify and rip.

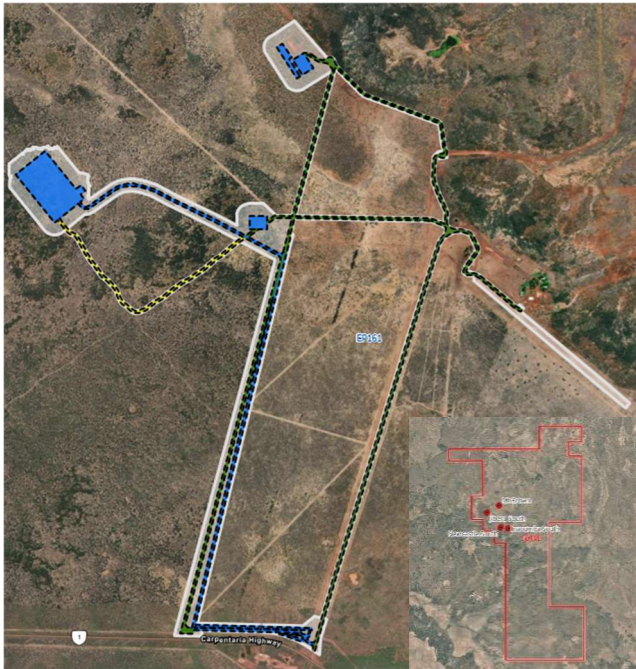
Legend

- Disturbance Footprint
- Project Area
- EP161

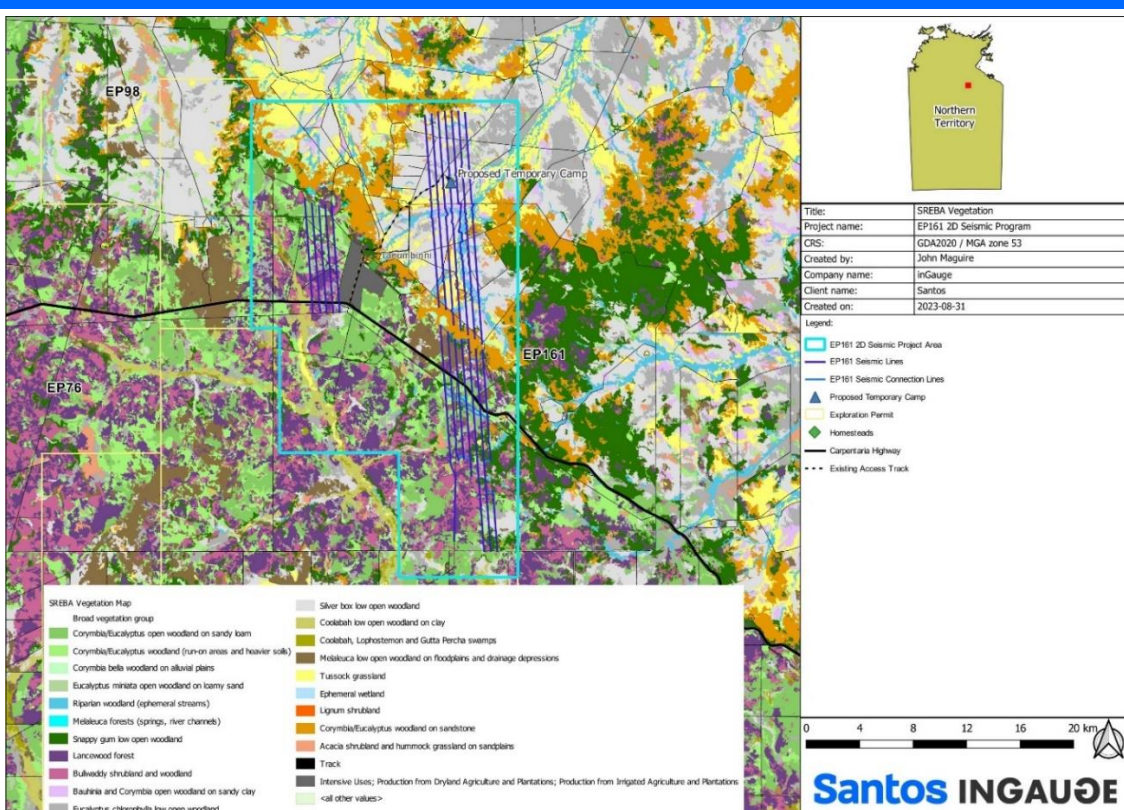
Project Area Vegetation Map	Pre-Disturbance Land Condition Summary

<p>Legend:</p> <ul style="list-style-type: none"> EP161 2D Seismic Project Area EP161 Seismic Lines EP161 Seismic Connection Lines Proposed Temporary Camp Exploration Permit Homesteads Carpentaria Highway Existing Access Track <p>SREBA Vegetation Map</p> <ul style="list-style-type: none"> Broad vegetation group Corymbia/Eucalyptus open woodland on sandy loam Corymbia/Eucalyptus woodland (run-on areas and heavier soils) Corymbia bella woodland on alluvial plains Eucalyptus miniata open woodland on bany sand Riparian woodland (ephemeral streams) Melaleuca forests (springs, river channels) Snappy gum low open woodland Lancewood forest Bullwaddy shrubland and woodland Banksia and Corymbia open woodland on sandy clay Eucalyptus chlorophylla low open woodland Silver box low open woodland Coolebah low open woodland on clay Coolebah, Lophostemon and Gulla Percha swamps Melaleuca low open woodland on floodplains and drainage depressions Tullock grassland Ephemeral wetland Lignum shrubland Corymbia/Eucalyptus woodland on sandstone Acacia shrubland and hummock grassland on sandstone Intensive Uses; Production from Dryland Agriculture and Plantations; Production from Irrigated Agriculture and Plantations; <all other values> 	<p>The Project Area is within a pastoralist property, located near the junction of two biogeographic regions as well as the headwaters of several catchments. As a result, the landscapes reflect to some degree those of the southern Sturt Plateau and Gulf Fall and Upland (upper Roper River) Bioregions. The Project Area soils are dominated by kandosols and rudosols. Rudosols are very shallow soils or those with minimal soil development and include very shallow rocky and gravelly soils across rugged terrain. The dominant vegetation type in the Project Area is woodland. Vegetation communities within the Project Area are dominated by Eucalyptus and Corymbia species (in the plains and undulating hills), Acacia woodlands/forests, and Melaleuca communities (within drainages lowlands, and depressions), Lancewood (<i>Acacia shirleyi</i>) woodland/forests and Bullwaddy (<i>Macropteranthes kekwickii</i>) woodlands.</p>

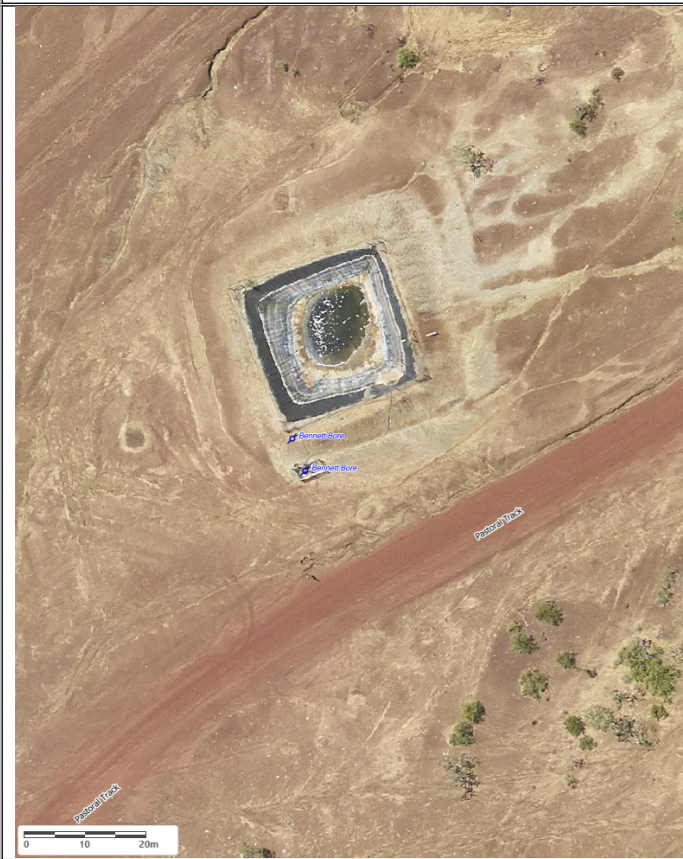
Rehabilitation Plan - EP 161 Bennett Bore and Pond

Location, Aim and Objectives		Prepared by:	EcOz Environmental Consultants, Ingaugue and Santos (date: 26/10/2023)
Property land use(s):	Cattle grazing Gas exploration	Key Contact:	Adam Hill, [REDACTED]
Rehabilitation aim:	To return disturbed land to a stable, self-sustaining landform that is similar to pre-existing and adjacent vegetation communities and/or landforms.	GPS Co-ordinates:	GDA 2020 Lat/Lon 16.41454° S 134.67615° E
Rehabilitation objectives:	<ul style="list-style-type: none"> Stable and self-sustaining. Safe for the land users and wildlife. Returned to its pre-disturbance condition that requires no ongoing management 	<ul style="list-style-type: none"> Re-instated to reflect the natural ecosystem/s, or establish an alternative outcome that is commiserate with the surrounding land use e.g. pastoralism Complementary (i.e. blends in) to the adjoining landscape. There are no impacts of AAPA Restricted Works Area that occur adjacent to works area.

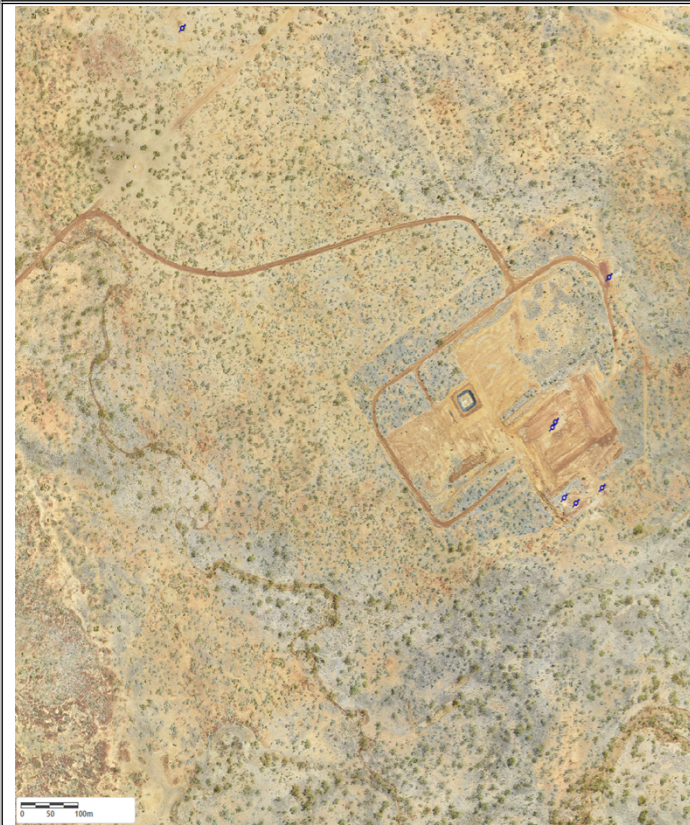
**Rehabilitation Plan - EP 161
Inacumba North**

Location, Aim and Objectives		Prepared by:	EcOz Environmental Consultants, Ingaugue and Santos (date: 26/10/2023)
Property land use(s):	Cattle grazing Gas exploration	Key Contact:	Adam Hill, [REDACTED]
Rehabilitation aim:	To return disturbed land to a stable, self-sustaining landform that is similar to pre-existing and adjacent vegetation communities and/or landforms.	GPS Co-ordinates:	16.51591° S 134.84185° E
Rehabilitation objectives:	<ul style="list-style-type: none"> Stable and self-sustaining. Safe for the land users and wildlife. Returned to its pre-disturbance condition that requires no ongoing management 	<ul style="list-style-type: none"> Re-instated to reflect the natural ecosystem/s, or establish an alternative outcome that is commiserate with the surrounding land use e.g. pastoralism Complementary (i.e. blends in) to the adjoining landscape. There are no impacts of AAPA Restricted Works Area that occur adjacent to works area.

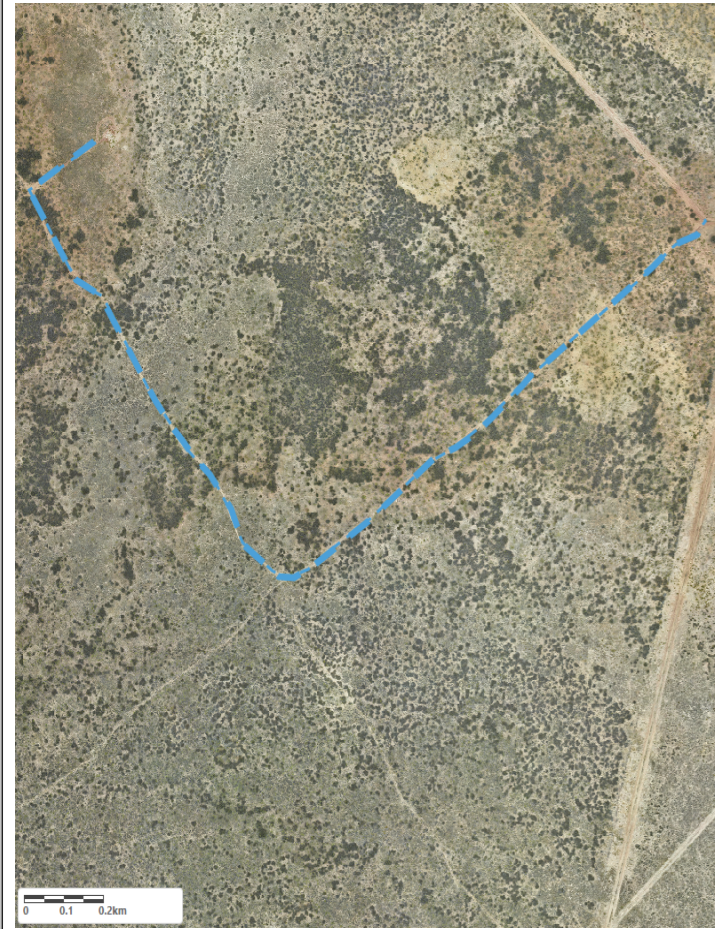
**Rehabilitation Plan - EP 161
Jibera South Access Track**

Rehabilitation Management Zones, Disturbance Area and Land Type		
Zone	Size (ha)	Land system(s) (refer to ecological report for details)
Access tracks (constructed as part of works and not transferred)	2.2	Land system – Lancewood 3 – Minor landsystem present – on gently undulating plains on mostly sandstone with tall open grassland present.

Rehabilitation Actions and Proposed Schedule	
Component	Rehabilitation actions
Linear Infrastructure	
Main access track	Removal of imported road base material (gravel etc), re-shaping the landform to blend the bare soil with the surrounding areas, stockpiled vegetation and topsoil re-spread, lightly scarify and shallow ripping to ensure the heavily compacted areas are loosened, suitable for vegetation growth.

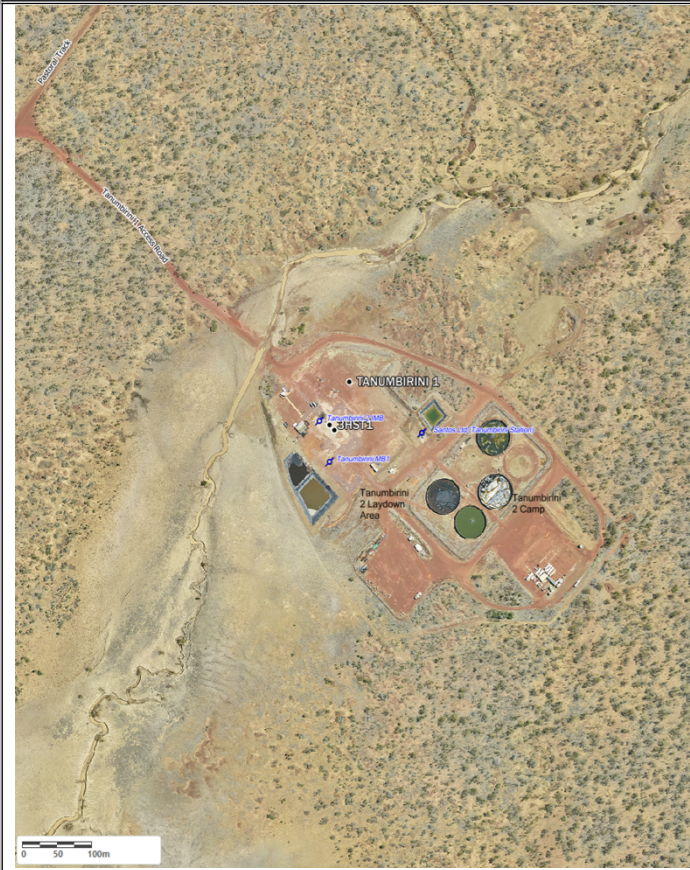
Rehabilitation Plan - EP 161 Tanumbirini 1-3 and Access Track

Location, Aim and Objectives		Prepared by:	EcOz Environmental Consultants, Ingaugue and Santos (date: 26/10/2023)
Property land use(s):	Cattle grazing Gas exploration	Key Contact:	Adam Hill, [REDACTED]
Rehabilitation aim:	To return disturbed land to a stable, self-sustaining landform that is similar to pre-existing and adjacent vegetation communities and/or landforms.	GPS Co-ordinates:	GDA 2020 Lat/Lon 16.40002° S 134.70471° E
Rehabilitation objectives:	<ul style="list-style-type: none"> Stable and self-sustaining. Safe for the land users and wildlife. Returned to its pre-disturbance condition that requires no ongoing management 	<ul style="list-style-type: none"> Re-instated to reflect the natural ecosystem/s, or establish an alternative outcome that is commiserate with the surrounding land use e.g. pastoralism Complementary (i.e. blends in) to the adjoining landscape. There are no impacts of AAPA Restricted Works Area that occur adjacent to works area.
