# Beetaloo Sub-Basin Multi-Well Drilling, Stimulation and Well Testing Program Environment Management Plan (ORI10-3) EP 98, EP76

**Land Condition Assessment  
Report (AECOM 2021)**

# Land Condition Assessment for Exploration Lease Pads 2021

Velkerri 76 N1, Amungee NW and Beetaloo W

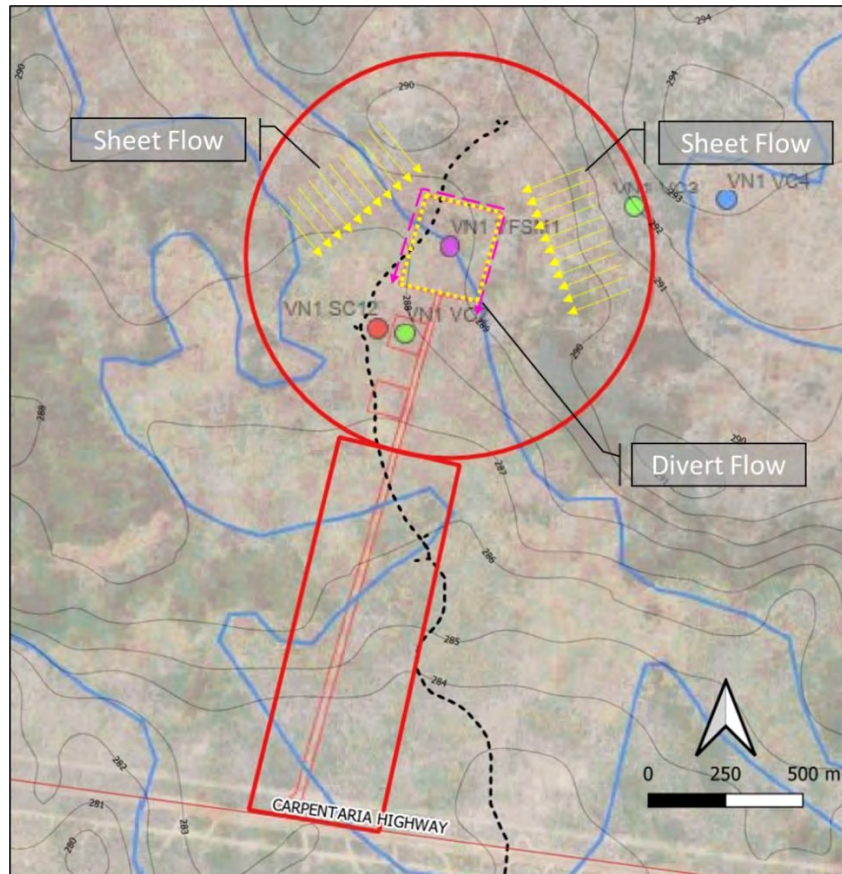
**Plate 2 Sheet Flow from the Surrounding Hills**

The SRTM data also indicates that sheet flow from the surrounding higher-lying areas requires consideration for the lease pad. Plate 2 shows that diversion drains around the lease pad will likely be required to direct flow around the lease pad, along with other design requirements.

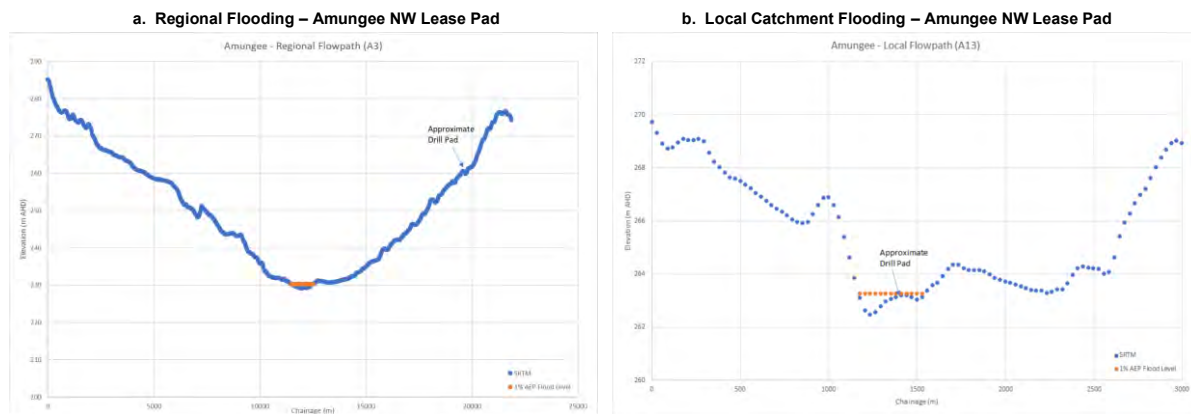
**Plate 3** Cross section showing relative flood level and location of Amungee NW lease pad with respect to local and regional flow path in 100-year event

The SRTM data was analysed to determine the approximate catchments for the Amungee NW lease pad (Plate 4). On a local scale, the Amungee NW lease pad is likely to experience inundation of up to 0.5 m in some areas, but is highly dependent on the horizontal accuracy of the SRTM data (refer Plate 3b). The local flow path for the 1% AEP was determined as 21.3 m<sup>3</sup>/s (Sub-catchment AC1).

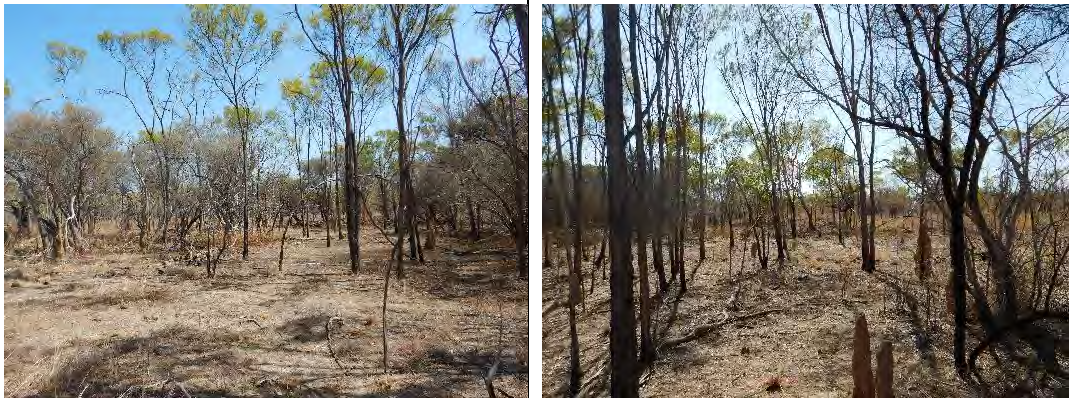
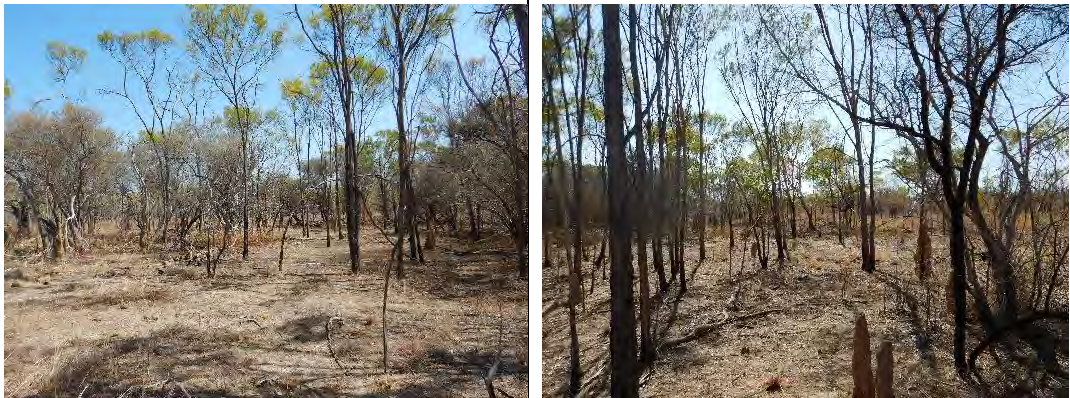
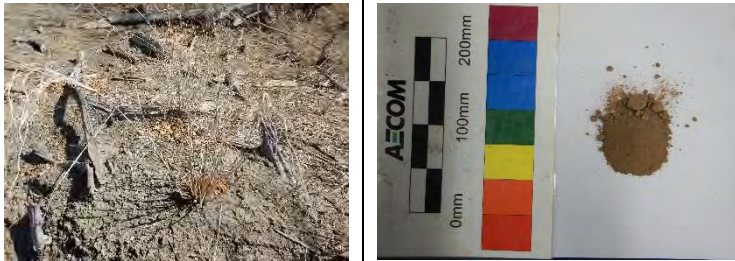
**Table 13 Velkerri 76 N1 Land Condition Description (survey October 2019)**

Velkerri 76 N1			
<b>Location</b>	GDA94, Zone 53, 440940E, 8179150N	<b>Vegetation community</b>	Open mixed woodland
<b>Vegetation description</b>	<i>Acacia shirleyi</i> and <i>Macropteranthes kekwickii</i> with mixed <i>Eucalyptus</i> open woodland.		
<b>Basal area (4 sweeps)</b>	146 ( <i>Acacia shirleyi</i> , <i>Macropteranthes kekwickii</i> , <i>Corymbia dichromophloia</i> , <i>Eucalyptus pruinosa</i> , <i>Eucalyptus chlorophylla</i> , <i>E.tectifca</i> , <i>Melaleuca sp.</i> )	<b>Stand basal area (average)</b>	29.2 m <sup>2</sup> /ha
<b>Landform</b>

Recent fire damage No erosion Cattle tracks			
<b>Vegetation Structure</b>	<b>Upper storey: 7 - 8 m</b>	<i>Acacia shirleyi</i> and <i>Macropteranthes kekwickii</i> with <i>Corymbia dichromophloia</i> and <i>Eucalyptus pruinosa</i>

<b>Mid-storey: 7 - 1 m</b>	<i>Melaleuca viridiflora</i> and <i>Erythrophleum chlorostachys</i>	
	<b>Understorey: 1 - 0 m</b>	<i>Dichanthium fecundum</i> , <i>Themeda avenacea</i> , <i>Eriachne armitii</i> tussock grasses and <i>Triodia bitextura</i> hummock grass, <i>Grewia retusifolia</i> and <i>Carissa lanceolata</i> shrubs	
<b>Soil texture</b>	Sandy loam with sub-rounded fragments present

<b>Soil drainage</b>	Moderately well drained		
<b>Soil colour</b>	10YR 3/3		
<b>Soil pH</b>	6-6.5		
<b>Termite mounds</b>	Sparse		
<b>Ground cover</b>	10% Vegetation, 20% Litter, 70% Bare Soil

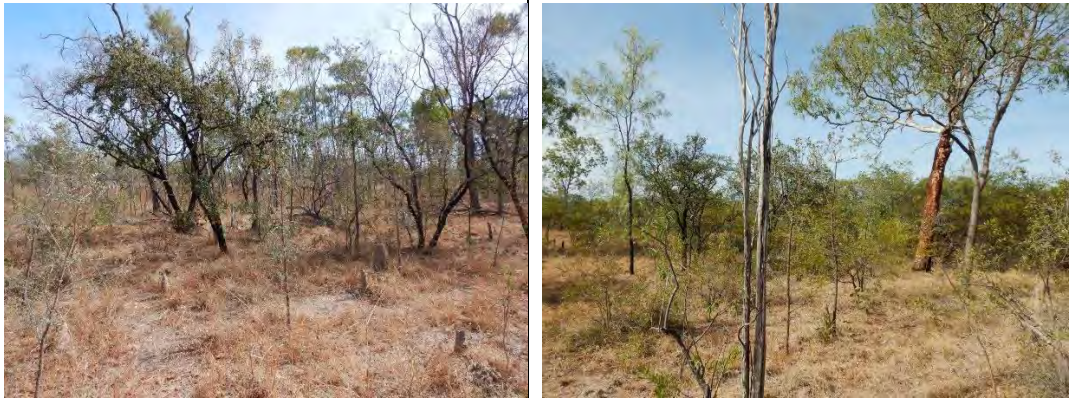
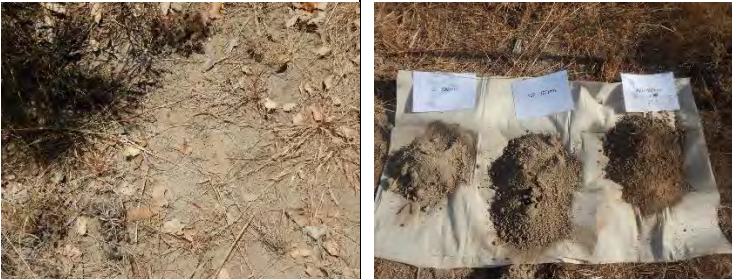
Amungee NW			
<b>Location</b>	GDA94, zone 53, 381039E, 8192324N	<b>Vegetation community</b>	<i>Corymbia</i> open woodland
<b>Vegetation description</b>	Low <i>Corymbia ferruginea</i> open woodland, over <i>Petalostigma pubescens</i> and <i>Hakea arborescens</i> sparse shrubland, over <i>Sorghum timorense</i> and <i>Chrysopogon fallax</i> tussock grassland		
<b>Vegetation transect</b>	No canopy 80%, <i>Corymbia ferruginea</i> 8.75%, <i>Corymbia dichromophloia</i> 5%, <i>Terminalia canescens</i> 3.5%, Dead 2%, <i>Acacia shirleyi</i> (Lancewood) 0.75%		
<b>Basal area (5 sweeps)</b>	17 ( <i>Acacia shirleyi</i> 6, <i>Corymbia dichromophloia</i> 3, <i>C. ferruginea</i> 2.5, <i>C. polycarpa</i> 2, Dead tree 2, <i>Erythrophleum chlorostachys</i> 1, <i>Terminalia canescens</i> 0.5)	<b>Stand basal area (average)</b>	17m <sup>2</sup> /ha
<b>Landform</b>

Fire - Moderate No erosion			
<b>Vegetation Structure</b>	<b>Upper storey: 7 - 8 m</b>	<i>Corymbia ferruginea</i> (8%)	
	<b>Mid-storey: 7 - 1 m</b>	<i>Petalostigma pubescens</i> (2%), <i>Hakea arborescens</i> (2%), <i>Terminalia canescens</i> (1%)	
	<b>Understorey: 1 - 0 m</b>	<i>Sorghum timorense</i> (40%), <i>Chrysopogon fallax</i> (5%), <i>Themeda avenacea</i> (5%)	
<b>Soil texture</b>	Sandy loam

<b>Soil drainage</b>	Moderately well drained		
<b>Soil colour</b>	10R 2.5/1		
<b>Soil pH</b>	7		
<b>Termite mounds</b>	Common		
<b>Ground cover</b>	50% Vegetation, 30% Litter, 20% Bare Soil

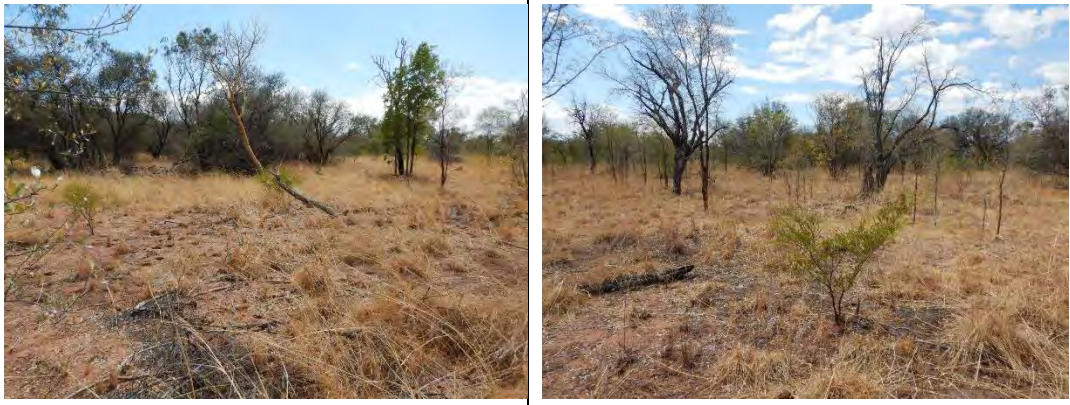
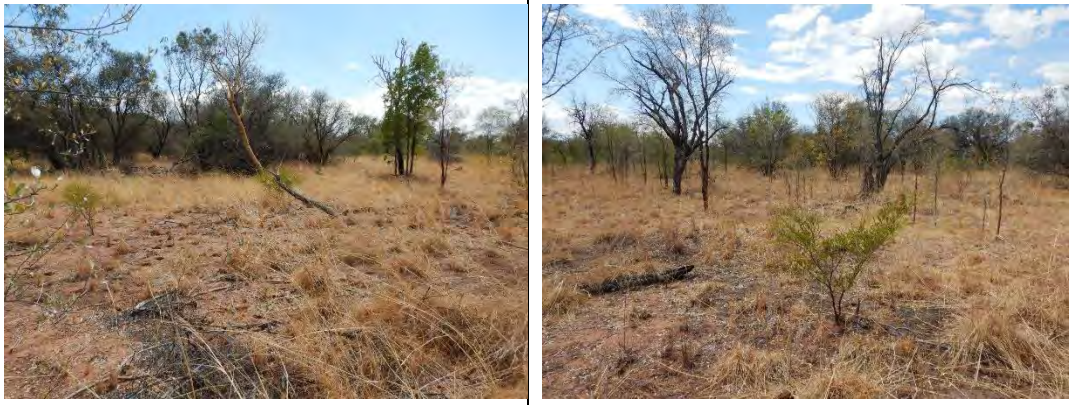
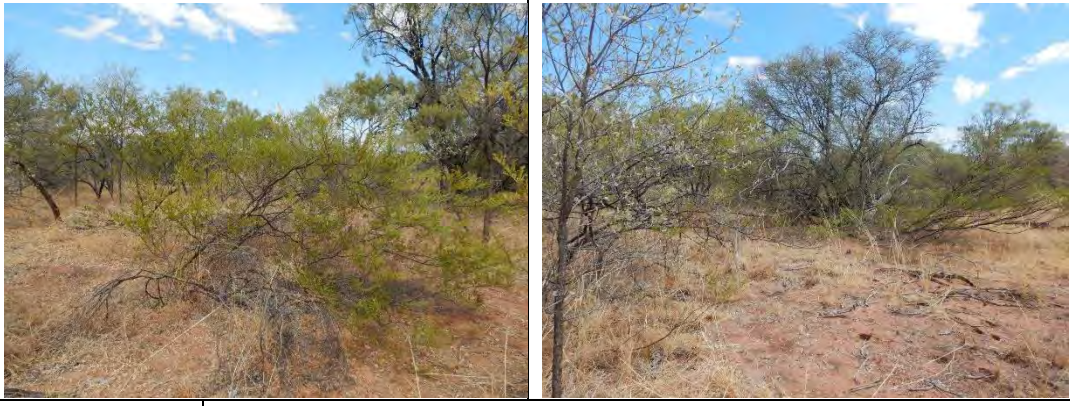
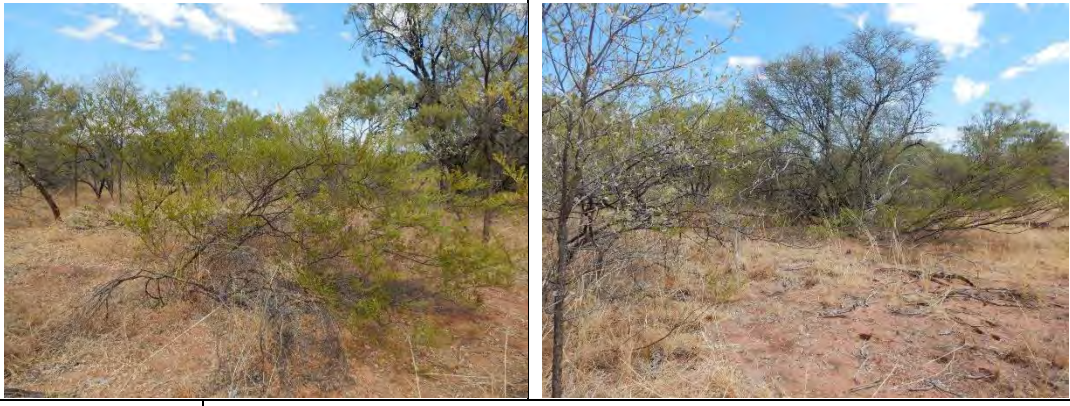
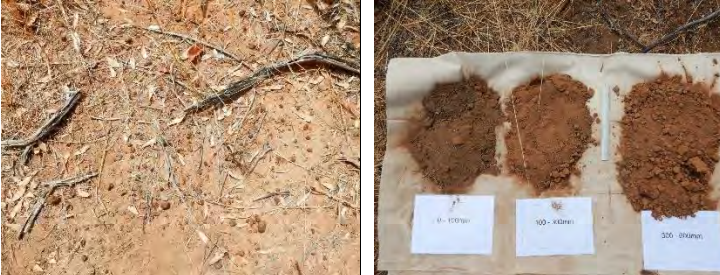
Tree hollows and flowering plants absent. Mistletoe scattered. Fallen logs abundant and litter shallow			
<b>Slope</b>

Fire moderate No erosion			
<b>Vegetation Structure</b>	<b>Upper storey: 6 - 8 m</b>	<i>Ventilago viminalis</i> (3%), <i>Gyrocarpus americanus</i> (2%), <i>Atalaya hemiglauca</i> (1%)	
	<b>Mid-storey: 1 - 6 m</b>	<i>Macropteranthes kekwickii</i> (10%), <i>Terminalia canescens</i> (6%), <i>Hakea arborescens</i> (2%)	
	<b>Understorey: 0 - 1 m</b>	<i>Sorghum plumosum</i> (20%), <i>Aristida</i> sp. (4%)	
<b>Soil texture</b>	Sandy loam

<b>Soil drainage</b>	Moderately well drained		
<b>Soil colour</b>	5YR 3/4 Dark Reddish Brown		
<b>Soil pH</b>	7		
<b>Termite mounds</b>	Sparse		
<b>Ground cover</b>	30% Vegetation, 10% Litter, 55% Bare Soil, 5% Gravel

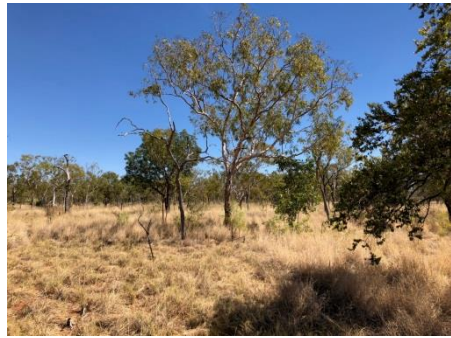
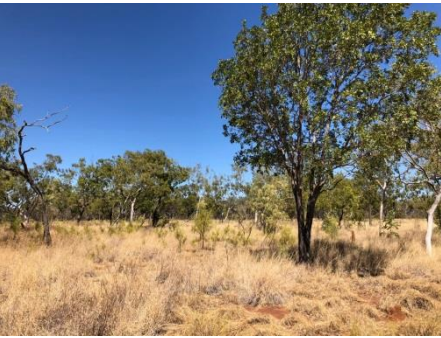
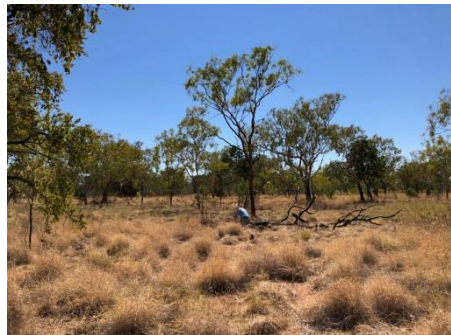
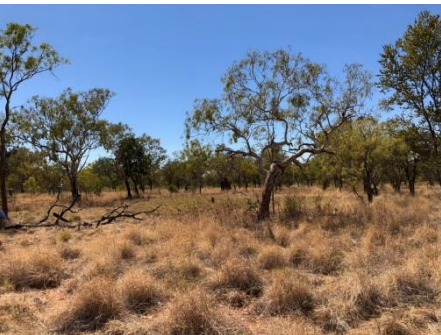
Table 10 Velkerri 76 S2 Condition Description

<b>Landform and soil</b>	Plains and rises associated with deeply weathered profiles (laterite) including sand sheets and other depositional products; sandy and earth soils. Trace of cracking clay soils.		
<b>Habitat type</b>	<i>Eucalyptus/Corymbia low woodland</i>

<b>Vegetation Community</b>	Eucalyptus low woodland/low open tussock grassland This vegetation community is considered regionally extensive and not subjected to extensive clearing.		
<b>Dominant flora species</b>	Canopy dominated by <i>Corymbia dichromophloia</i> , <i>Erythrophleum chlorostachys</i> . Shrub layer including <i>Eucalyptus sp.</i> Ground layer species include <i>Aristida latifolia</i> , <i>Pterocaulon sphacelatum</i> , <i>Triodia bitextura</i> .	<b>Additional Habitat Photos across survey site (August 2018)</b>

<b>Habitat condition</b>	Good condition with evidence of recent grazing. Large hollow bearing trees and logs were common in the area. The large hollows provide suitable nesting and shelter for numerous fauna species including reptiles, arboreal mammals, and nocturnal birds. The habitat contained moderate refuge opportunities in the form of dense leaf litter, dense grass cover, and woody debris. Good continuous cover adjoining adjacent woodland habitat. No evidence of weeds or feral animals.

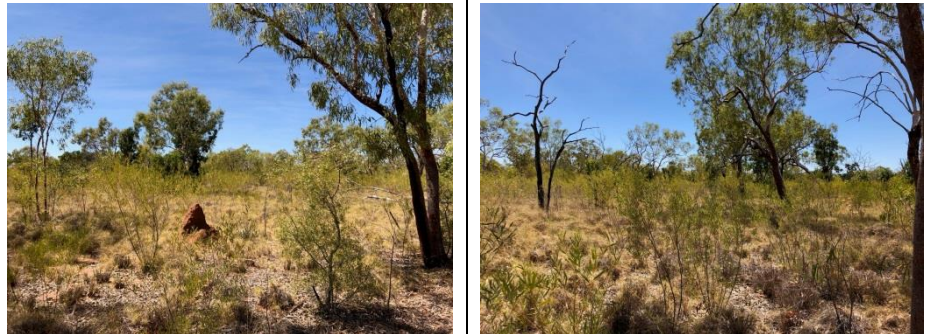
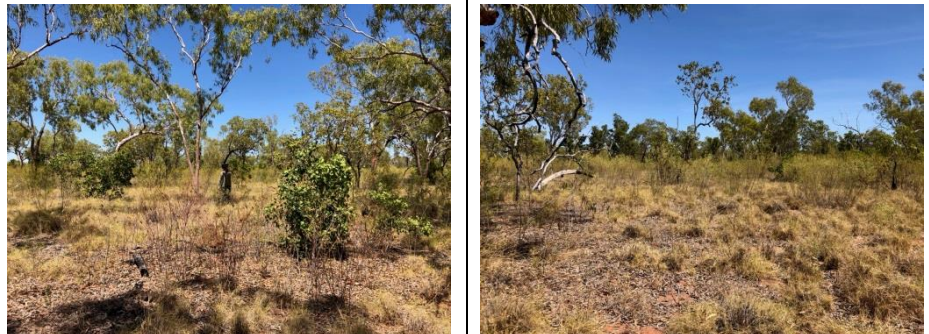
Table 11 Kyalla 117 N2-1 Condition Description

Site ID	Kyalla 117 N2-1	Habitat photos at central point of survey site (August 2018)	
Location	-16°50' 29.01, 133°39' 0.16		
Landform and soil	Plains and rises associated with deeply weathered profiles (laterite) including sand sheets and other depositional products; sandy and earth soils

Habitat type	<i>Corymbia</i> low woodland		
Vegetation Community	<i>Corymbia</i> low woodland/ <i>Terminalia</i> (mixed) sparse shrubland/ <i>Chrysopogon</i> (mixed) low tussock grassland This vegetation community is considered regionally extensive and not subjected to extensive clearing.

Dominant flora species	Canopy dominated by <i>Corymbia dichromophloia</i> , <i>Eucalyptus setosa</i> . Shrub layer including <i>Acacia ancistrocarpa</i> , <i>Alphitonia pomaderroides</i> , <i>Brachychiton paradoxus</i> . Ground layer species include <i>Triodia bitextura</i>		
Habitat condition	Good condition with evidence of recent grazing. Vegetation appeared to heavily burnt in recent years. No evidence of hollow bearing trees and logs. The habitat contained moderate to high refuge opportunities in the form of dense leaf litter, tussock grass cover, and woody debris. Good continuous cover adjoining adjacent woodland habitat and regionally extensive. No evidence of weeds or feral animals.	<p style="text-align: center;"><b>Additional Habitat Photos across survey site (August 2018)</b></p>

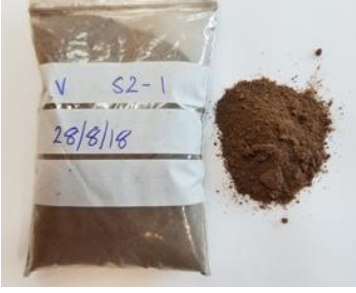
Soil Id	Photo	Soil pH	Soil Colour	Dispersion Test Observations
Kyalla N2-1		5.14	1.5YR 4/6	<p><b>Initial Observation</b></p> <ul style="list-style-type: none"> <li>Sample was fully crumbed when submerged in demineralised water.</li> </ul> <p><b>Final Observation</b></p> <ul style="list-style-type: none"> <li>Non-dispersive, particles crumble though water remains clear.</li> </ul>
Velkerri S2

5.02	10YR 3/4	<p><b>Initial Observation</b></p> <ul style="list-style-type: none"> <li>Sample was fully crumbed when submerged in demineralised water.</li> </ul> <p><b>Final Observation</b></p> <ul style="list-style-type: none"> <li>Non-dispersive, particles crumble though water remains clear.</li> </ul>
<p><b>NOTE:</b>  Initial Observation - observation made when the sample was submerged in water  Final Observation - observation made after 2 hours</p>
