Peak Helium  
EP134  
2D Seismic EMP  
PKH1  
Appendices  
Contents

# **Environmental Assessment**

## **EP134 Seismic Program**

#### **PEAK HELIUM**

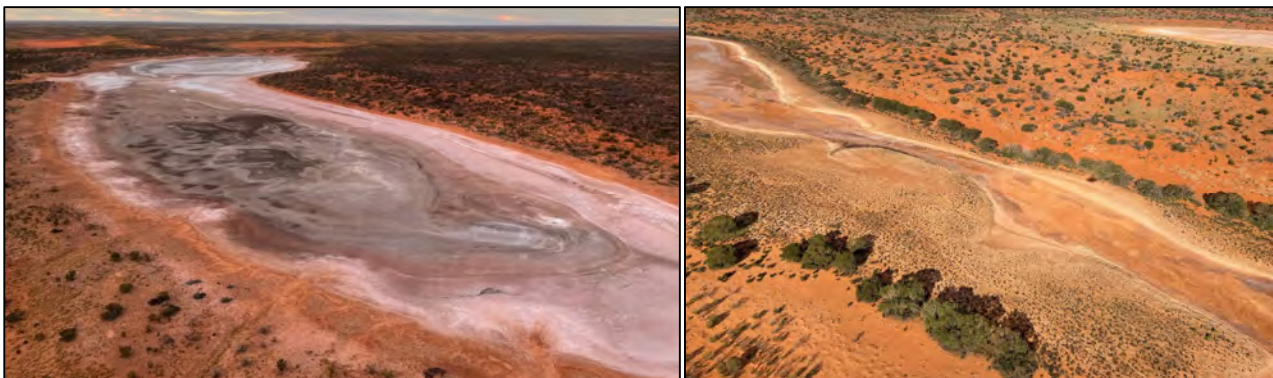
Figure 2-2. Aerial photographs of salt pans and lakes within Karinga Creek paleo-drainage system

There are two SOBS adjacent to the project footprint – Poona SOBS located between the four north-eastern project footprints, and Karinga Creek SOBS immediately to the west of the project footprint. These two SOBS are areas of bioregional significance. Both of these sites occur within Karinga Creek paleo-drainage system SOCS and are part of an ancient river system. Saline lakes and basins, such as Poona and Karinga Creek, hold potential to be important habitats for 49 rare, threatened, and poorly known species. It is important to note that botanical attributes of these areas of significance are rarely well documented due to a lack of surveying history because of their remote location.

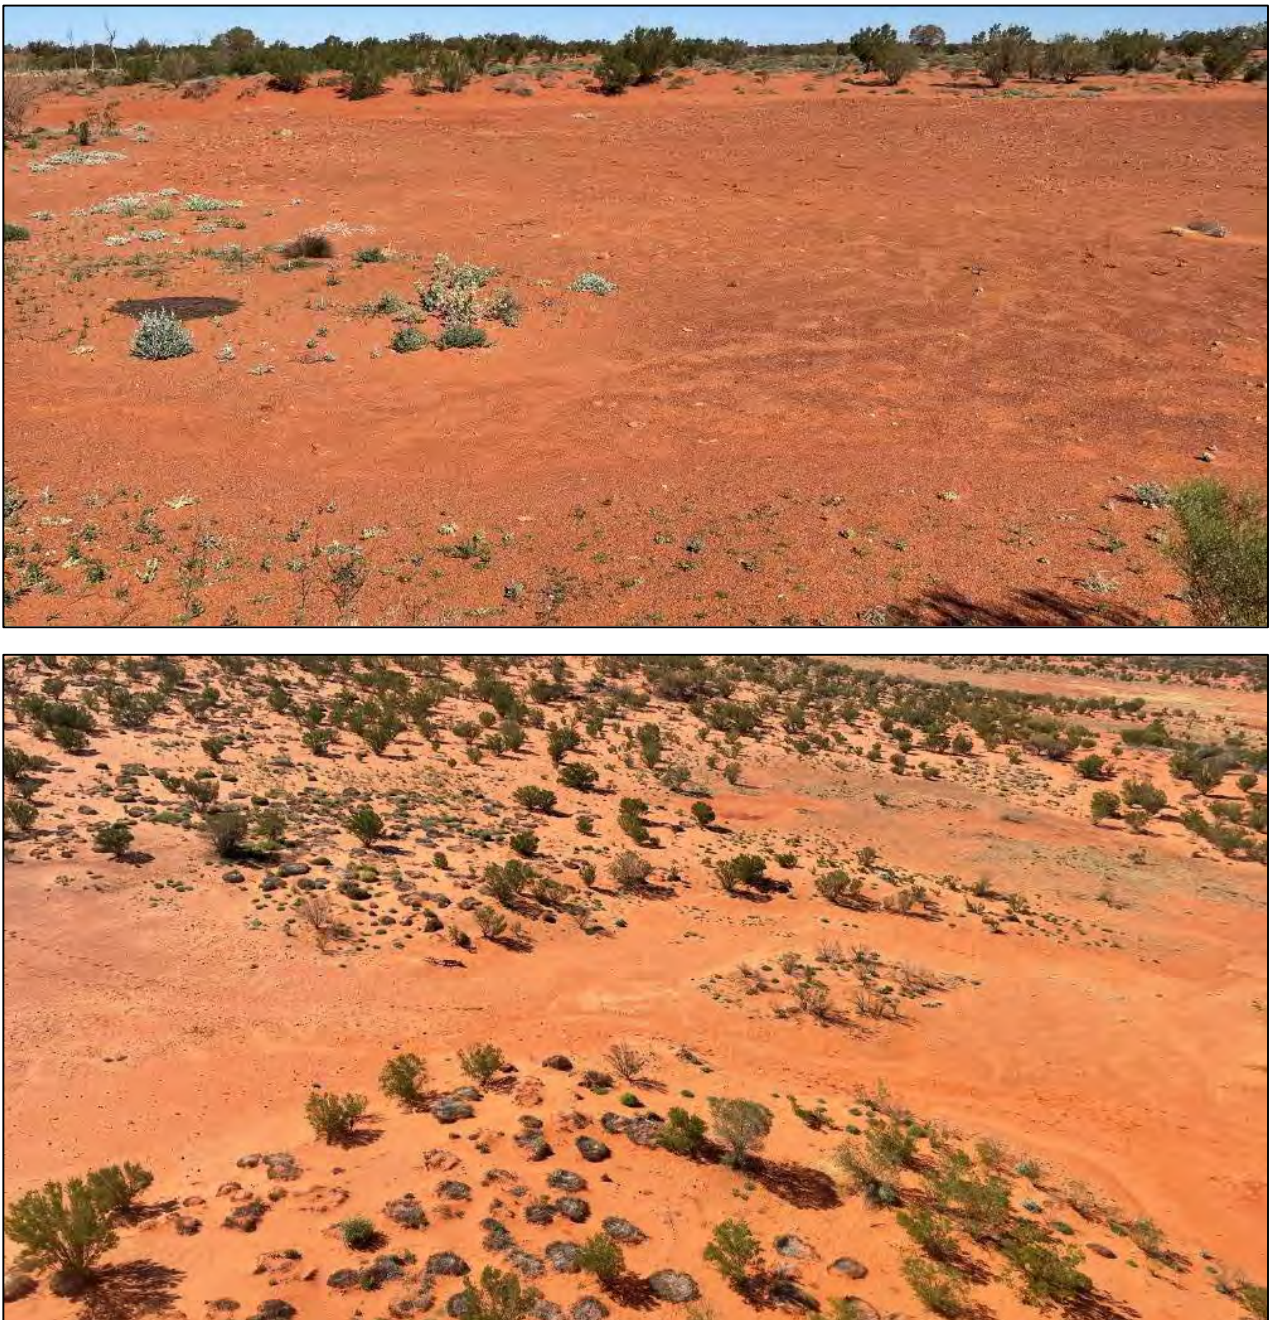
There are 19 small clay pans within the project footprint. These have been mapped (Figure 3-12) and provided as a spatial data layer. This information is valuable to assist with identifying areas to avoid in order to minimise impacts of erosion and preserve biodiversity within the region. Clay pans are often found to have a high probability of artefact occurrence – further information can be found in the projects Archaeological Survey Report.

**Figure 3-3. Photographs of two sites of clay pans along the 2D seismic acquisition corridors**

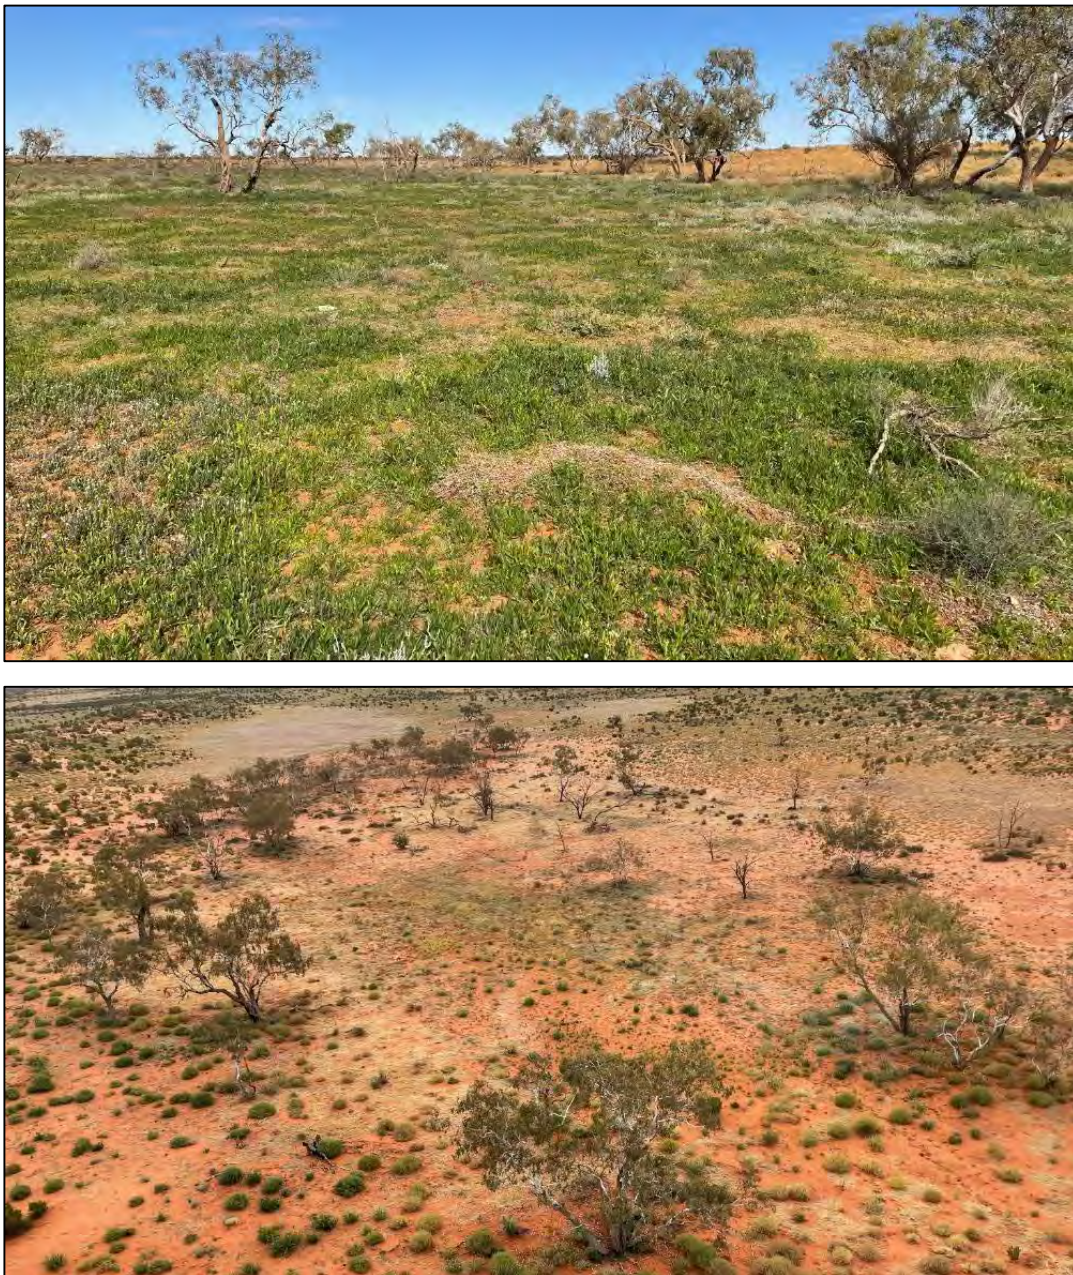
There are three seasonal swamps within the project footprint. These have been mapped (Figure 3-12) and provided as a spatial data layer. This information is valuable to assist with identifying areas to avoid in order to minimise impacts of erosion and preserve biodiversity within the region. Seasonal swamps are often found to have a high probability of artefact occurrence – further information can be found in the projects Archaeological Survey Report.

**Figure 3-4. Photographs of two sites of seasonal swamps along the 2D seismic acquisition corridors**

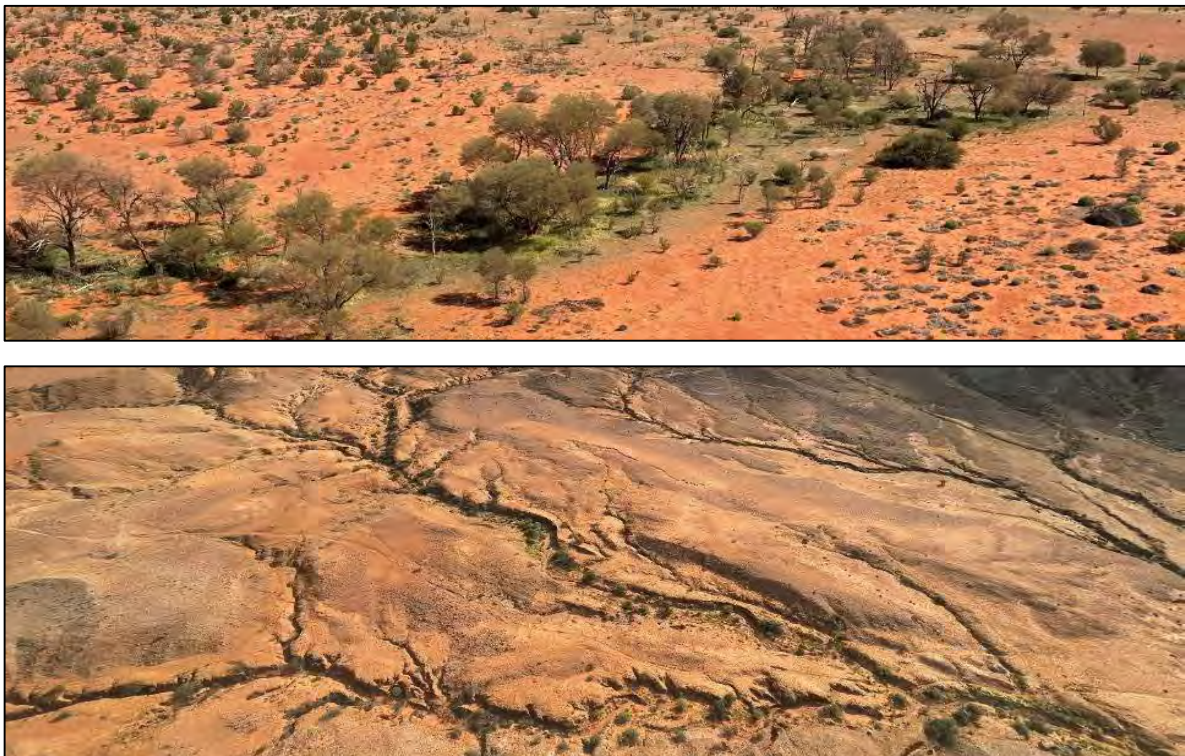
There are a total of 29 ephemeral drainage line crossings within the project footprint, seven are located on existing access tracks, while 22 will be new disturbances. These have been mapped (Figure 3-12) and provided as a spatial data layer. It is noted that drainage lines within the project footprint do not hold especial biodiversity value and are not linked to downstream sensitive riparian habitat – as such they do not need to be buffered in accordance with the NT *Land Clearing Guidelines* (DEPWS 2020). Standard weed and erosion management will be sufficient to minimise any potential impacts if crossings are required.

**Figure 3-5. Photographs of two sites of drainage lines along the 2D seismic acquisition corridors**

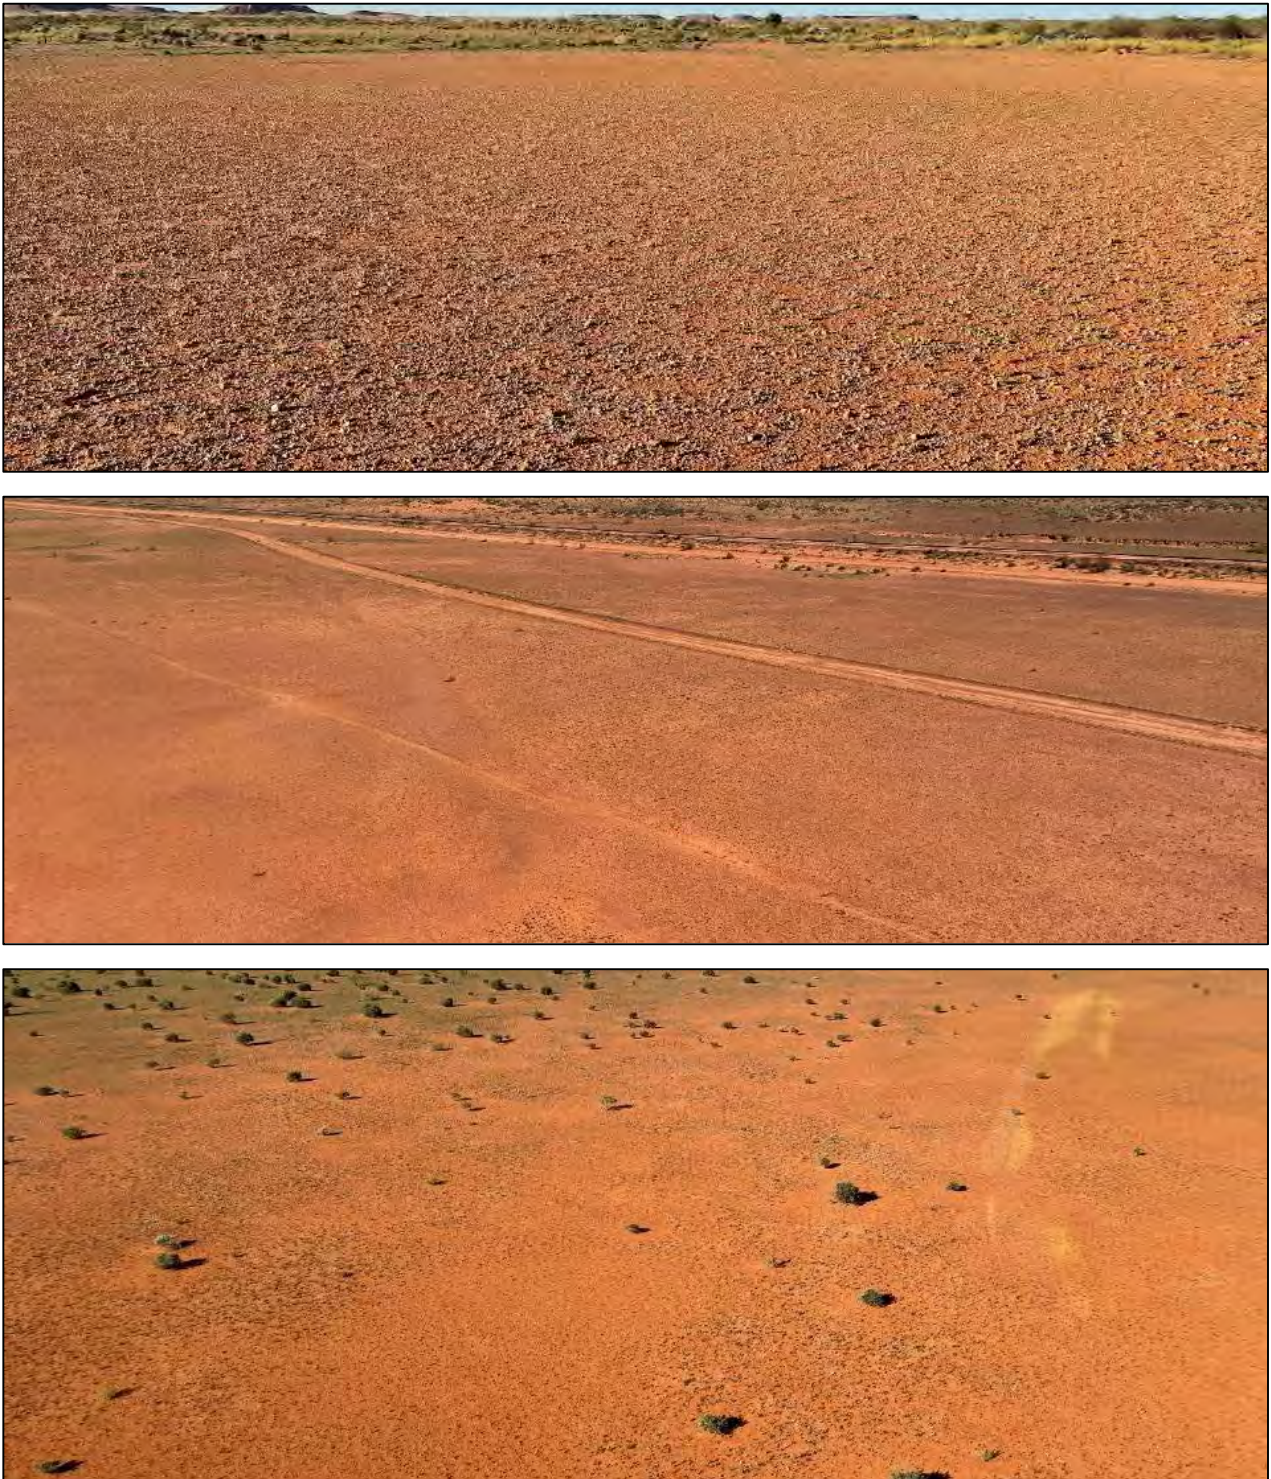
Figure 3-6. Photographs of three sites of open plains along the 2D seismic acquisition corridors

Broad undulating, stony and calcareous plains with bluebush or sparse trees and shrubs (*Acacia kempeana*, *Acacia aneura*, *Eremophila spp.* and *Senna spp.*) over minor perennial grasses and forbs. They are common in the northern part of the project footprint. These areas can have a rocky (i.e. stony gibber plains) or loamy surface and typically have very little vegetation present (limited to short tussocks, forbs, chenopod shrubs – and sparse *Acacia* shrub). Soils are typically clays to clay loams with a relatively high surface gravel content, but large expanses of sandy loams with low to no rocks are also present. Widely spaced parallel sand dunes and low sand hills are often present within these areas.

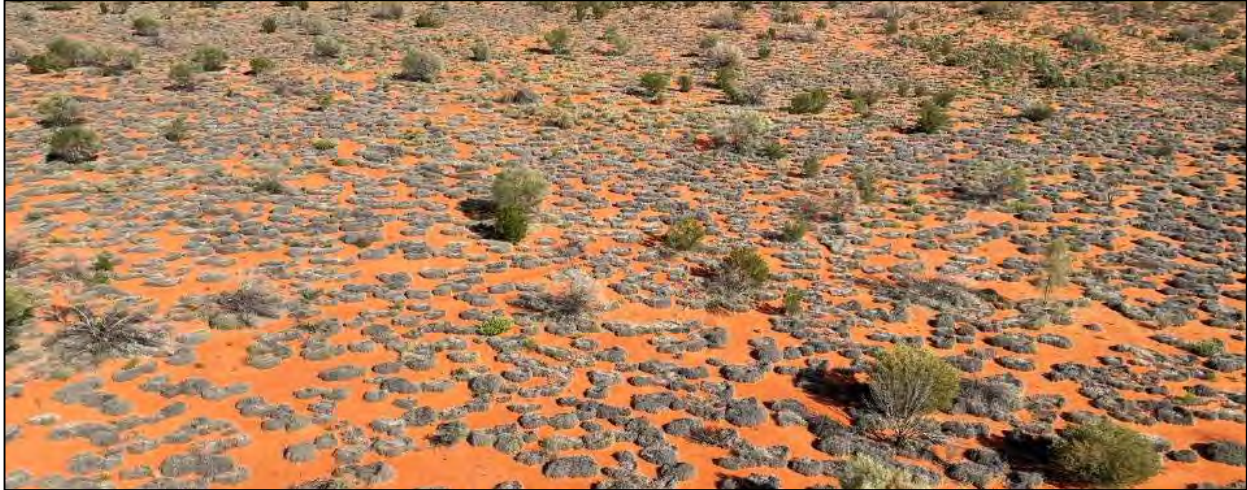
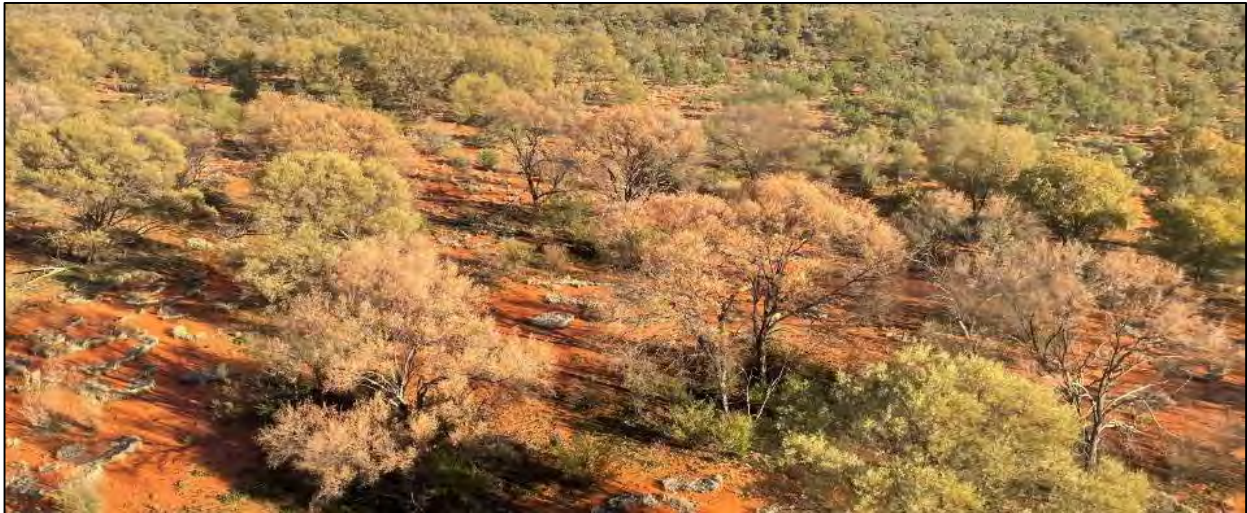
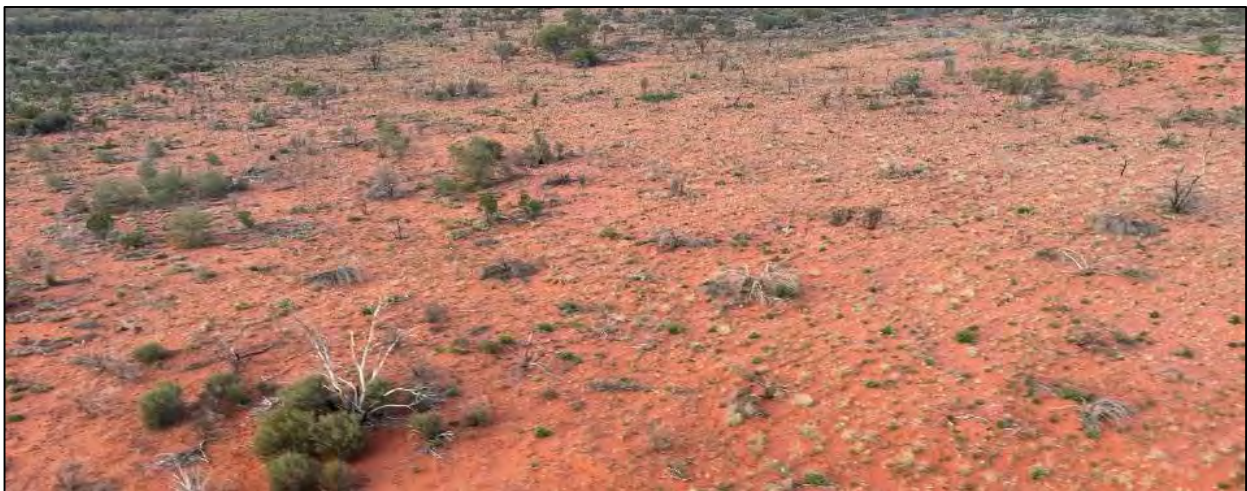
**Figure 3-7. Photographs of three sites of sandplain along the 2D seismic acquisition corridors**

Sandplains are flat to gently undulating plains with red sand to sandy red earth soils, which predominately occur in the south part of the project footprint. They include sandy calcareous plains (with open or patchy Mulga over Kerosene Grass or Oat Grasses and forbs) and spinifex sandplains (with Mulga, mallee or scattered Desert Oak over spinifex). Low dunes and minor limestone/calcrete rises are scattered throughout. Fire has produced floristic differences, and recent drought has resulted in senesced spinifex.

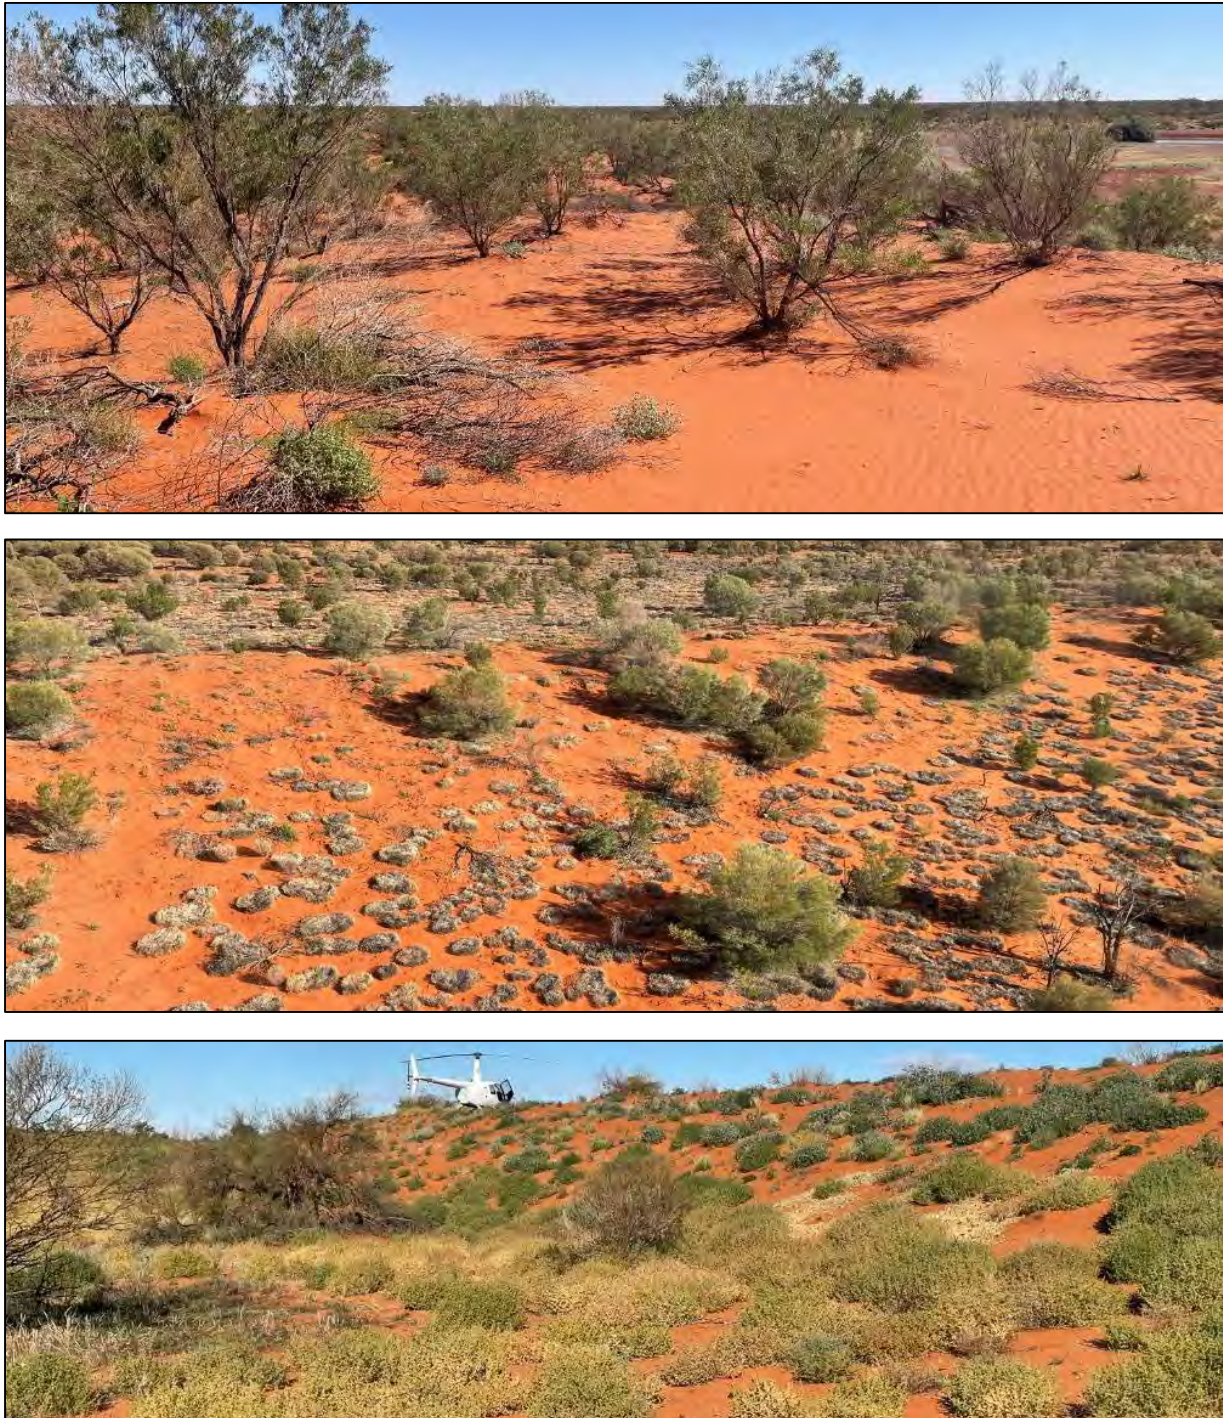
**Figure 3-8. Photographs of three sites of dunes along the 2D seismic acquisition corridors**

Dunes within the project footprint have a range of orientations from parallel (SE to NW direction), reticulate dunes or irregular dunes. They are stabilized by spinifex, low shrubs (*Acacia* spp. and *Dodonaea viscosa*) and trees. They have low relief (between 4 and 6 m); with some larger examples in the south eastern part of the project footprint that may reach up to 10 m. They have soft red aeolian sands and support an open shrubland over sparse understory of forbs, tussock grass and occasionally Spinifex.

Dune crests within the project footprint have been mapped (Figure 3-12) and has been provided as a spatial data layer. This information is valuable to assist with identifying areas to avoid in order to minimise impacts on erosion and preserve biodiversity within the region.

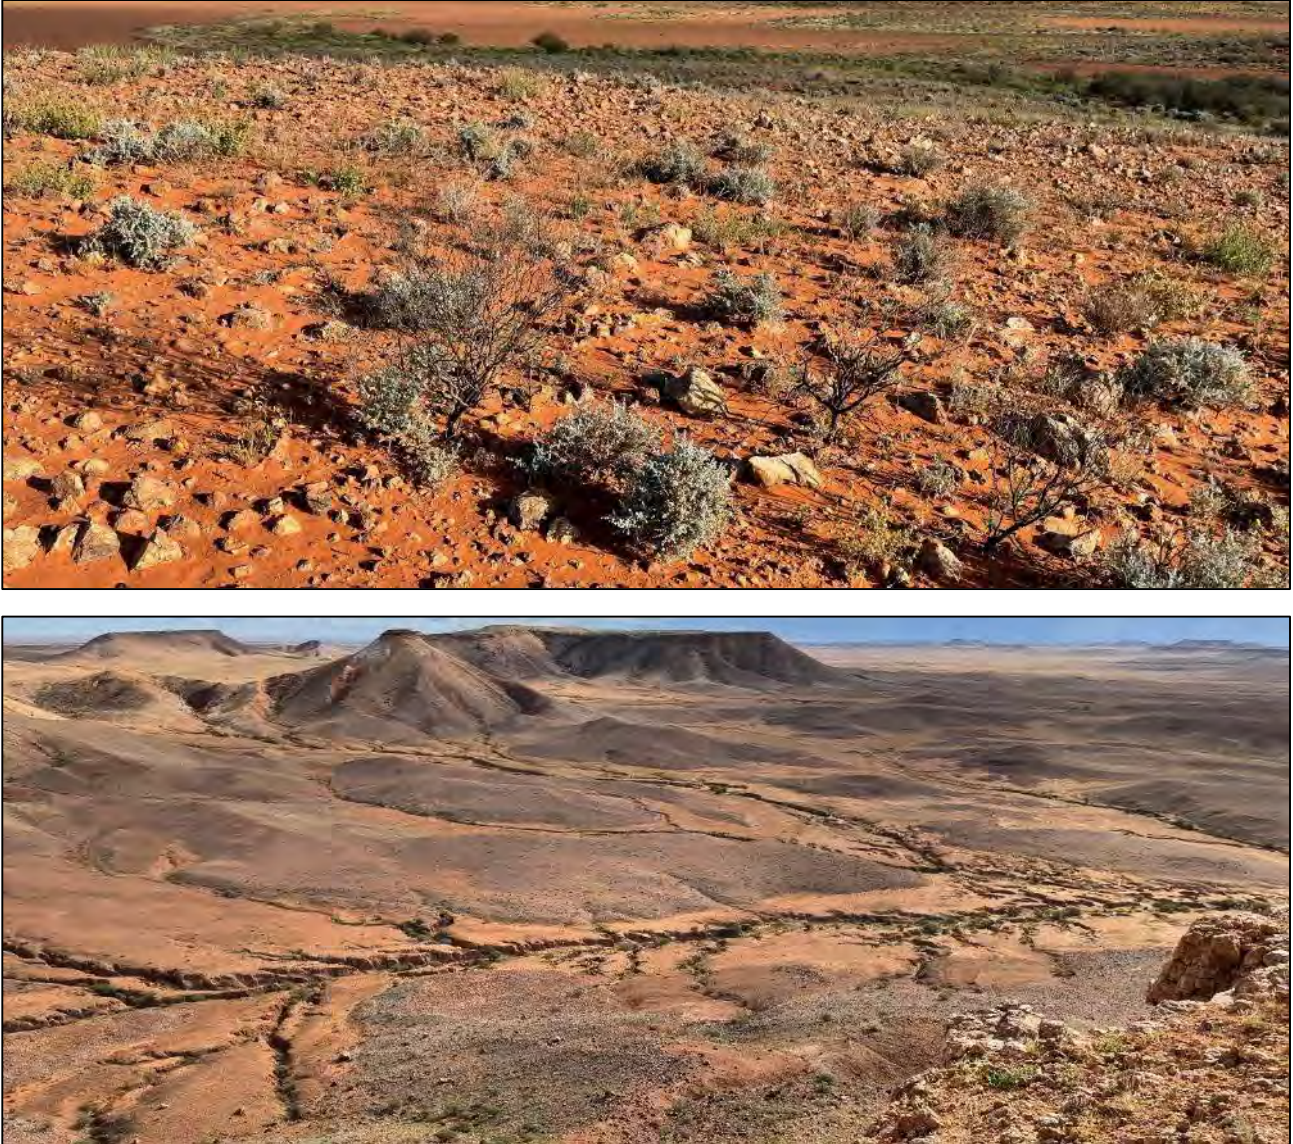
**Figure 3-11. Photographs of rocky hills, breakaways, and mesas along the 2D seismic acquisition corridors**

open (scattered Mulga, Dead Finish, Witchetty Bush, Bluebush and Saltbush over mainly Oat Grass, Mulga Grass, Copperburrs and forbs) and often restricted to drainages and associated minor flood-out zones.

Rocky hill, breakaways, and mesas within the project footprint have been mapped (Figure 3-12) and have been provided as a spatial data layer. This information is valuable to assist with identifying areas to avoid in order to minimise impacts on erosion.

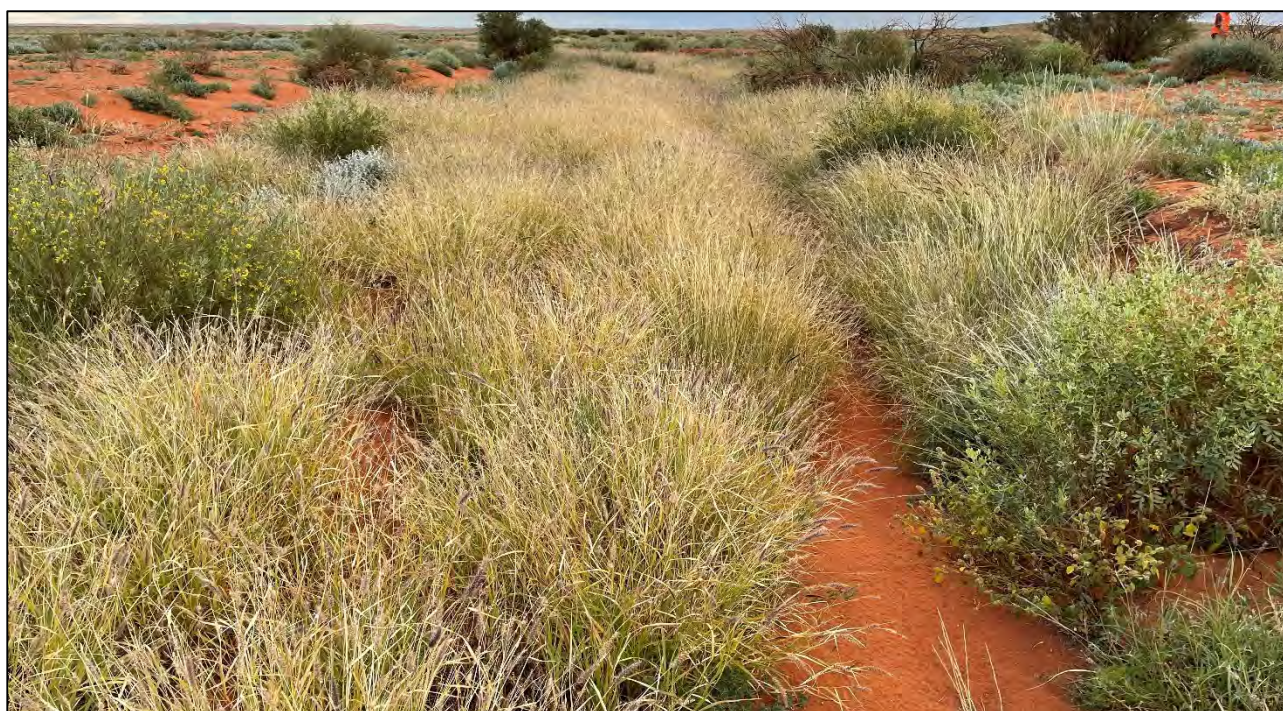
**Figure 3-13. Photographs of Buffel Grass infestation within a drainage line**

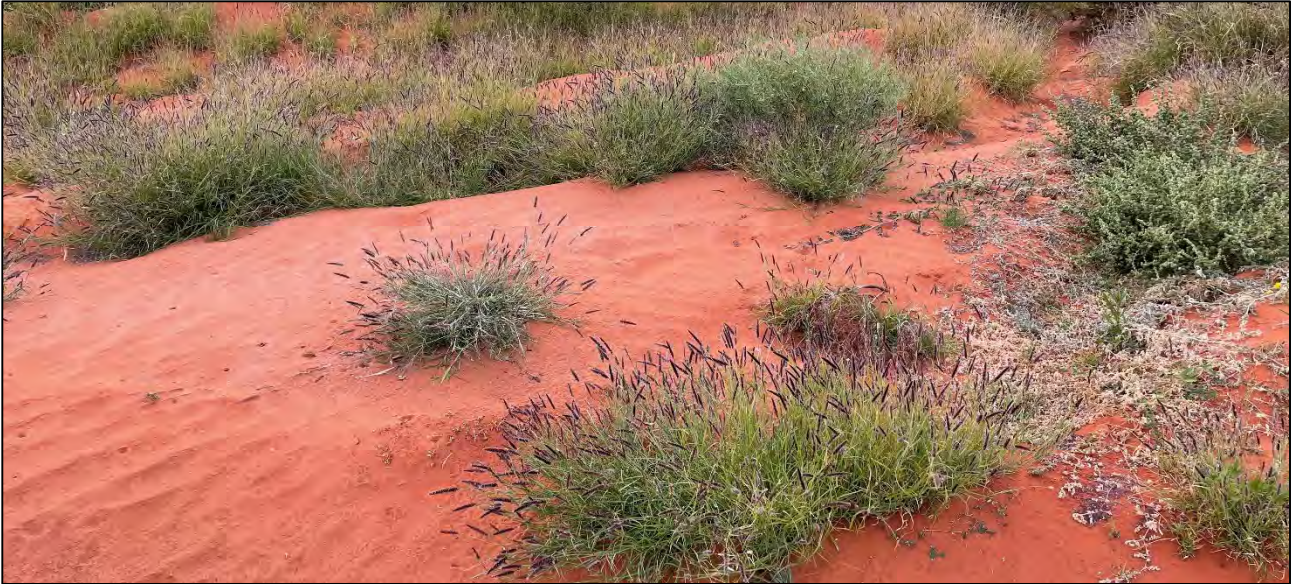
**Figure 3-14. Photographs of Buffel Grass infestation on a sand dune**

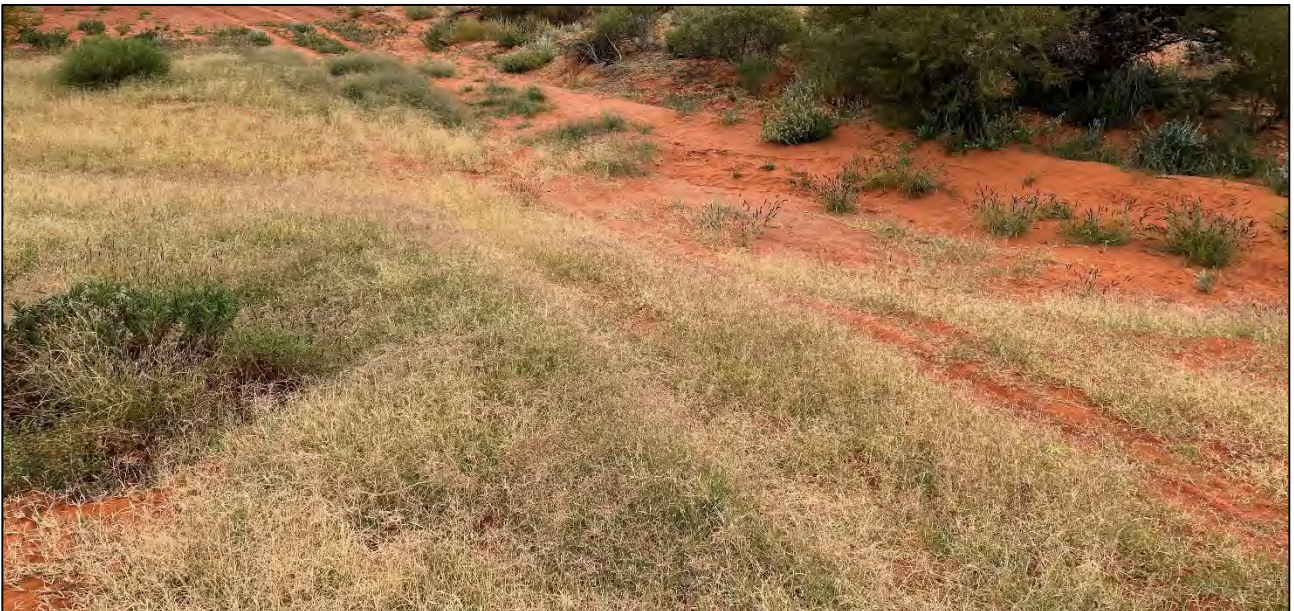
**Figure 3-15. Photographs of Couch Grass infestation in a drainage**

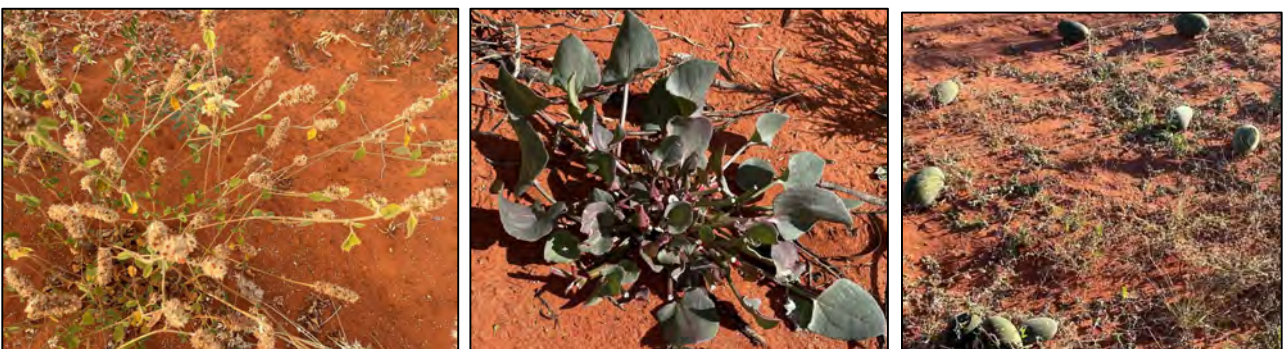
**Figure 3-16. Photographs of Spiked Malvastrum (left photograph) and Rub Dock (right photograph)**

A few other low impact and widespread environmental weeds were also recorded – Bitter Paddymelon (*Citrullus colocynthis*), Ruby Dock (*Rumex vesicarius*), Couch Grass (*Cynodon dactylon*) and Spiked Malvastrum (*Malvastrum americanum*) – representative photographs of infestations are provided in Figure 3-15 and Figure 3-16. These species are commonly observed on pastoral stations in this region and are not of major concern. Most occurrences were within drainage lines and on the edges of station tracks or other disturbances (i.e. bores, dams or water points).

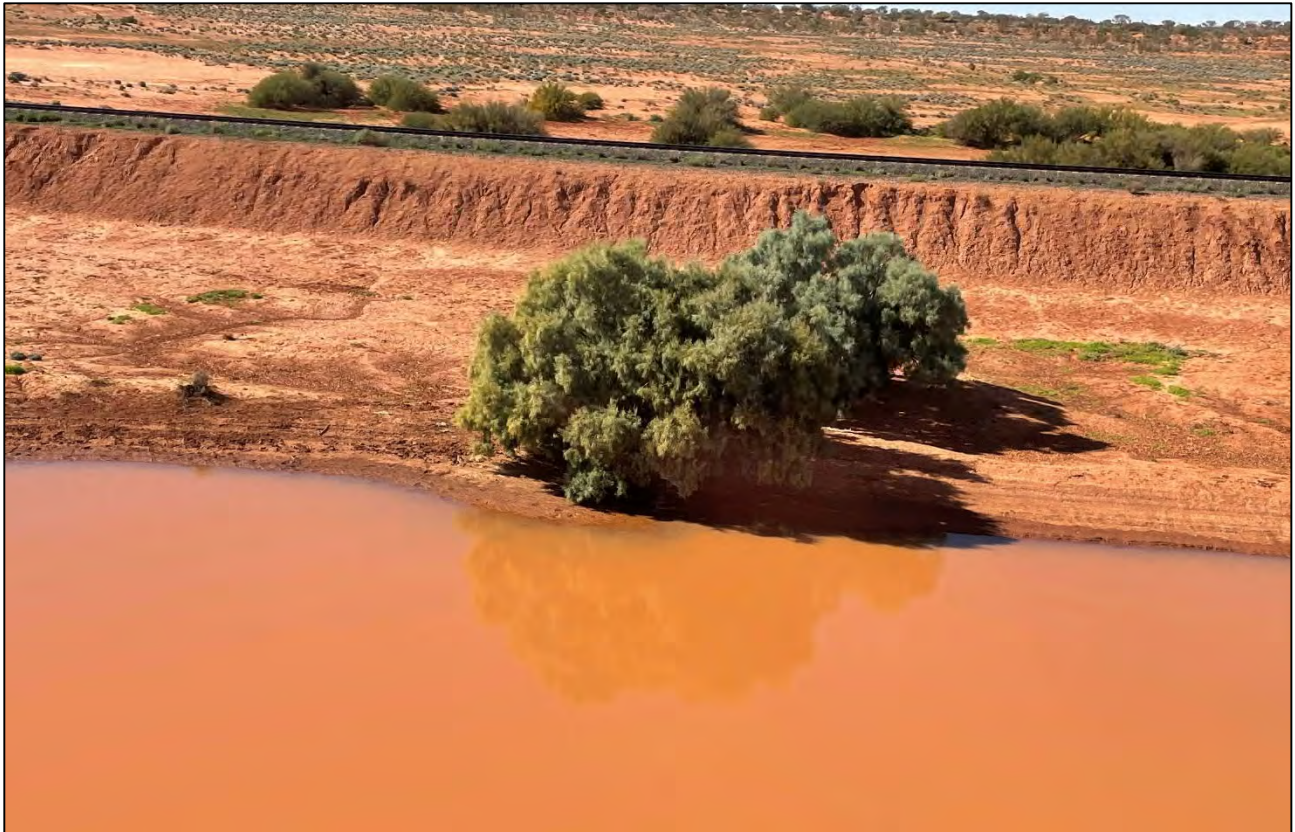
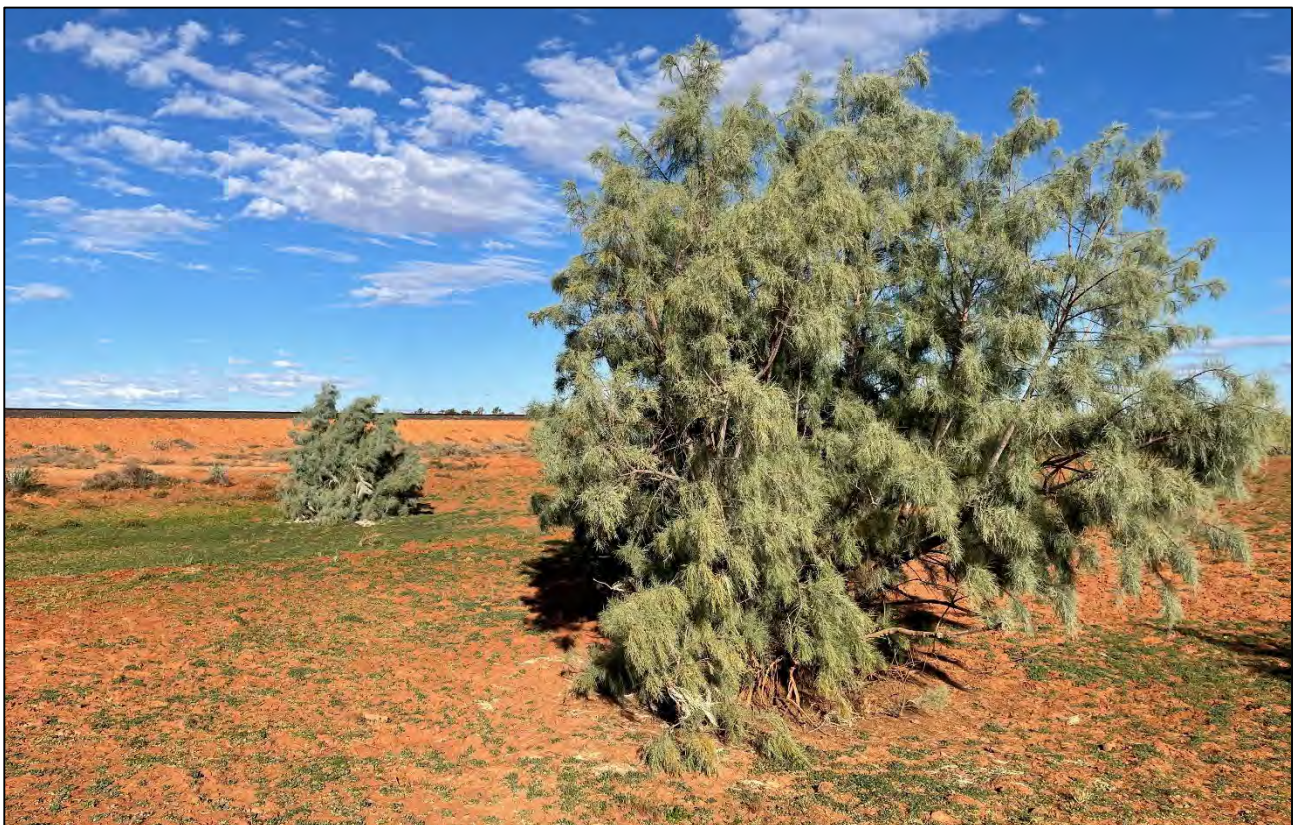
Incidentally, Athel Pine (*Tamarix aphylla*) (Class A/B species / WONS) was observed at two locations adjacent to the railway service road (photographs provided in Figure 3-17).

Figure 3-17. Photographs of two sites of Athel Pine observed on the western side of the railway track

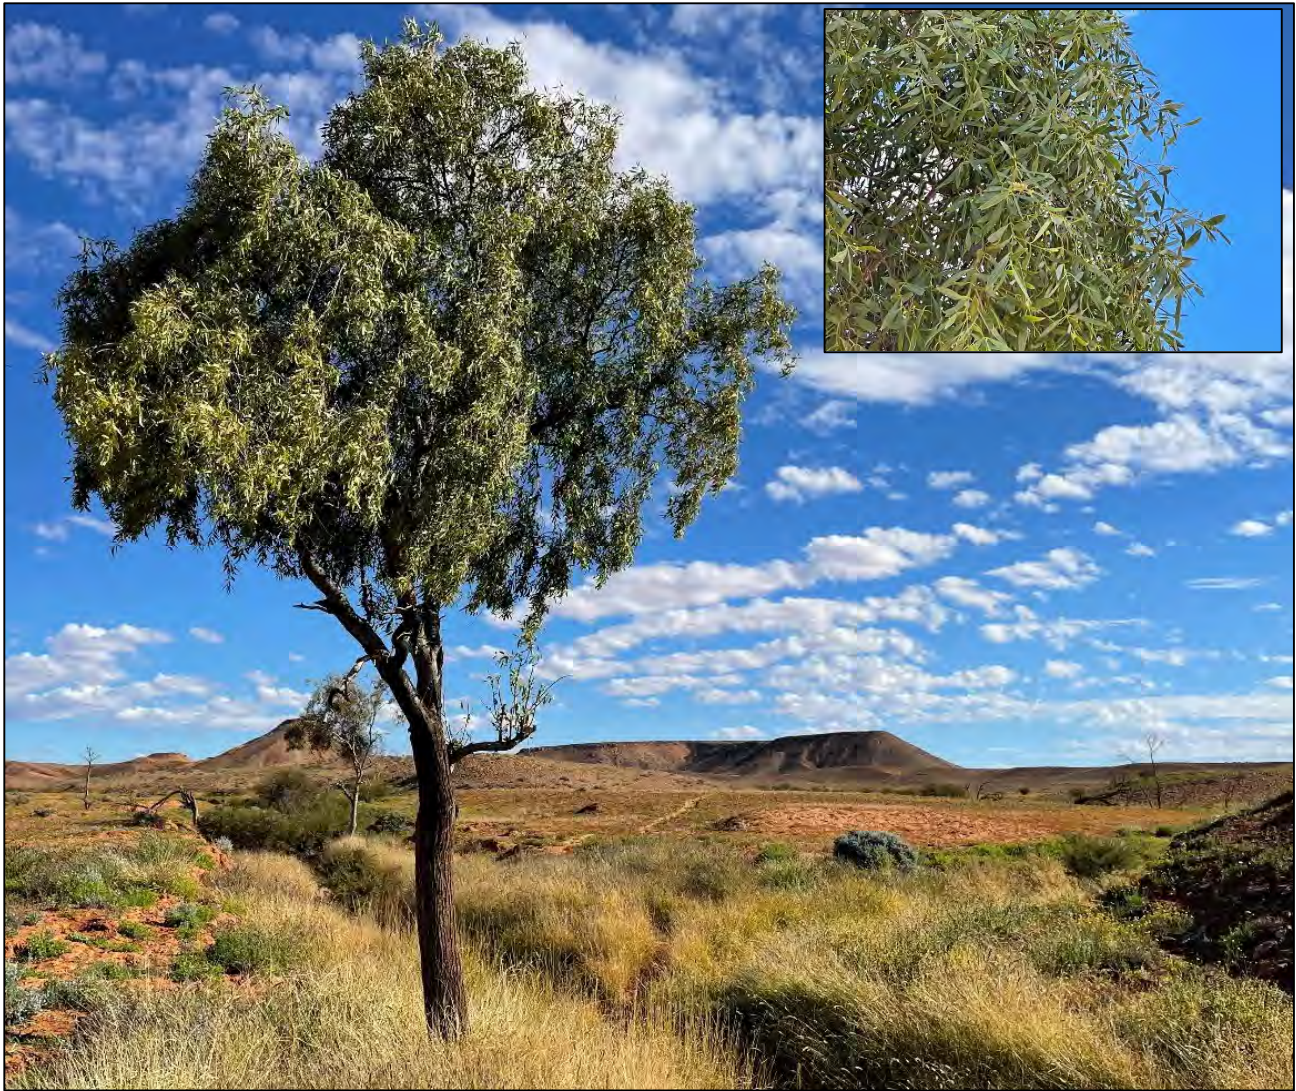
Figure 4-1. Photograph of Desert Quandong (*Santalum acuminatum*) at site 1a on line 1

During field surveys, an individual tree located nearby to the 2D seismic line 1 was suspected as being a Desert Quandong at site 1q (latitude: -25.1142019 longitude: 133.9526449) (photograph shown in Figure 4-1; refer to Section 6.1 for a map of this records). Identification could not be fully validated as there was no fruit available (and could be Native Plum, *Santalum lanceolatum*); however based on leaf shape and the size of the tree it is highly likely to be *Santalum acuminatum* and should be avoided.

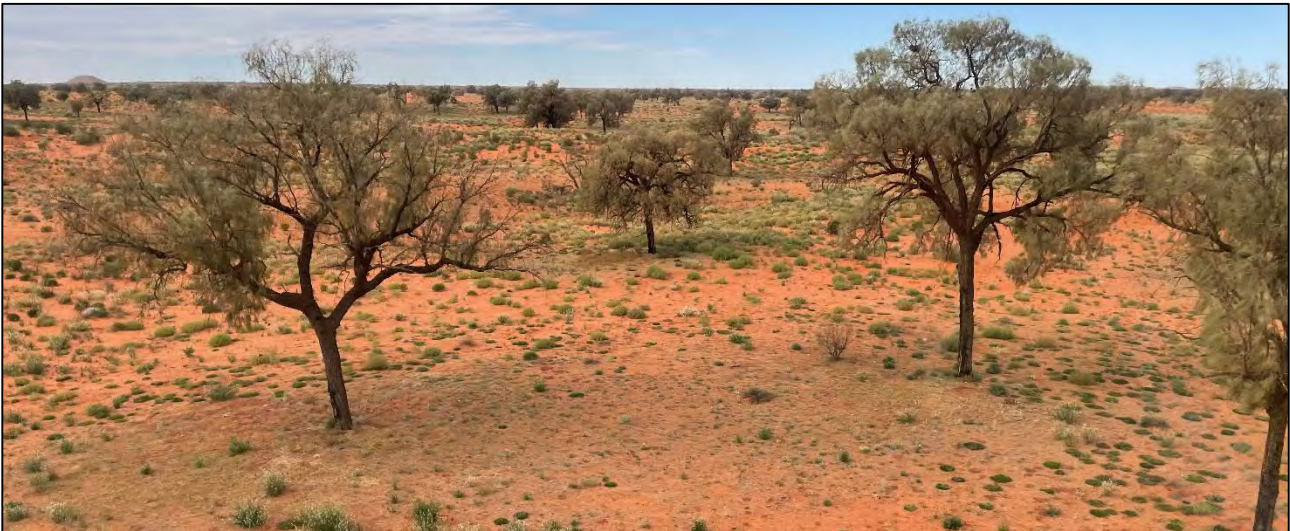
Figure 4-3. Photograph of Desert Oak (*Allocasuarina decaisneana*) within dune swales

Princess Parrot were not observed during the survey; however, there are several patches of large Desert Oak (*Allocasuarina decaisneana*) on seismic lines 4.2, 3.2, 1 and 2.3 (patches shown in Figure 4-3). These areas may contain suitable nesting hollows – although none were observed at inspection sites. These trees are scattered to sparse and can be easily avoided by the 2D seismic line establishment. As such, minimal impacts to this species are expected from the 2D seismic program.

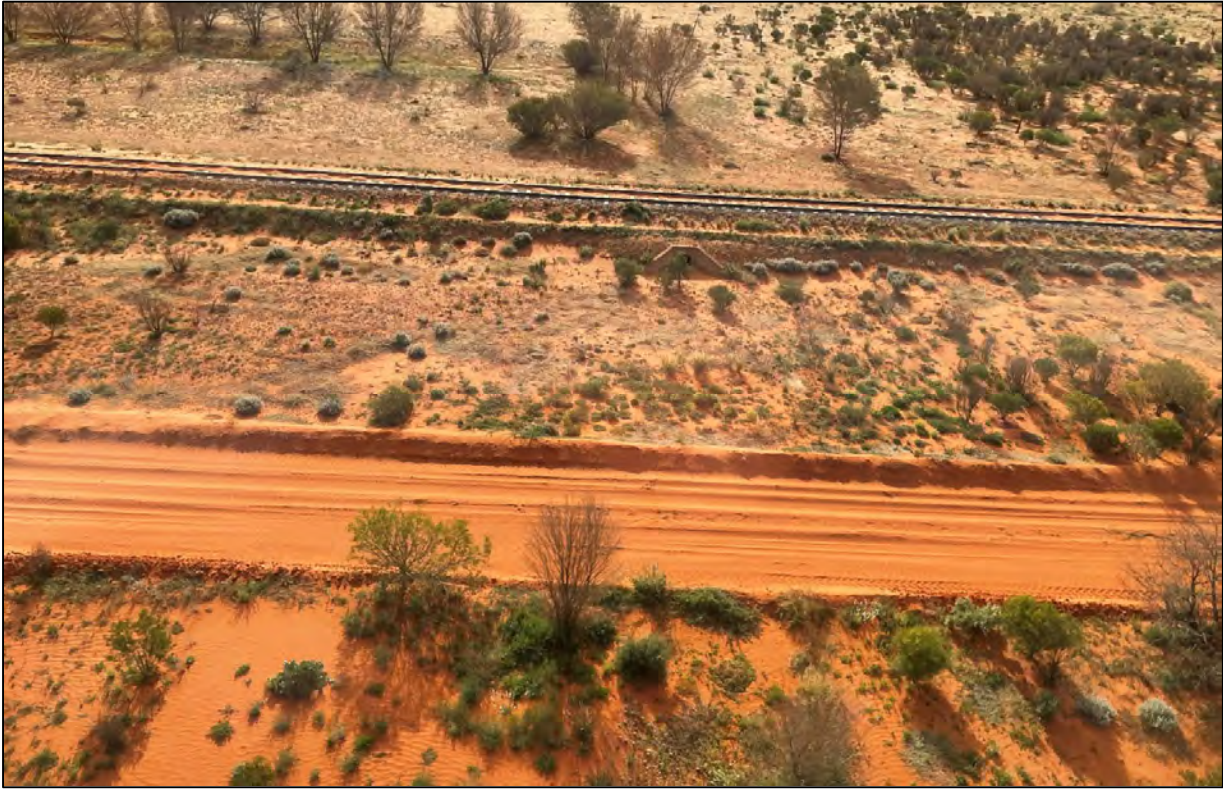
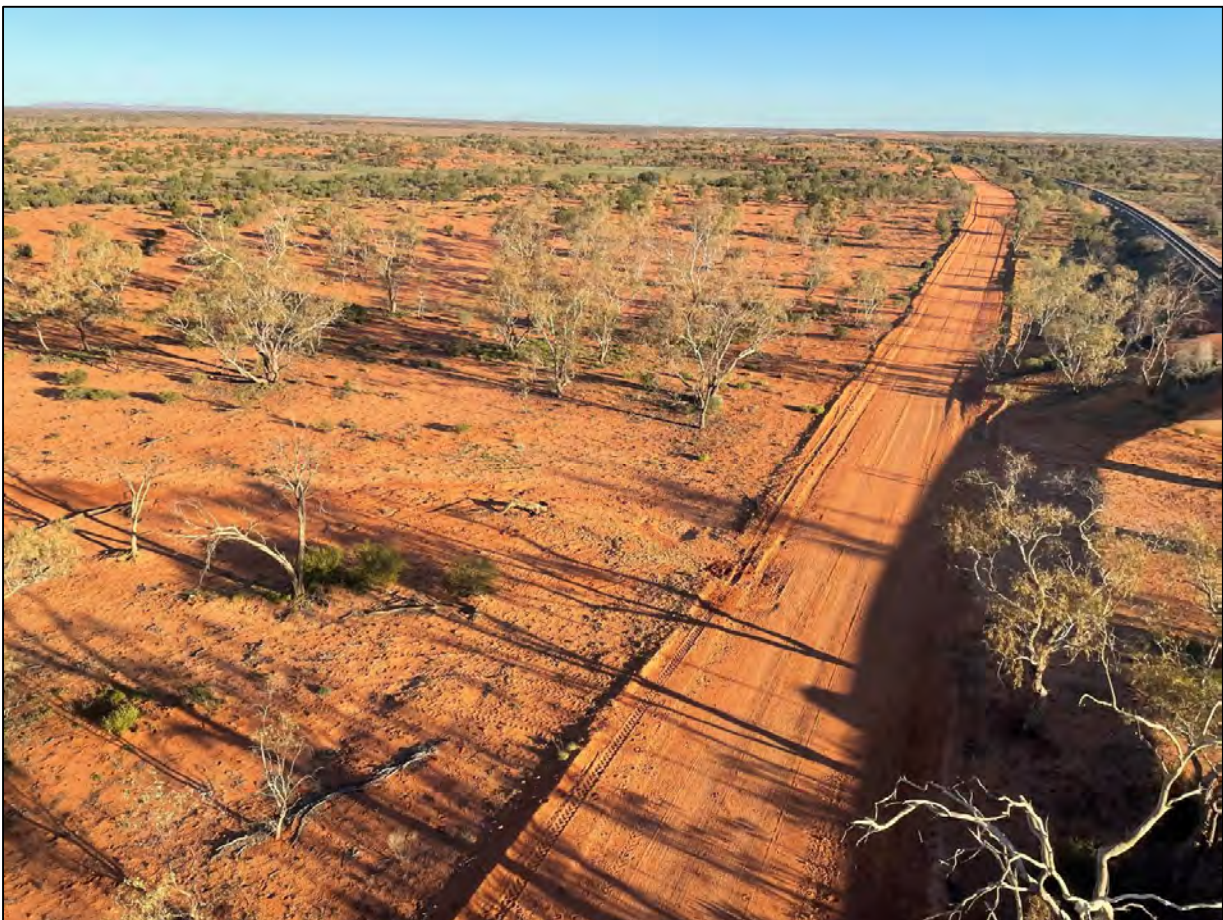
**Figure 6-2. Aerial photographs of railway service track and surrounding environment**

- The railway service track is in good condition and will not require any upgrades for 2D seismic exploration (if access approvals are given for this area). Shown in Appendix F – Maps 3, 8 and 9.
- It is noted that there are numerous scattered infestation of Buffel Grass that are established in the windrows and immediate surrounds, and some small infestations of Couch Grass at drainage outlet points. However, if vehicles stay on the current track, weed risk remains low.
- It is also noted that Athel Pine (a Weed of National Significance) was observed at two location is close proximity to the railway corridor (see Appendix F – Map 3). Both occurrences were in old borrow pits / dams, which are not traversed by the existing access road. Risk of spreading this species as a result of 2D seismic works is negligible if vehicles and workers stay on the existing track.

- The service track also crosses a major watercourse – Karinga Creek (see Appendix F – Map 3). Impacts to this creek will be negligible if 2D seismic works are restricted to the existing track.
