Peak Helium  
EP134  
2D Seismic EMP  
PKH1  
Appendices  
Contents

# **Environmental Assessment**

## **EP134 Seismic Program**

#### **PEAK HELIUM**

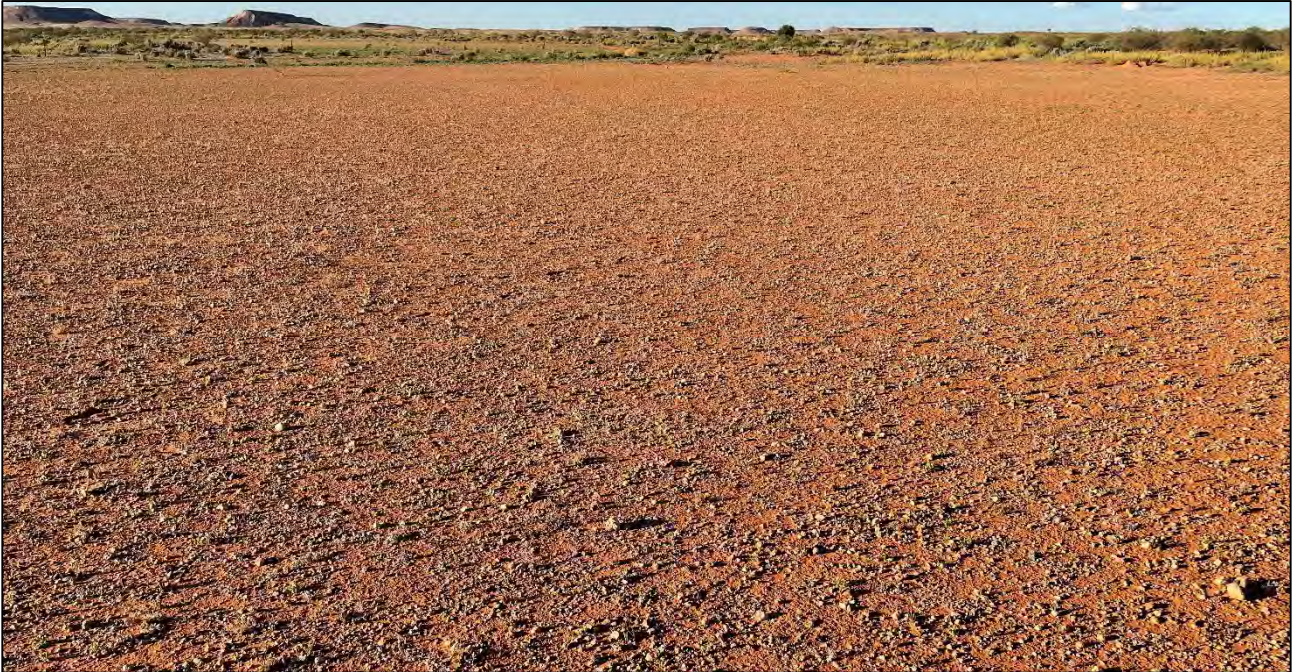
**Figure 6-3. Photograph of flat rocky plain where the temporary camp is proposed to be located if required**

- The proposed exploration camp (if required) will be 100x100m (1 ha) and occurs within EP82.
- The site is open flat rocky plain with minimal vegetation coverage (see Figure 6-3).
- No environmental issues identified.

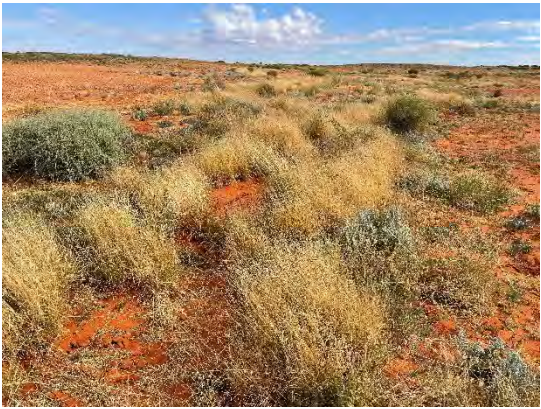
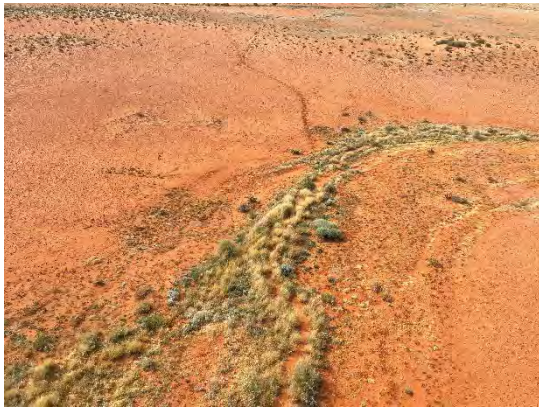
| Site | Latitude | Longitude | Stream order | Description | Plates | |
|---|---|---|---|---|---|---|
| 1b | -25.154348 | 133.96286 | 1 | <p>Minor intermittent stream.<br/>Weakly defined banks.</p> <ul style="list-style-type: none"> <li>Width (3-4m)</li> <li>Bank height (0.2m)</li> </ul> <p>Tussock grasses and scattered low Senna shrubs and chenopod shrubs.<br/>Weed management required (Buffel Grass infestation).<br/>Minor cut required.</p> | | |

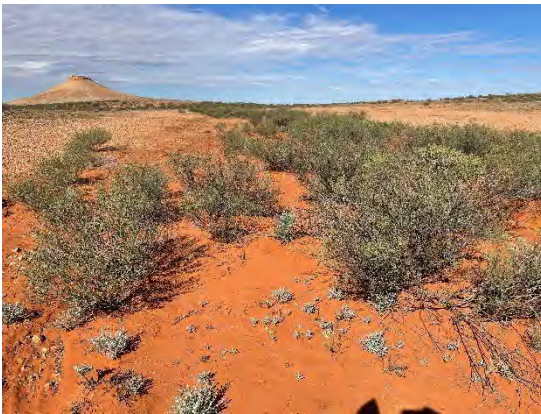
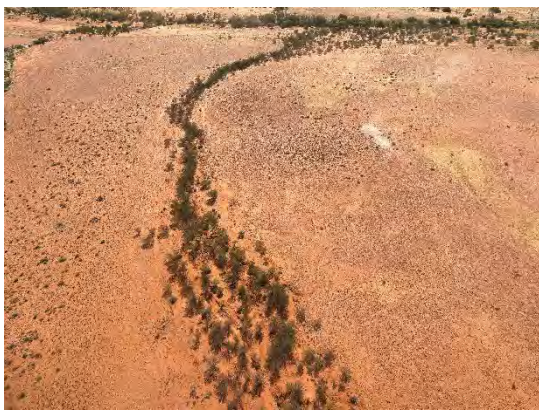
| Site | Latitude | Longitude | Stream order | Description | Plates | |
|---|---|---|---|---|---|---|
| 1c | -25.145214 | 133.95998 | 1 | <p>Minor intermittent stream.<br/>Low banks present, semi-braided in parts.</p> <ul style="list-style-type: none"> <li>Width (4-5m)</li> <li>Bank height (0.5m)</li> </ul> <p>Low Senna shrubland with sparse grasses and forbs.<br/>No weeds present.<br/>Minor cut required, but will require erosion controls to minimise chance of erosion along seismic line.</p> | | |

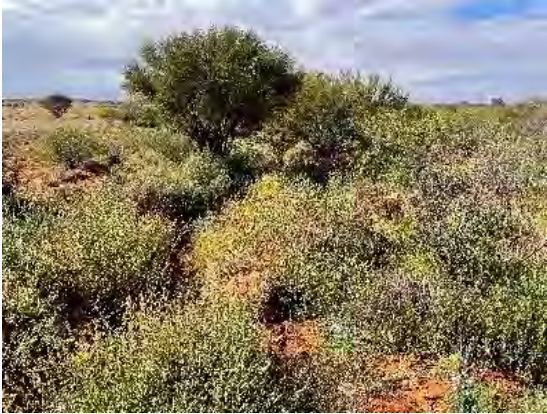
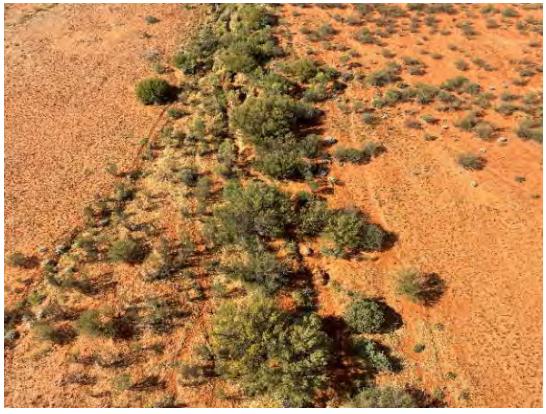
| Site | Latitude | Longitude | Stream order | Description | Plates | |
|---|---|---|---|---|---|---|
| 1d | -25.143507 | 133.959409 | 1 | <p>Minor intermittent stream.<br/>Well defined banks, semi-braided channel.</p> <ul style="list-style-type: none"> <li>Width (5-7m)</li> <li>Bank height (1m)</li> </ul> <p>Scattered low trees and shrubs over a dense cover of tussock grasses and forbs.<br/>Weed management required (Buffel Grass infestation).<br/>Minor cut required. Will require erosion controls to minimise chance of erosion along seismic line.</p> | | |

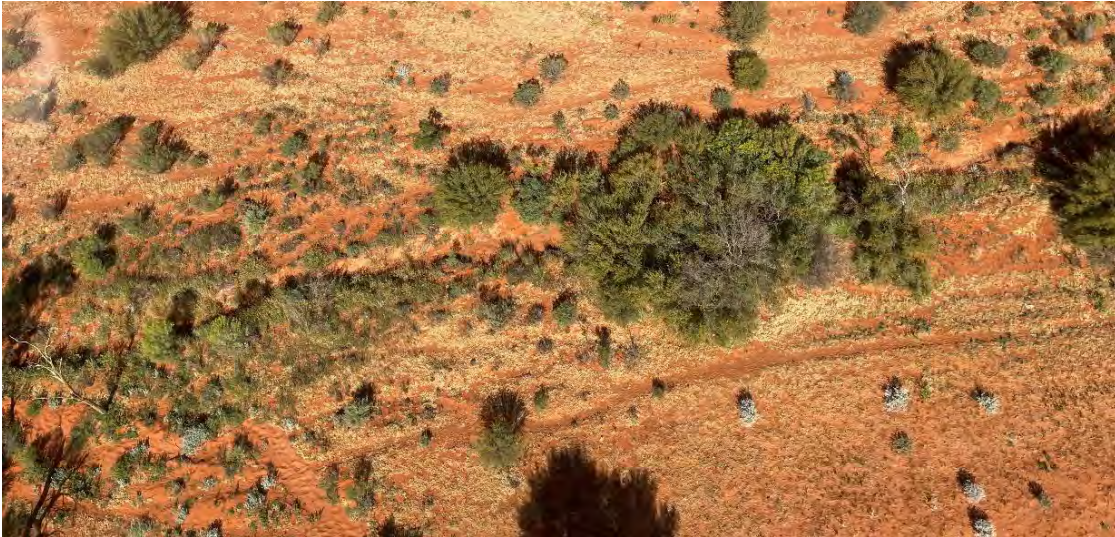
| Site | Latitude | Longitude | Stream order | Description | Plates | |
|---|---|---|---|---|---|---|
| 1e | -25.142944 | 133.95920 | 1 | <p>Minor intermittent stream.<br/>Well defined banks,</p> <ul style="list-style-type: none"> <li>Width (3m)</li> <li>Bank height (0.5m)</li> </ul> <p>Patchy shrubs and dense Buffel and other forbs and tussocks.<br/>Weed management required (Buffel Grass infestation).<br/>Minor cut required.<br/>Will require erosion controls to minimise chance of erosion along seismic line.</p> | | |

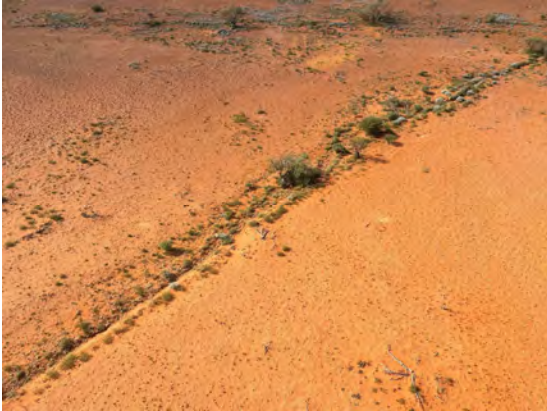
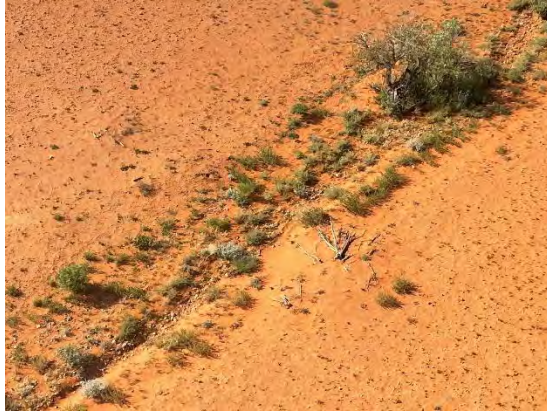
| Site | Latitude | Longitude | Stream order | Description | Plates | |
|---|---|---|---|---|---|---|
| 1f | -25.127651 | 133.95419 | 1 | <p>Minor intermittent stream.<br/>Moderately defined banks.</p> <ul style="list-style-type: none"> <li>Width (1m)</li> <li>Bank height (0.5m)</li> </ul> <p>Sparse shrubs over tussock grasses and forbs.<br/>Weed management required (Buffel Grass infestation).<br/>Potentially no cut required (very shallow banks).<br/>Will likely require restoration works to minimise chance of erosion along wheel ruts created during exploration.</p> | | |

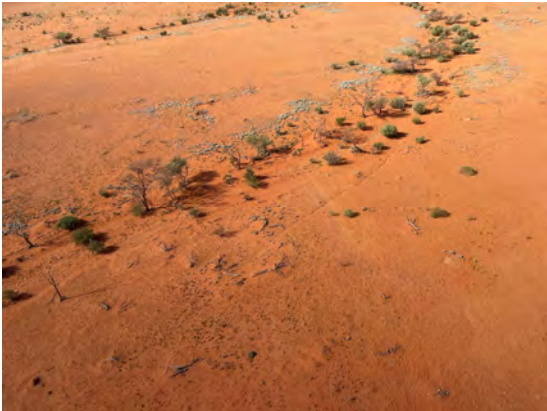
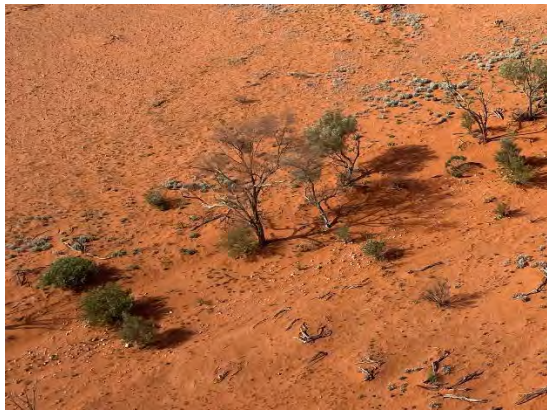
| Site | Latitude | Longitude | Stream order | Description | Plates | |
|---|---|---|---|---|---|---|
| 1g | -25.132449 | 133.95560 | 1 | <p>Minor intermittent stream.<br/>Weakly defined.</p> <ul style="list-style-type: none"> <li>Width (1m)</li> <li>Bank height (0.2m)</li> </ul> <p>Scattered Mulga and shrubs over sparse tussocks.<br/>No weeds present.<br/>Likely no cut required (due to very shallow banks).<br/>Will likely require restoration works to minimise chance of erosion along wheel ruts created during exploration.</p> | | |

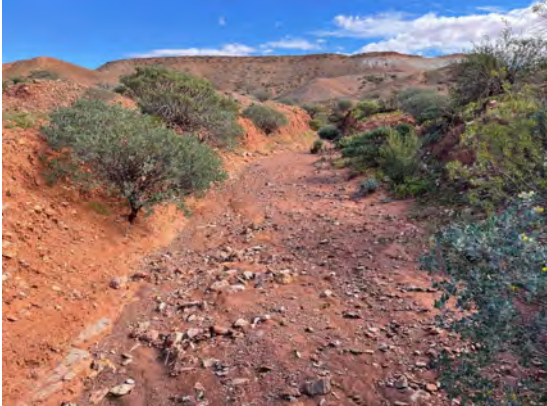
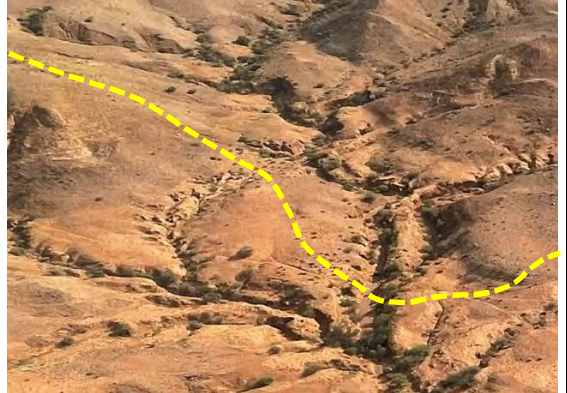
| Site | Latitude | Longitude | Stream order | Description | Plates | |
|---|---|---|---|---|---|---|
| 1i | -25.124576 | 133.95384 | 1 | <p>Moderate sized intermittent drainage gully(s).<br/>Well defined banks.</p> <ul style="list-style-type: none"> <li>Width (2-5m)</li> <li>Bank height (2-2.5m)</li> </ul> <p>Scattered shrubs (mostly Dead Finish) over sparse forbs and tussock grass.</p> <p>Weed management required (Buffel Grass scattered, low density / patchy occurrence).<br/>Earthworks / cuts required.</p> <p>Erosion risk area; minimise number of crossing to reduce erosion management.</p> | | <p><i>Yellow dashed line indicates recommended seismic line alignment that minimises disturbance of drainages (to minimise erosion management issues post exploration).</i></p> |

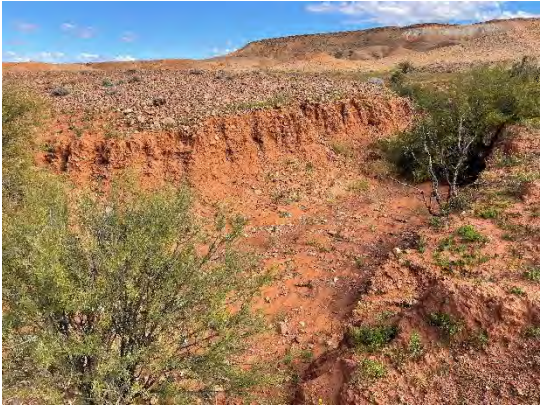
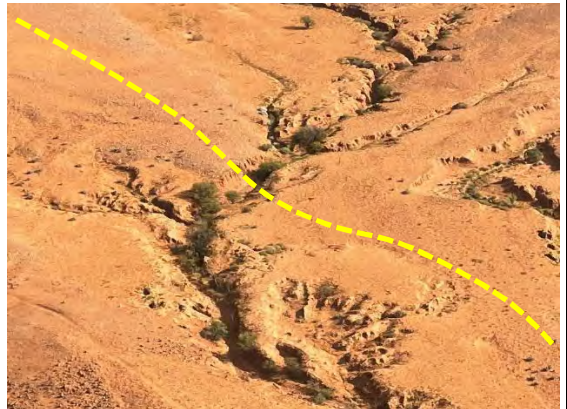
| Site | Latitude | Longitude | Stream order | Description | Plates | |
|---|---|---|---|---|---|---|
| 1k | -25.12232 | 133.95470 | 1 | <p>Moderate sized intermittent drainage gully.<br/>Well defined banks.</p> <ul style="list-style-type: none"> <li>Width (5m)</li> <li>Bank height (2m)</li> </ul> <p>Scattered shrubs (mostly Dead Finish) over sparse forbs and tussock grass.</p> <p>Weed management required (Buffel Grass scattered, low density / patchy occurrence).<br/>Earthworks / cuts required.</p> <p>Erosion risk area; minimise number of crossing to reduce erosion management.</p> | | <p><i>Yellow dashed line indicates recommended seismic line alignment that minimises disturbance of drainages (to minimise erosion management issues post exploration).</i></p> |

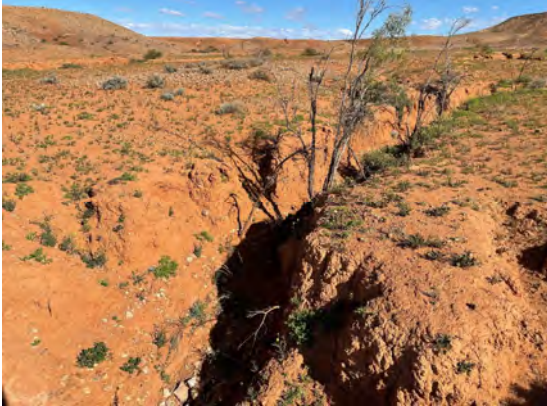
| Site | Latitude | Longitude | Stream order | Description | Plates | |
|---|---|---|---|---|---|---|
| 1l | -25.12153 | 133.95474 | 1 | <p>Moderate sized intermittent drainage gully.</p> <p>Well defined banks.</p> <ul style="list-style-type: none"> <li>Width (1.5m)</li> <li>Bank height (1.5m)</li> </ul> <p>Sparse shrubs, forbs and tussock grasses</p> <p>Weed management required (Buffel Grass scattered, low density / patchy occurrence).</p> <p>Earthworks / cuts required.</p> <p>Erosion risk area; minimise number of crossing to reduce erosion management.</p> | | |

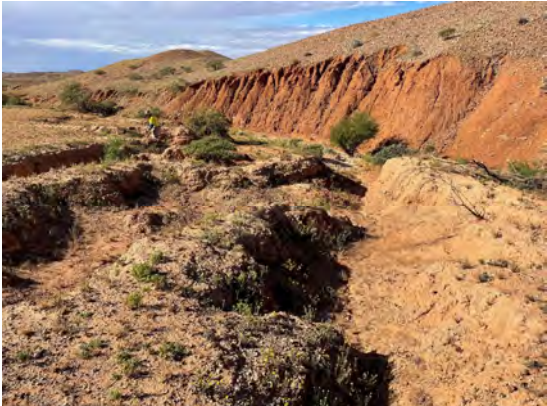
| Site | Latitude | Longitude | Stream order | Description | Plates | |
|---|---|---|---|---|---|---|
| 1m | -25.121259 | 133.95501 | 1 | <p>Small sized intermittent drainage gully(s).</p> <p>Well defined banks.</p> <ul style="list-style-type: none"> <li>Width (1-3m)</li> <li>Bank height (1-1.5m)</li> </ul> <p>Sparse shrubs, forbs and tussock grasses</p> <p>Weed management required (Buffel Grass scattered, low density / patchy occurrence).</p> <p>Earthworks / cuts required.</p> <p>Erosion risk area; minimise number of crossing to reduce erosion management.</p> | | |

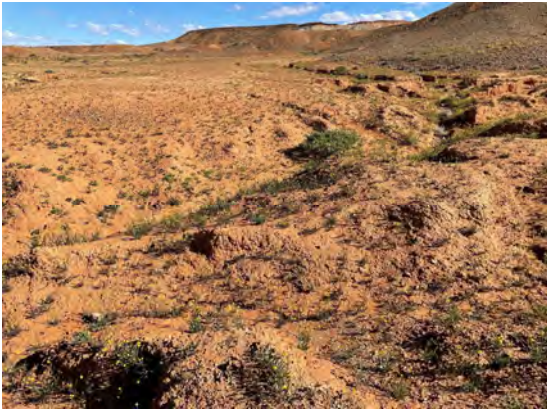
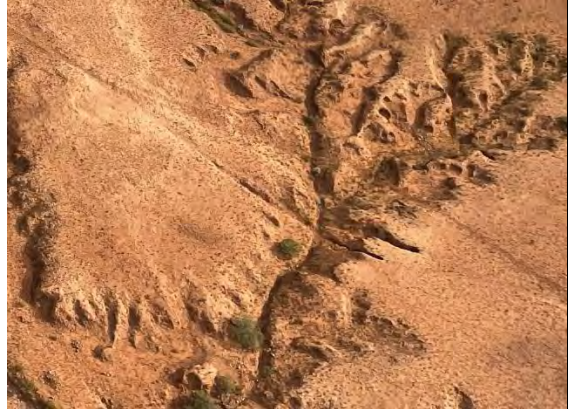
| DESCRIPTIONS OF DRAINAGE LINE CROSSINGS | | | | | |
|---|---|---|---|---|---|
| 1n | -25.120630 | 133.95524 | 1 | <p>Small sized intermittent drainage gully(s).<br/>Well defined banks; braided.</p> <ul style="list-style-type: none"> <li>Width (1-2m)</li> <li>Bank height (1m)</li> </ul> <p>Sparse shrubs, forbs and tussock grasses<br/>No weeds present/observed.<br/>Earthworks / cuts required.<br/>Erosion risk area; minimise number of crossing to reduce erosion management.</p> | |

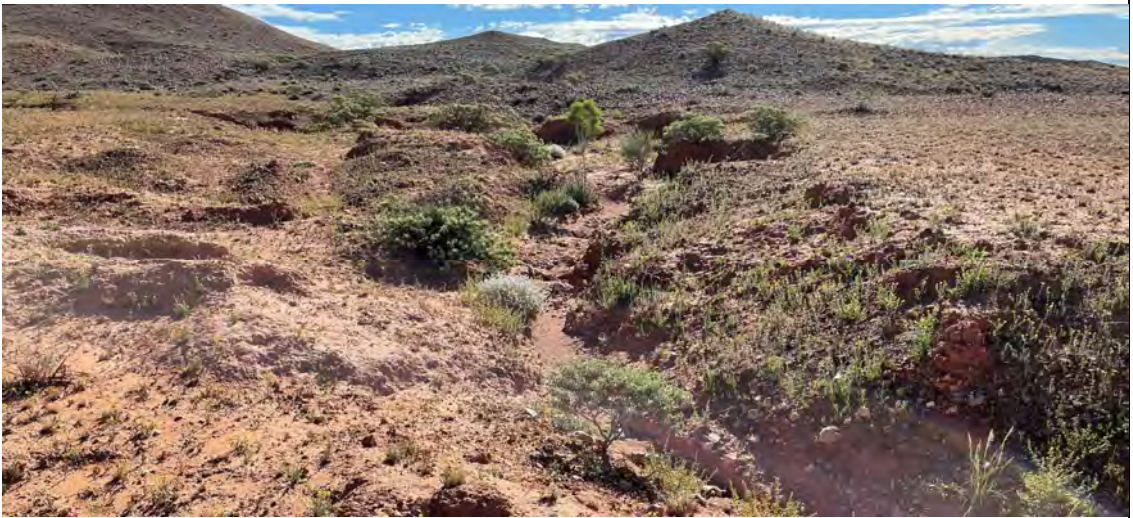
| DESCRIPTIONS OF DRAINAGE LINE CROSSINGS | | | | | |
|---|---|---|---|---|---|
| 1o | -25.120415 | 133.95530 | 1 | <p>Small sized intermittent drainage gully(s).<br/>Well defined banks; braided.</p> <ul style="list-style-type: none"> <li>Width (5-6m)</li> <li>Bank height (&lt;1m)</li> </ul> <p>Sparse shrubs, forbs and tussock grasses<br/>Weed management required (Buffel Grass scattered, low density / patchy occurrence).<br/>Earthworks / cuts required.<br/>Erosion risk area; minimise number of crossing to reduce erosion management.</p> | |

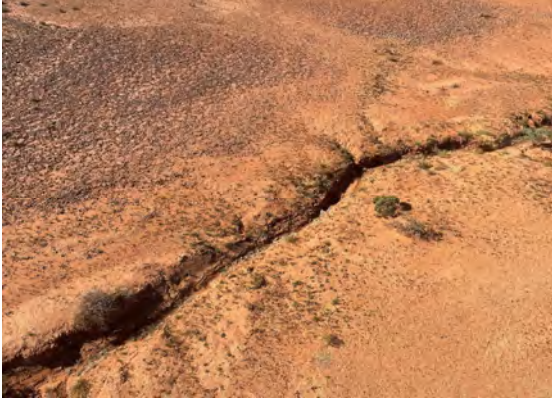
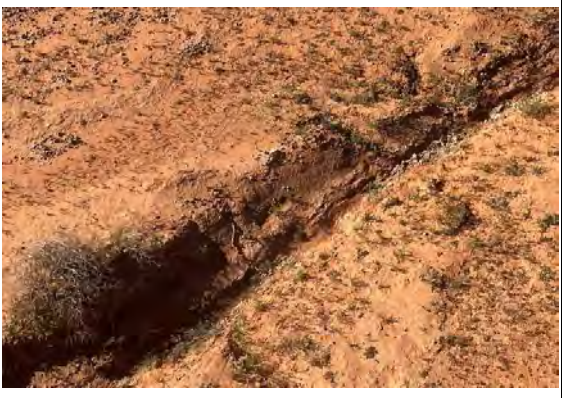
| Site | Latitude | Longitude | Stream order | Description | Plates | |
|---|---|---|---|---|---|---|
| 1p | -25.119047 | 133.95510 | 1 | <p>Moderate sized intermittent drainage gully.</p> <p>Well defined banks.</p> <ul style="list-style-type: none"> <li>Width (3m)</li> <li>Bank height (2m)</li> </ul> <p>Sparse shrubs, forbs and tussock grasses</p> <p>Weed management required (Buffel Grass scattered, low density / patchy occurrence).</p> <p>Earthworks / cuts required.</p> <p>Erosion risk area; minimise number of crossing to reduce erosion management.</p> | | |

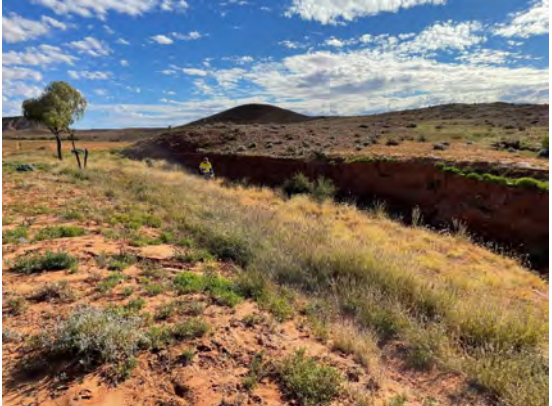
| Site | Latitude | Longitude | Stream order | Description | Plates | |
|---|---|---|---|---|---|---|
| 1q | -25.114202 | 133.95264 | 1 | <p>Moderate sized drainage.</p> <p>Well defined banks.</p> <ul style="list-style-type: none"> <li>Width (6m)</li> <li>Bank height (1-2.5m)</li> </ul> <p>Tussock grassland (Buffel) with scattered trees, forbs and short native tussocks</p> <p>Weed management required (Buffel Grass infestation).</p> <p>Earthworks / cuts required.</p> <p>Erosion risk area; minimise number of crossing to reduce erosion management.</p> <p>Threatened tree present (Quandong, <i>Santalum acuminatum</i>); avoid all trees.</p> | | |

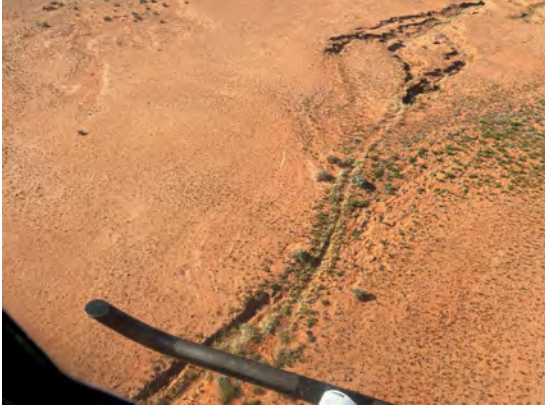
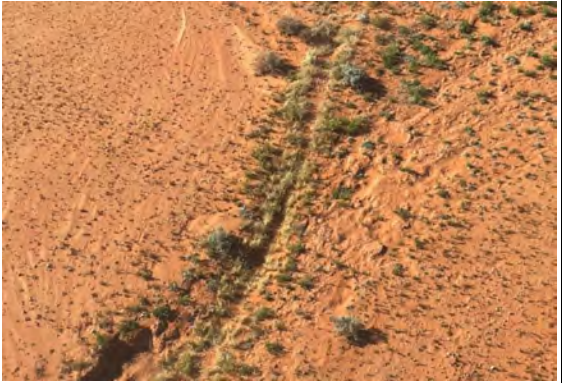
| Site | Latitude | Longitude | Stream order | Description | Plates | |
|---|---|---|---|---|---|---|
| 1r | -25.112796 | 133.95220 | 1 | <p>Moderate sized intermittent drainage gully.</p> <p>Well defined banks.</p> <ul style="list-style-type: none"> <li>Width (4m)</li> <li>Bank height (1m)</li> </ul> <p>Tussock grassland (Buffel) with scattered trees, forbs and short native tussocks</p> <p>Weed management required (Buffel Grass infestation).</p> <p>Earthworks / cuts required.</p> <p>Erosion risk area; minimise number of crossing to reduce erosion management.</p> <p>Avoid clearing trees.</p> | | |

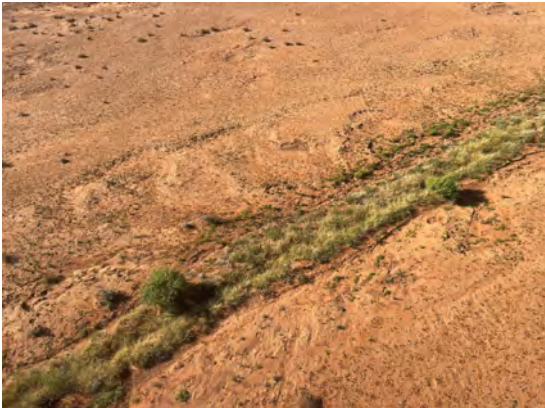
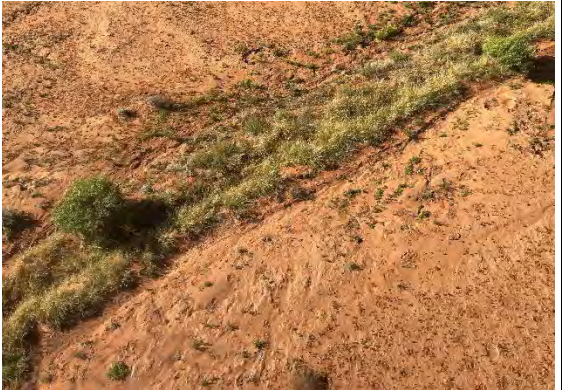
| Site | Latitude | Longitude | Stream order | Description | Plates | |
|---|---|---|---|---|---|---|
| 1s | -25.110771 | 133.95096 | 1 | <p>Moderate sized drainage.</p> <p>Well defined banks.</p> <ul style="list-style-type: none"> <li>Width (5-6m)</li> <li>Bank height (1-1.5m)</li> </ul> <p>Weed management required (Buffel Grass infestation).</p> <p>Earthworks / cuts required.</p> <p>Erosion risk area; minimise number of crossing to reduce erosion management.</p> <p>Threatened tree potentially present (Quandong, <i>Santalum acuminatum</i>) (not ground-checked at time of survey); avoid all trees.</p> | | |

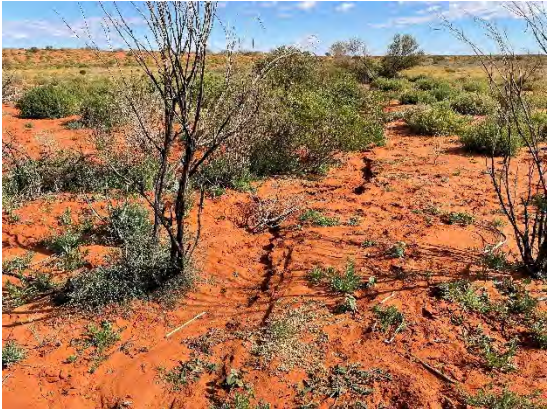
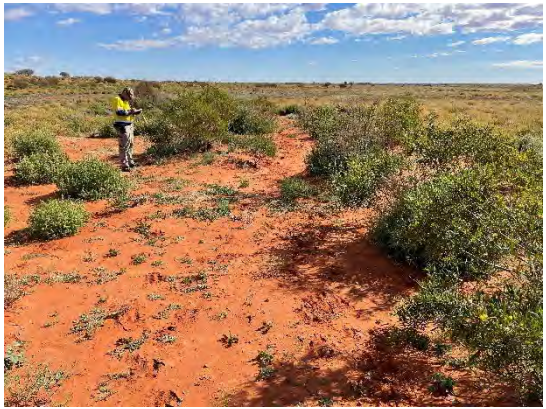
| Site | Latitude | Longitude | Stream order | Description | Plates | |
|---|---|---|---|---|---|---|
| 2.2a | -25.264049 | 133.74342 | 1 | <p>Minor intermittent stream.<br/>Weakly defined banks.</p> <ul style="list-style-type: none"> <li>Width (1m)</li> <li>Bank height (&lt;0.2m)</li> </ul> <p>Open low shrubs (<i>Acacia ligulata</i> and <i>A. kempeana</i>).<br/>Cattle impacts along drainage resulting in minor erosion.<br/>No weed issues.<br/>Potentially no cut required (very shallow banks); however, will likely require restoration works to minimise chance of erosion along wheel ruts post exploration.</p> | | |

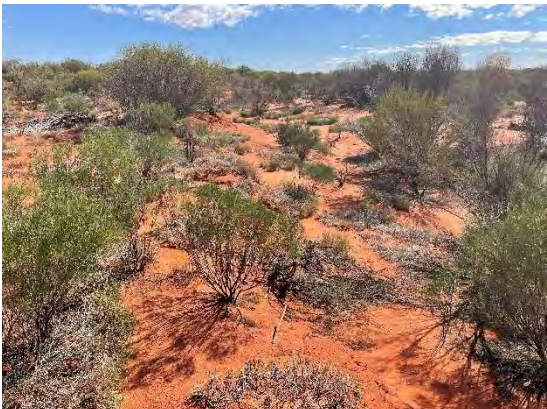
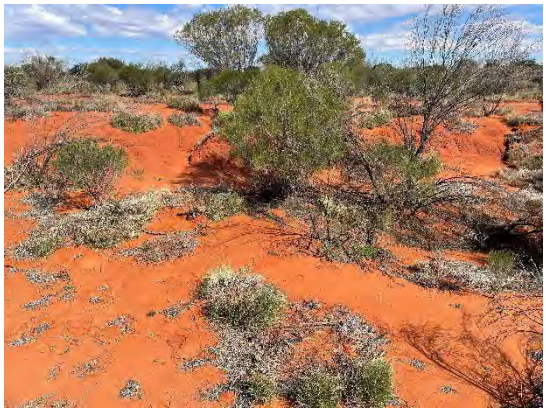
| Site | Latitude | Longitude | Stream order | Description | Plates | |
|---|---|---|---|---|---|---|
| 2.2c | -25.30633 | 133.63649 | 1 | <p>Minor intermittent stream.<br/>Moderately defined banks.</p> <ul style="list-style-type: none"> <li>Width (4m)</li> <li>Bank height (1m)</li> </ul> <p>Open shrubland (<i>Acacia ligulata</i> and <i>Dodonaea</i>).<br/>No weed issues.<br/>Rill erosion present on banks (minor only).<br/>Will require minor cut and associated erosion controls, or scout along drainage to find appropriate crossing.</p> | | |

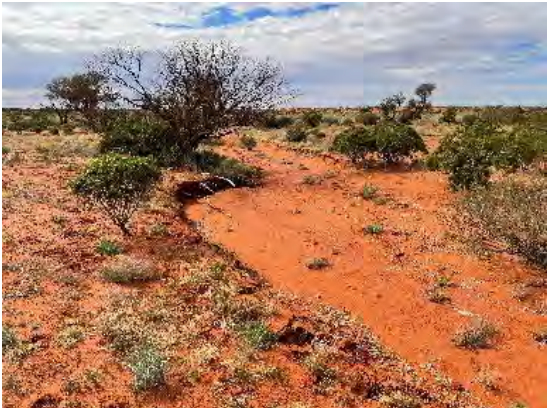
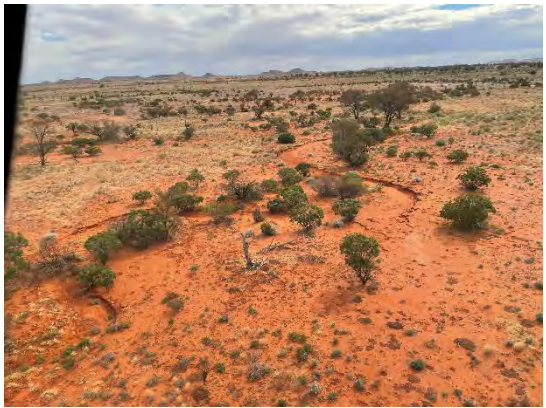
| Site | Latitude | Longitude | Stream order | Description | Plates | |
|---|---|---|---|---|---|---|
| 2.3b | -25.171564 | 133.98282 | 1 | <p>Moderate intermittent stream.</p> <p>Moderately defined banks; less defined to north.</p> <ul style="list-style-type: none"> <li>Width (3m)</li> <li>Bank height (0.3m)</li> </ul> <p>Scattered shrubs, forbs and tussock grasses. Occasional Mulga</p> <p>No weed issues.</p> <p>Moving line 30m (approx.) to north will avoid the main part of this drainage and the crossing point will likely not require cuts / minimal erosion management.</p> | | |

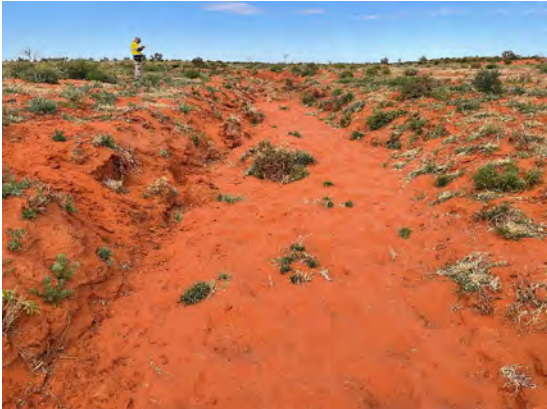
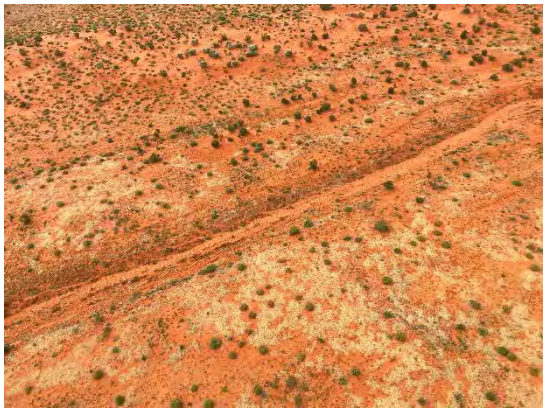
| Site | Latitude | Longitude | Stream order | Description | Plates | |
|---|---|---|---|---|---|---|
| 2.3c | -25.168256 | 133.99090 | 1 | <p>Moderate intermittent stream.</p> <p>Well defined banks:</p> <ul style="list-style-type: none"> <li>Width (3m)</li> <li>Bank height (1-1.5m)</li> </ul> <p>Sparse low shrubs, forbs and tussock grasses</p> <p>Weed management required (moderate Buffel Grass infestation).</p> <p>High level of cattle impact.</p> <p>Will require cut and associated erosion controls, or scout along drainage to find appropriate crossing.</p> | | |

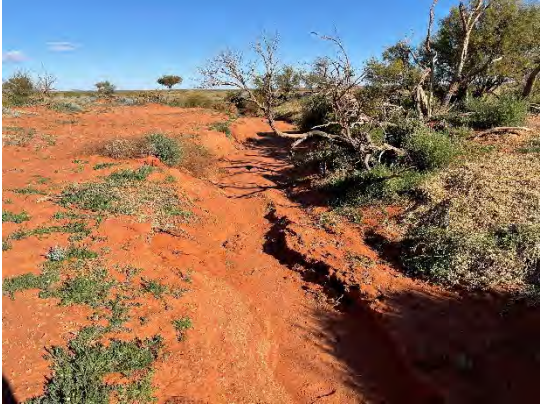
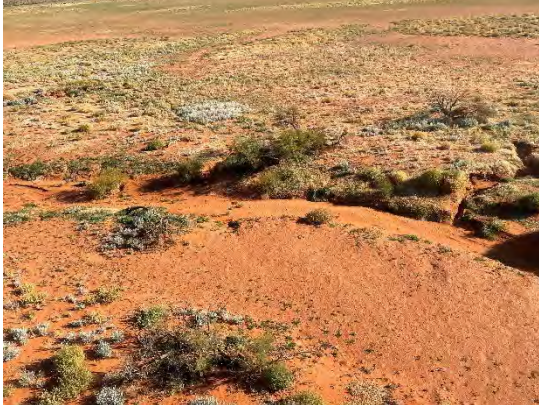
| Site | Latitude | Longitude | Stream order | Description | Plates | |
|---|---|---|---|---|---|---|
| 3.1d | -25.14976 | 133.79266 | 1 | <p>Moderate intermittent stream.</p> <p>Well defined banks:</p> <ul style="list-style-type: none"> <li>Width (3m)</li> <li>Bank height (1-1.5m)</li> </ul> <p>Scattered shrubs and forbs.<br/>Sparse tussock grasses.</p> <p>No weed issues.</p> <p>Some cattle disturbance.</p> <p>Rill and gully erosion present.</p> <p>Will require cut and associated erosion controls, or scout along drainage to find appropriate crossing.</p> | | |

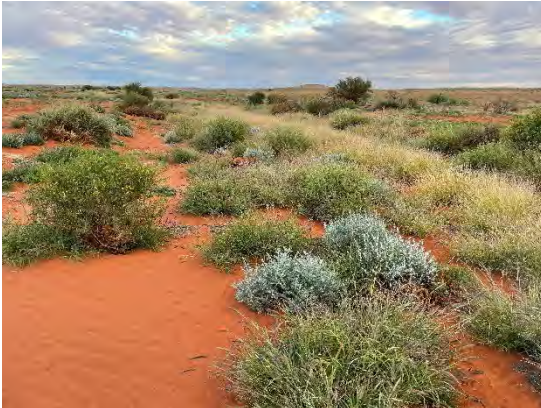
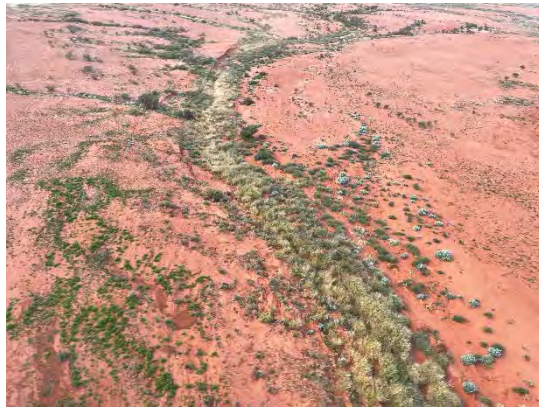
| Site | Latitude | Longitude | Stream order | Description | Plates | |
|---|---|---|---|---|---|---|
| 3.1j | -25.103532 | 133.80928 | 1 | <p>Moderate intermittent stream.</p> <p>Moderately defined banks:</p> <ul style="list-style-type: none"> <li>Width (10m)</li> <li>Bank height (1m)</li> </ul> <p>Open shrubland over Buffel Grass.</p> <p>Weed management required (Buffel Grass infestation).</p> <p>Creek bank erosion present (minor only).</p> <p>Will require minor cut and associated erosion controls, or scout along drainage to find appropriate crossing.</p> | | |

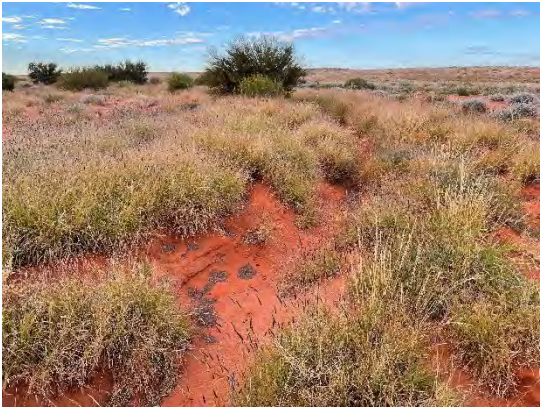
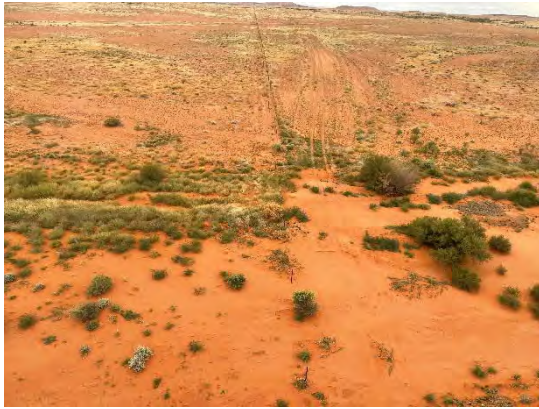
| DESCRIPTIONS OF DRAINAGE LINE CROSSINGS | | | | | |
|---|---|---|---|---|---|
| 3.1l | -25.092258 | 133.813193 | 1 | <p>Minor intermittent stream.<br/>Well defined banks:</p> <ul style="list-style-type: none"> <li>Width (8-10m)</li> <li>Bank height (1m)</li> </ul> <p>Open shrubland over Buffel Grass.<br/>Weed management required (Buffel Grass infestation).<br/>Creek bank erosion present (minor only).<br/>Relocate line to fence line track 100m to east to avoid requirement to cut into drainage / weed spread risk.</p> | |

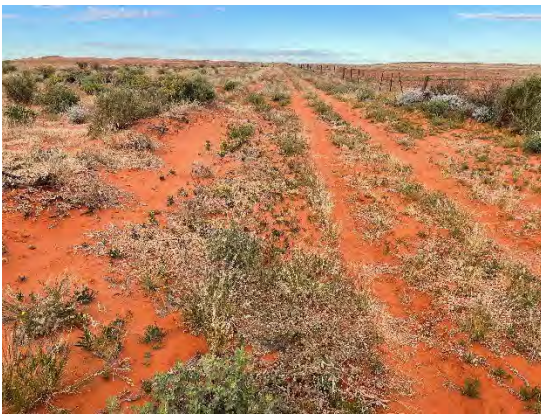
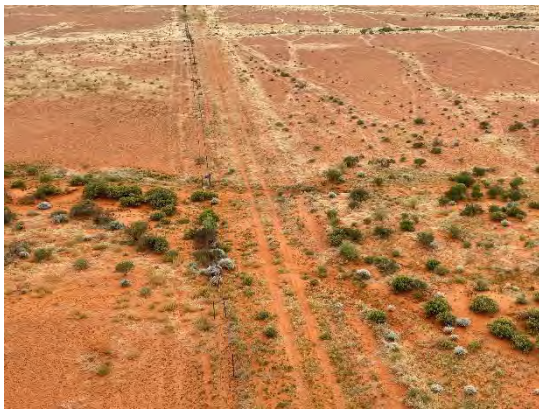
| DESCRIPTIONS OF DRAINAGE LINE CROSSINGS | | | | | |
|---|---|---|---|---|---|
| 3.1m | -25.077772 | 133.81428 | 1 | <p>Minor intermittent stream.<br/>Moderately defined banks:</p> <ul style="list-style-type: none"> <li>Width (3m)</li> <li>Bank height (&lt;1m)</li> </ul> <p>Low open shrubland over scattered tussocks and forbs<br/>Weed management required (Buffel Grass infestation).<br/>Seismic uses existing station track so no cut required.</p> | |

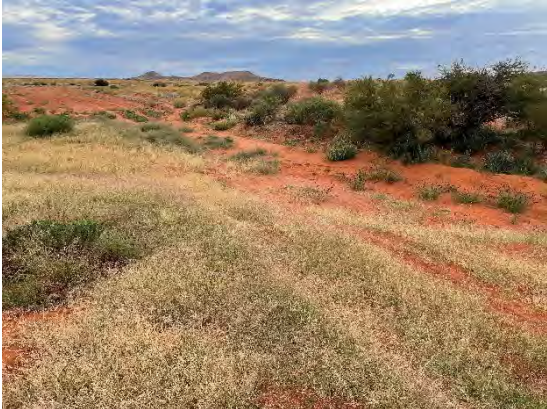
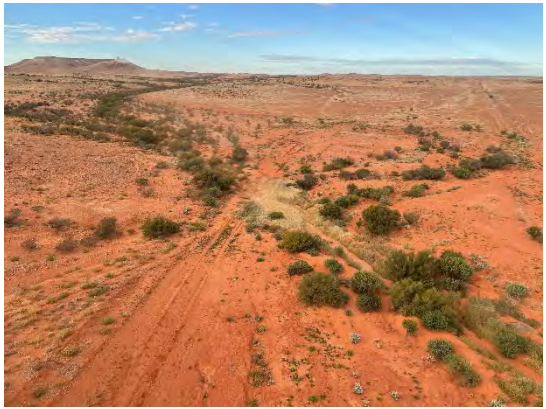
| Site | Latitude | Longitude | Stream order | Description | Plates | |
|---|---|---|---|---|---|---|
| 3.1n | -25.071804 | 133.81463 | 1 | <p>Moderate intermittent stream.</p> <p>Well defined banks:</p> <ul style="list-style-type: none"> <li>Width (8m)</li> <li>Bank height (1m)</li> </ul> <p>Open shrubland over Buffel Grass and Couch Grass</p> <p>Weed management required (Buffel Grass and Couch Grass infestation).</p> <p>Eroding banks present.</p> <p>Seismic uses existing station track so no cut required.</p> | | |

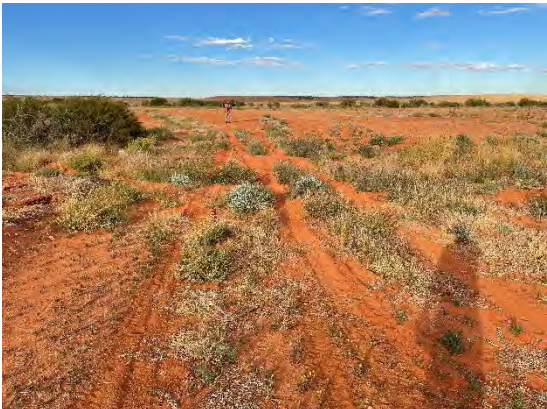
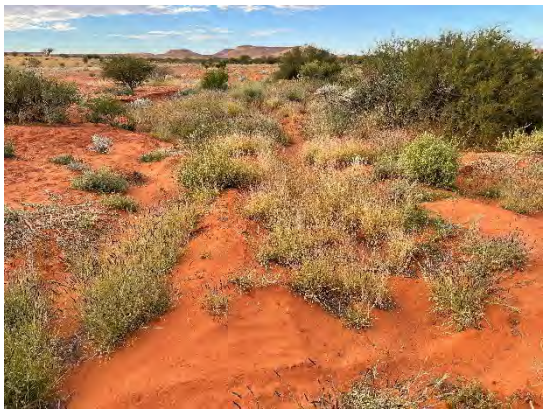
| Site | Latitude | Longitude | Stream order | Description | Plates | |
|---|---|---|---|---|---|---|
| 3.1o | -25.070268 | 133.81452 | 1 | <p>Minor intermittent stream.</p> <p>Moderately defined banks:</p> <ul style="list-style-type: none"> <li>Width (4-5m)</li> <li>Bank height (0.5m)</li> </ul> <p>Open shrubland over Buffel Grass</p> <p>Weed management required (Buffel Grass infestation).</p> <p>Eroding banks present.</p> <p>Seismic uses existing station track so no cut required.</p> | | |

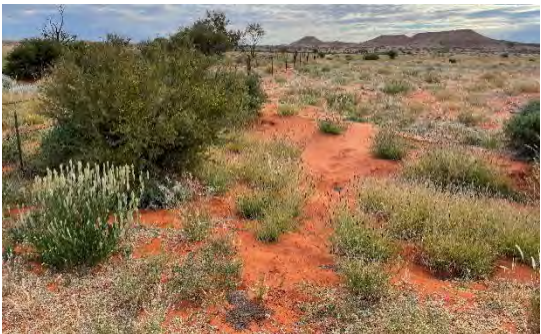
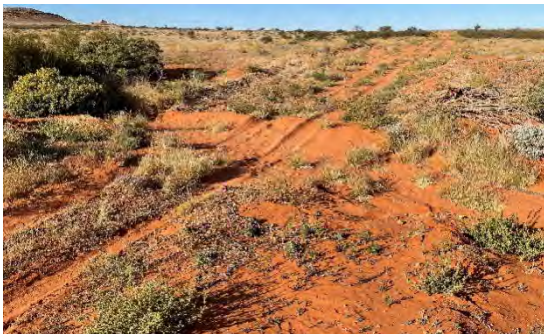
| Site | Latitude | Longitude | Stream order | Description | Plates | |
|---|---|---|---|---|---|---|
| 3.1r | -25.064346 | 133.814242 | 1 | <p>Moderate intermittent stream.</p> <p>Well defined banks:</p> <ul style="list-style-type: none"> <li>Width (2m)</li> <li>Bank height (0.5m)</li> </ul> <p>Low open shrubs over Buffel Grass. Shrubs localised to drainage.</p> <p>Weed management required (Buffel Grass infestation).</p> <p>Move line 90m to east from fence line to existing station track as there is no clear track along fence line (therefore vegetation clearing will be required; increasing risk of Buffel spread and erosion).</p> | <p>Current seismic alignment on fence line</p> | <p>Existing station track to east</p> |

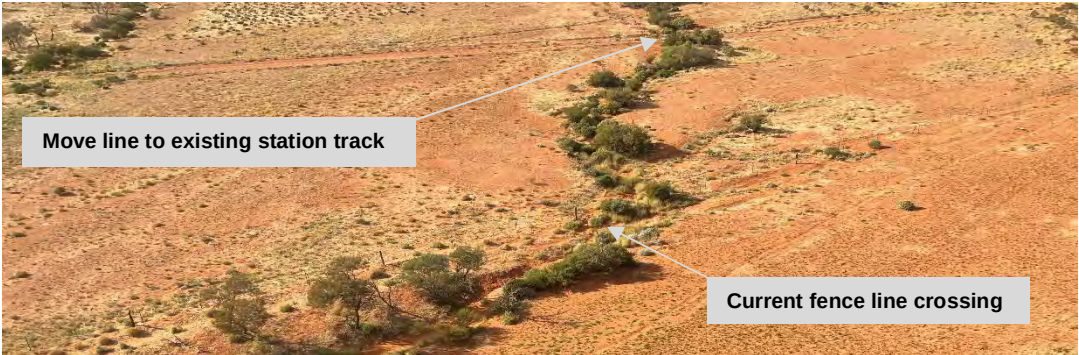
| Site | Latitude | Longitude | Stream order | Description | Plates | |
|---|---|---|---|---|---|---|
| | | | | | <p>Move line to existing station track</p> <p>Current fence line crossing</p> | |

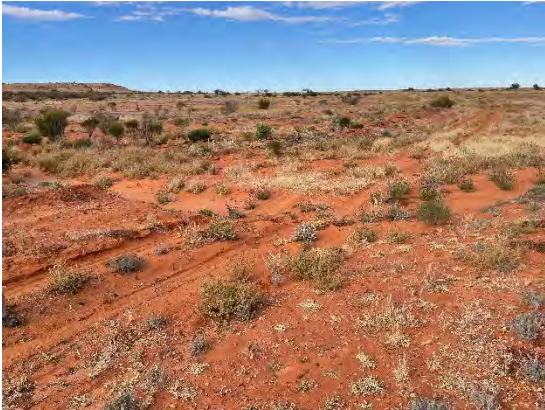
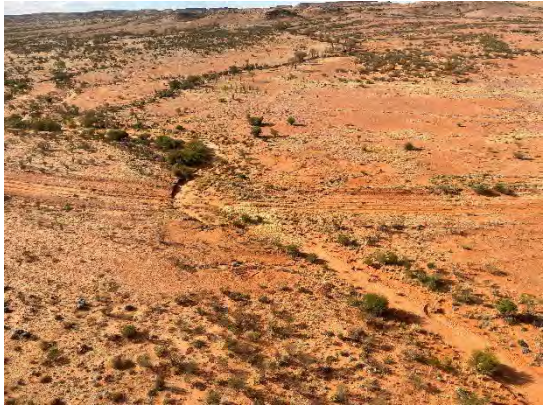
| Site | Latitude | Longitude | Stream order | Description | Plates | |
|---|---|---|---|---|---|---|
| 3.1s | -25.060242 | 133.81585 | 1 | <p>Minor intermittent stream.<br/>Moderately defined banks:</p> <ul style="list-style-type: none"> <li>Width (6-8m)</li> <li>Bank height (1m)</li> </ul> <p>Patchy shrubs over Buffel Grass and Couch Grass<br/>Weed management required (Buffel and Couch Grass).<br/>Minor erosion on track<br/>Located on station track.</p> | | |

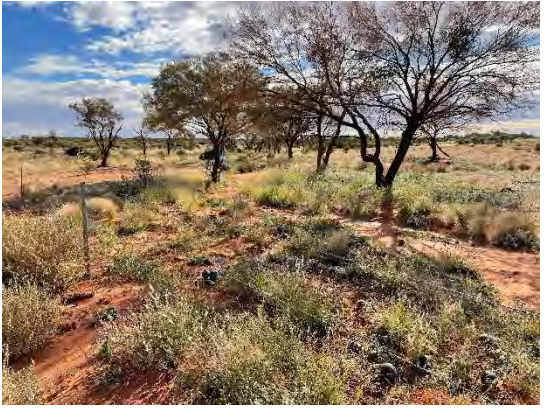
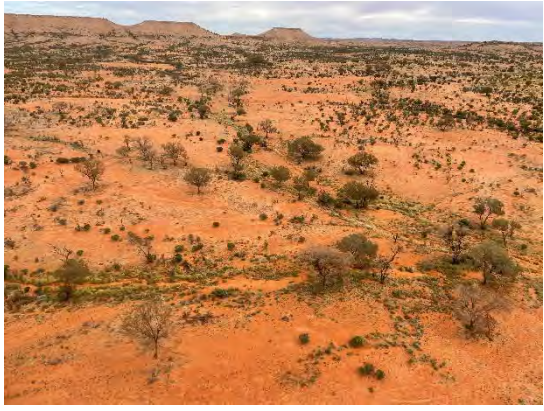
| Site | Latitude | Longitude | Stream order | Description | Plates | |
|---|---|---|---|---|---|---|
| 3.1u | -25.049609 | 133.82750 | 1 | <p>Minor intermittent stream.<br/>Moderately defined banks:</p> <ul style="list-style-type: none"> <li>Width (2m)</li> <li>Bank height (0.2m)</li> </ul> <p>Open Mulga over tussocks<br/>Weed management required (Buffel and Couch Grass).<br/>Located on old seismic line.<br/>Fence line present.<br/>Requires minor cut and erosion controls.<br/>Consider moving line to south away from drainage.</p> | | |

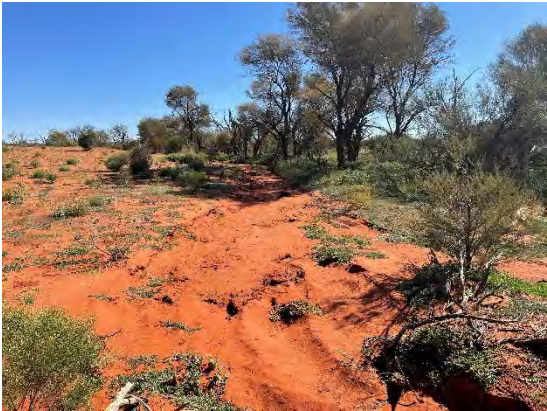
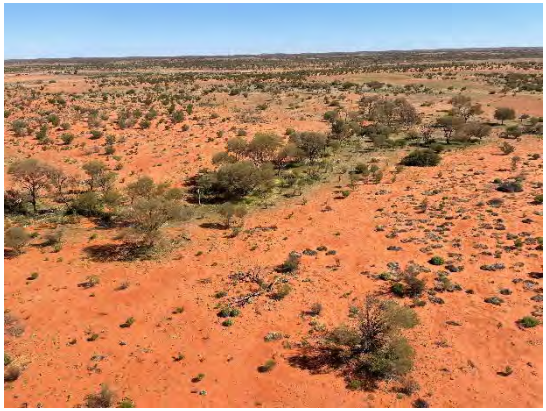
| Site | Latitude | Longitude | Stream order | Description | Plates | |
|---|---|---|---|---|---|---|
| 6.2o | -25.172851 | 133.54608 | 1 | <p>Minor intermittent stream.<br/>Moderately defined banks:</p> <ul style="list-style-type: none"> <li>Width (4-5m)</li> <li>Bank height (0.2m)</li> </ul> <p>Open Mulga Low Woodland with Dead Finish shrubs over forbs and tussocks.</p> <p>Minor weed issues; consider weed management at this location to minimise spread.</p> <p>Select a crossing point that would not require cuts (or minor cut) and avoid trees.</p> | | |

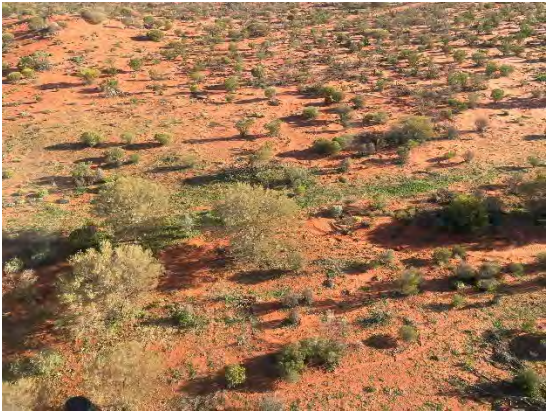
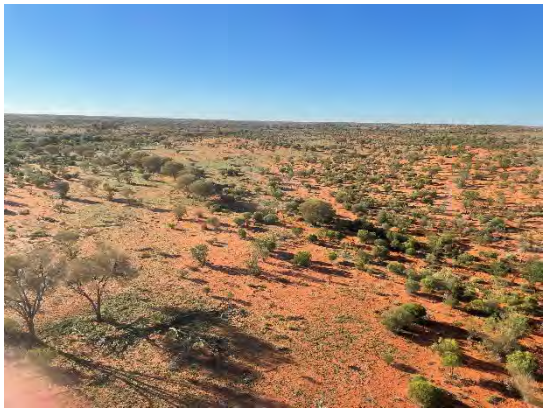
| Site | Latitude | Longitude | Stream order | Description | Plates | |
|---|---|---|---|---|---|---|
| 7a | -25.181758 | 133.54861 | 1 | <p>Minor intermittent stream.<br/>Weakly defined banks:</p> <ul style="list-style-type: none"> <li>Width (4-5m)</li> <li>Bank height (&lt;0.2m)</li> </ul> <p>Open shrubland, scattered Mulga over tussocks and forbs.</p> <p>No weed issues.</p> <p>No cut required as shallow bank; minimal erosion risk.</p> | | |

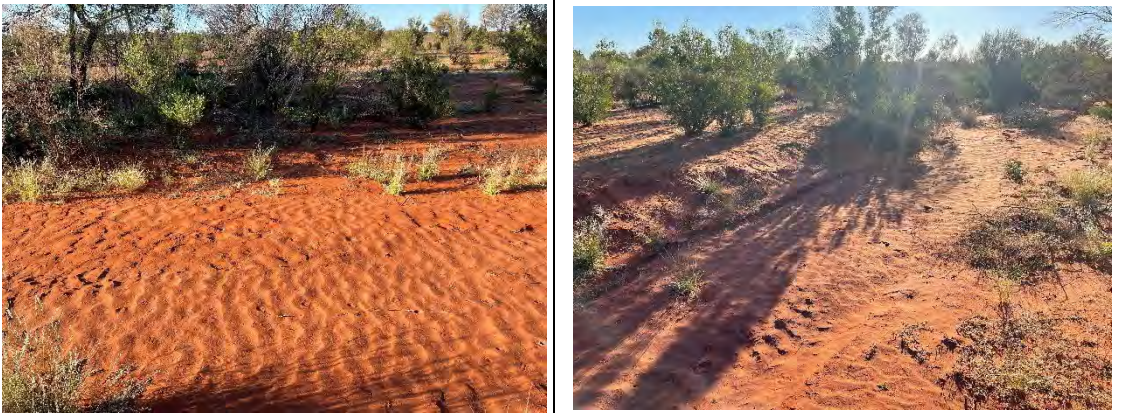
| DESCRIPTIONS OF DRAINAGE LINE CROSSINGS | | | | | |
|---|---|---|---|---|---|
| 7d | -25.170046 | 133.52193 | 1 | <p>Minor intermittent stream.</p> <p>Well defined banks:</p> <ul style="list-style-type: none"> <li>Width (3m)</li> <li>Bank height (0.5m)</li> </ul> <p>Open shrubland over sparse forbs and tussock grasses.</p> <p>No weed issues.</p> <p>Minor cut required. Will require erosion controls to minimise chance of erosion along seismic line.</p> | |
