## Beetaloo Basin Shenandoah South 3D Seismic Program Environment Management Plan (TAM3-2) EP 117 and EP 98

Prepared by Tamboran B2 Pty Ltd

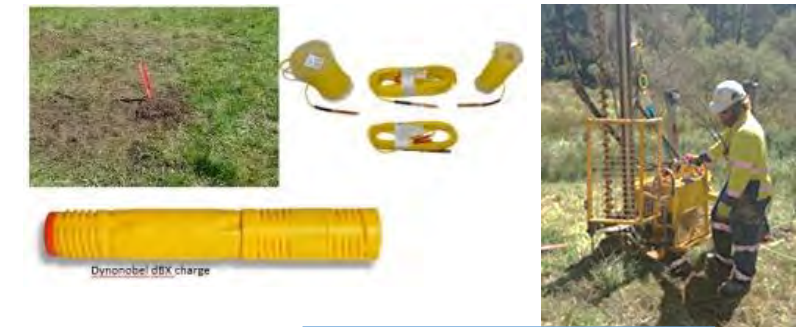
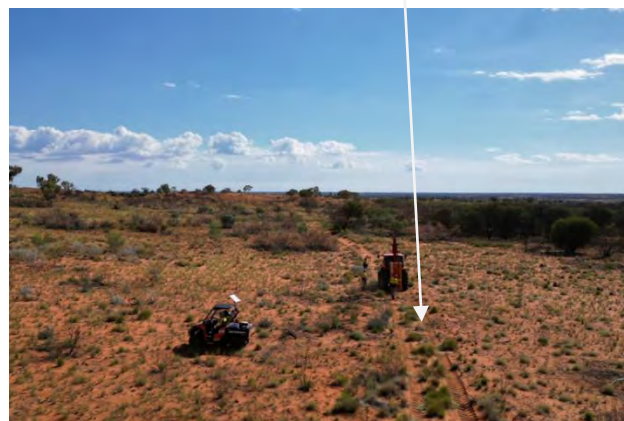
Figure 7: 3D seismic activity overview

Energy Source  
Weight drop mounted on tractor / positrak / tracked machine

Energy Source  
seismic charges

Source lines  
(minimal clearing)

Receiver- Geophones / Nodes

Production of 3D subsurface  
model

Seismic Line Rehabilitation

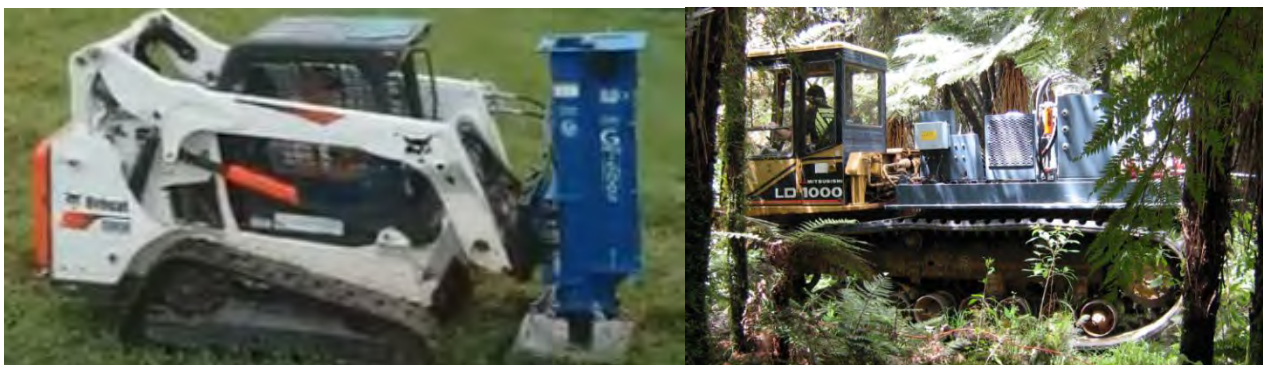
**Figure 8: Example of accelerated weight drop mounted on tractor / positrak / tracked machine**

Figure 8 provides examples of the AWD mounted on a positrak or tracked machine.

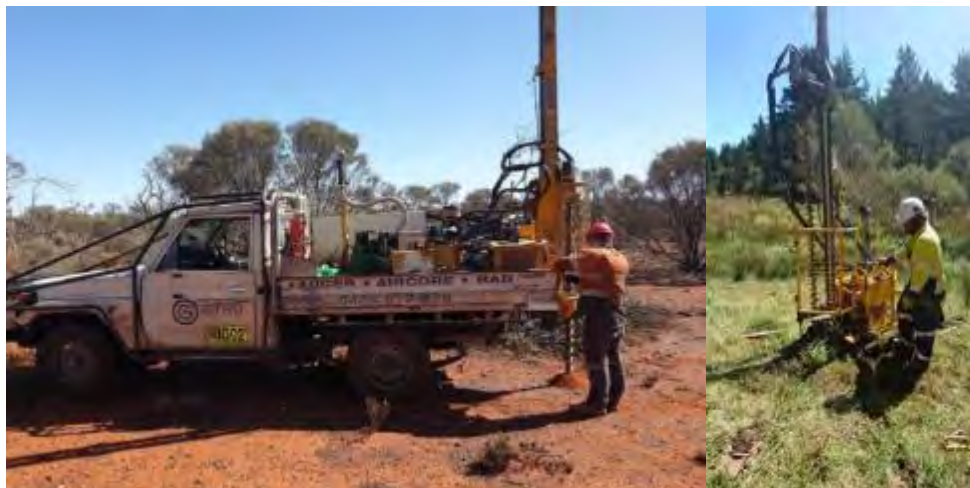
**Figure 9: Example of a small rig that could be used for installing dynamite charges during a seismic survey**

Seismic acquisition using small dynamite charges reduces the required land clearing substantially (~90% less clearing). Small charges are placed at 10 to 15 m below the ground surface using a small ATV/4WD mounted auger (Figure 9).

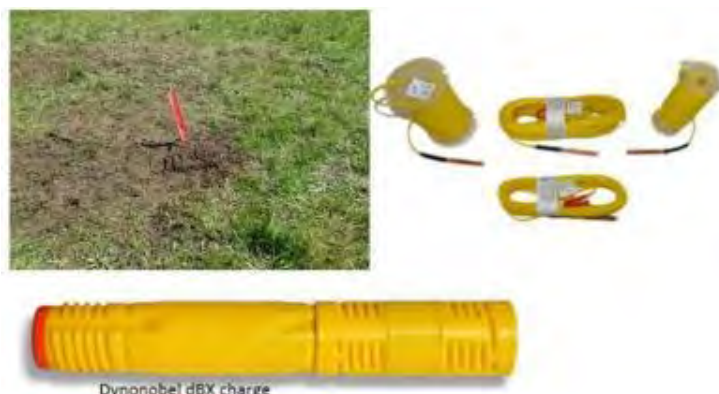
**Figure 10: Example of loaded charge in hole ready for detonation and example of a charge used in seismic survey acquisition; charge length is approximately 400 – 500 mm**

A 200 g to 1,000 g high performance pentolite charge will be used. This charge is specifically designed for seismic surveying. The charges are packed in place within each shot hole, with the blast contained within the subsurface (i.e. no expulsion of earth from the surface). Figure 10 is an example of a typical small seismic charge used during a New Zealand seismic shoot.

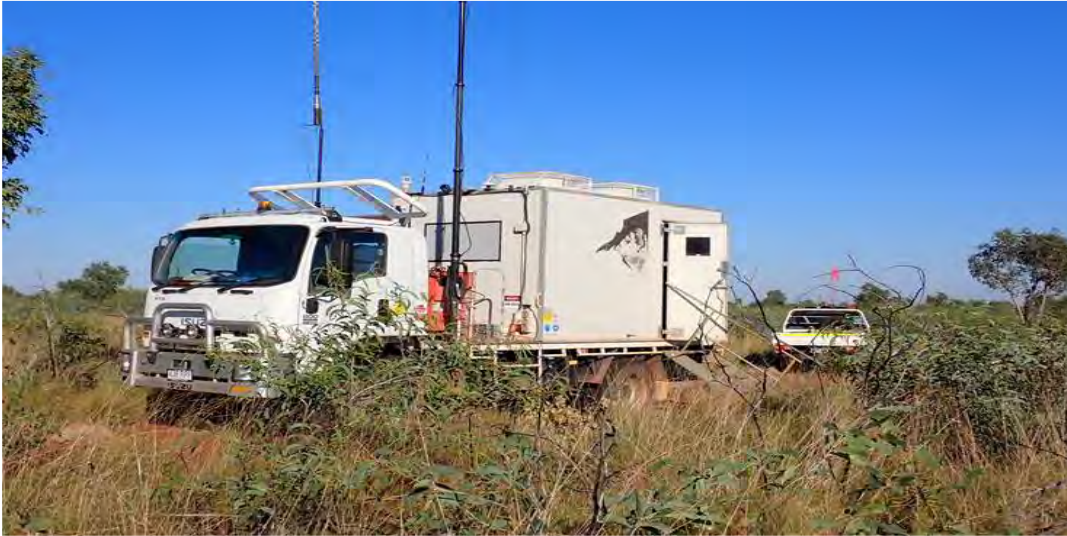
Figure 12: Data recording van used during seismic acquisition

Seismic lines will still be located to avoid dense vegetation patches (i.e. Lancewood/Bullwaddy vegetation community), avoid large habitat trees or sensitive flora, with no vegetation clearing in watercourses and associated riparian vegetation. In areas with low vegetation density (such as *Corymbia* / *Erythrophleum* open woodland) ground disturbance will be restricted to the removal of rocks and fallen branches and the pushing over or slashing of grasses and shrubs to provide effective ground contact of the seismic vibro-source and the geophones and minimise the risk of fire (Figure 12).

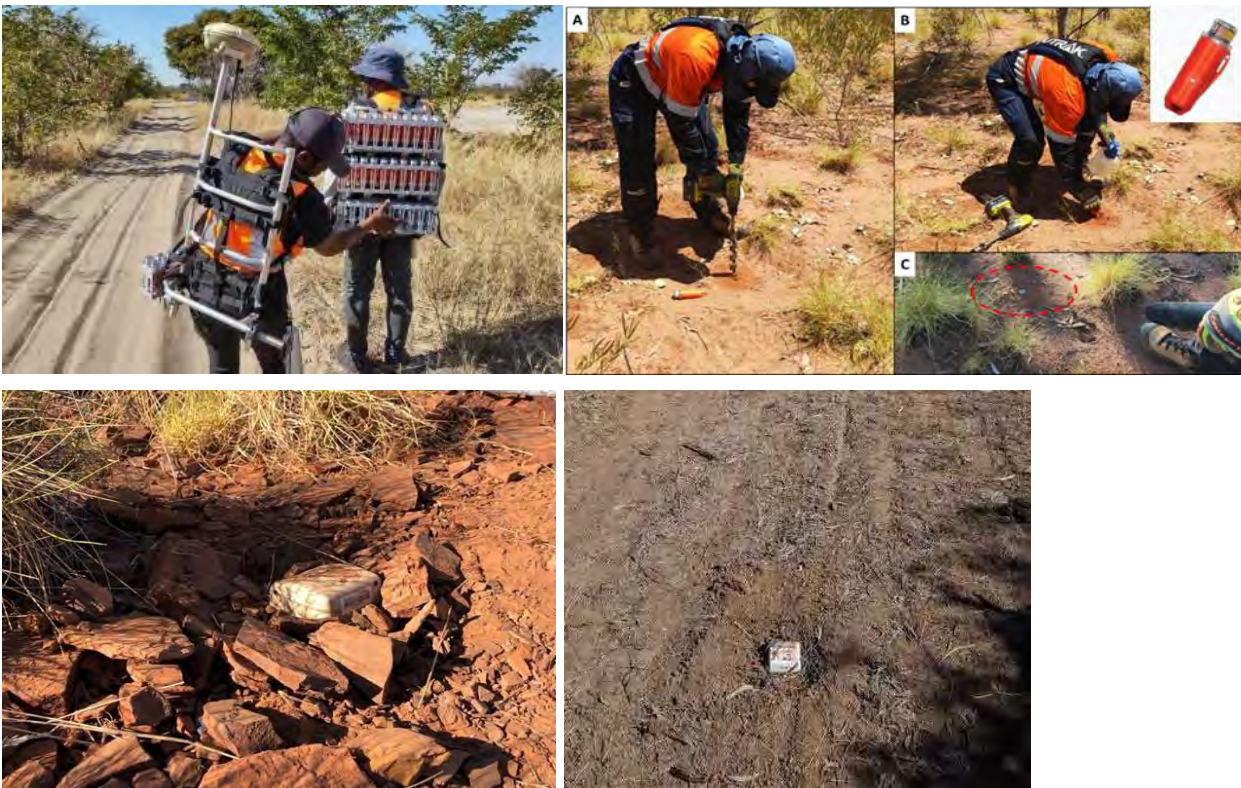
Figure 13: Example of a deployed node

The receivers (nodal geophones) will be hand carried along lines and put into the ground, usually deployed with a handheld drill and auger bit, light 4WD vehicles or ATVs. The nodal geophones are autonomous units, containing the actual geophone as well as battery and data storage in one unit. These nodes are deployed at regular intervals along the non-cleared lines perpendicular to the source lines, these may be able to be carried through areas of riparian vegetation to avoid any damage to vegetation where access permits. The installation of nodes requires minimal disturbance (Figure 13).
