Northern Territory
Cabomba Eradication
Program 2007/08 June 2009

Northern Territory Cabomba Eradication Program 2007/08

Department of Natural Resources, Environment, The Arts and Sport

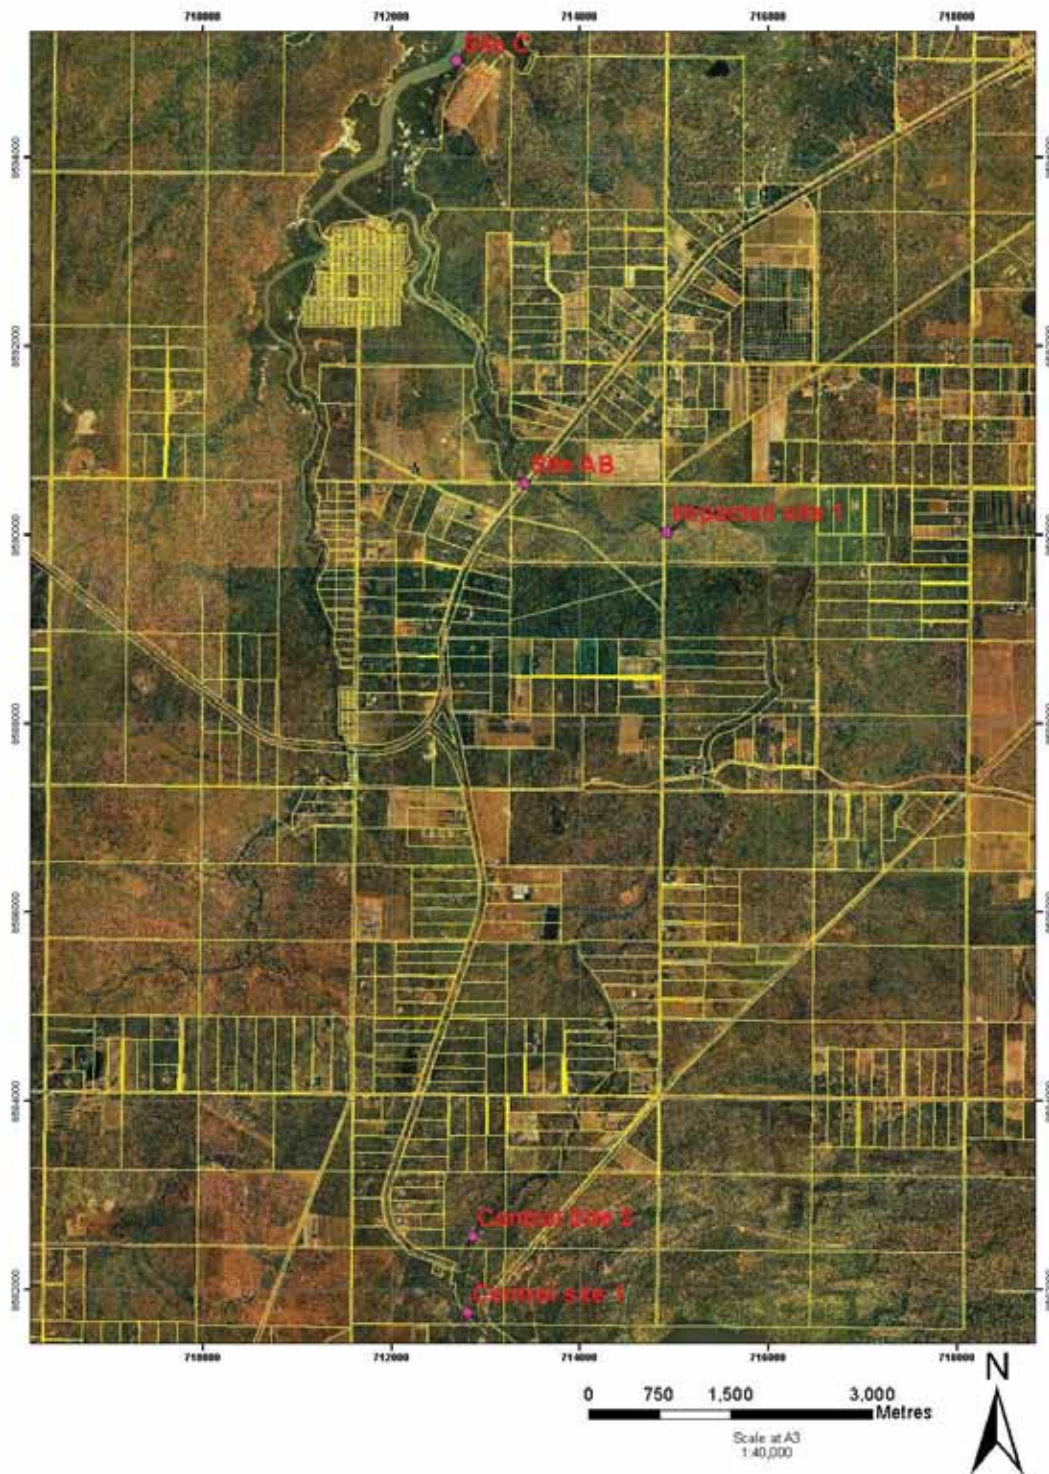
Figure 1: 2007-08 water quality monitoring sites Darwin river

- Site AB is in the lower freshwater reach of Darwin River below all infestations of *Cabomba*; and
- Site C is downstream of the Darwin-Blackmore Rivers confluence adjacent to the intake for an aquaculture operation.

Water quality sites were rationalised as a consequence of the limited extent of *Cabomba* in 2008 and the lack of 2,4-D detection in previous years in addition to the reduced herbicide application. Two additional sites would be monitored if herbicide was detected at Site AB and the monitoring regime and response to the detection of the 2,4-D-n-butyl ester would follow the 'Adaptive assessment approach' outlined in Appendix B and formerly described in the 2006-07 public report.

It was predetermined that if the concentration of 2,4-D-n-butyl ester exceeded a 'trigger value' concentration of 1.0 mg/L at Site AB, action would immediately be taken to prevent any further increase (e.g. reduce/cease application volumes) or spread to downstream areas. Action would also be taken if herbicide was detected at Site C.

The herbicide 2,4-D-n-butyl ester was detected on one occasion at the Darwin River monitoring site AB in the 2008 year. On the 13/06/2008 a sample registered 0.04mg/L (Table 2). A follow up sample was carried out within 24 hours however the second sample was unable to detect any chemical presence above 0.02 mg/L. This departure was not regarded as a threat to the aquatic ecosystems as the sample remained below the trigger value of 1 mg/L. There was no detectable herbicide found down stream at Site C on the Blackmore River for this sampling event.

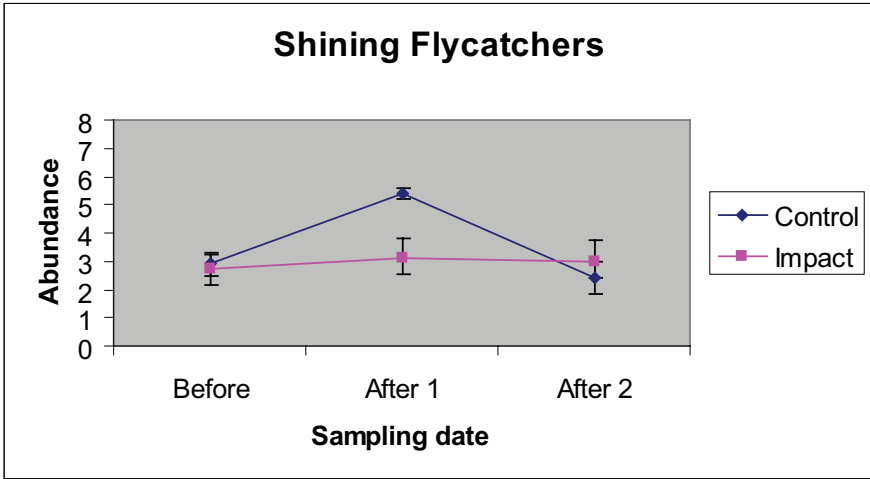
Figure 5: The mean of the total abundance per section of Shining Flycatchers in the control / impact sites from before the initial treatment ('before'), after the initial treatment ('after 1') and in 2008 ('after 2'). Whiskers denote 95% confidence interval.

All species-groups were present in control and impact pools at all three sampling periods. At the 2008 sampling, there were no significant differences in abundance between control and impact sites, for any of the four species-groups. Three of the four species groups (Shining Flycatcher, kingfishers, herons and bitterns) increased slightly (but not significantly) in the impact pools since the first surveys in 2004 (survey number one). In contrast, the abundance of the cormorant-darter group remained low in the impact pools: the greater abundance of this group in control sites was not significant and in part reflected pre-treatment differences.

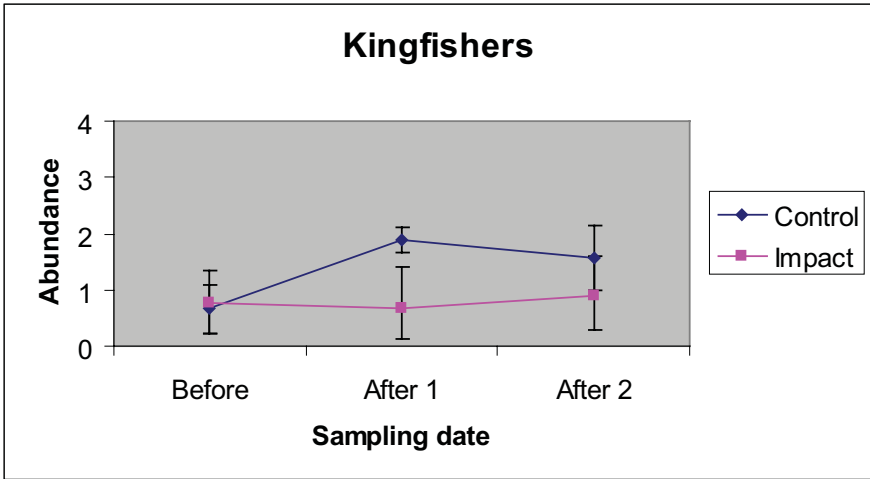
Figure 6: The mean of the total abundance per section of kingfishers in the control / impact sites across the three surveys. Whiskers denote 95% confidence interval.

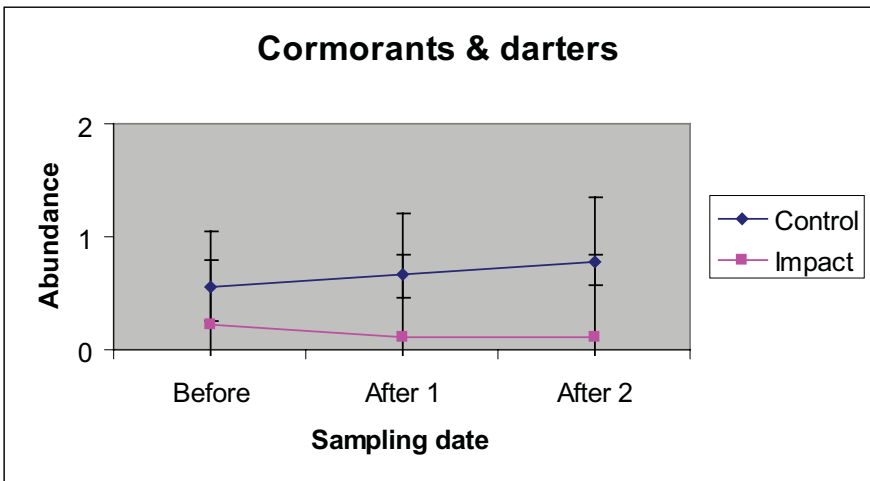
Figure 7: The mean of the total abundance per section of cormorants & darters in the control / impact sites across the three surveys. Whiskers denote 95% confidence interval.

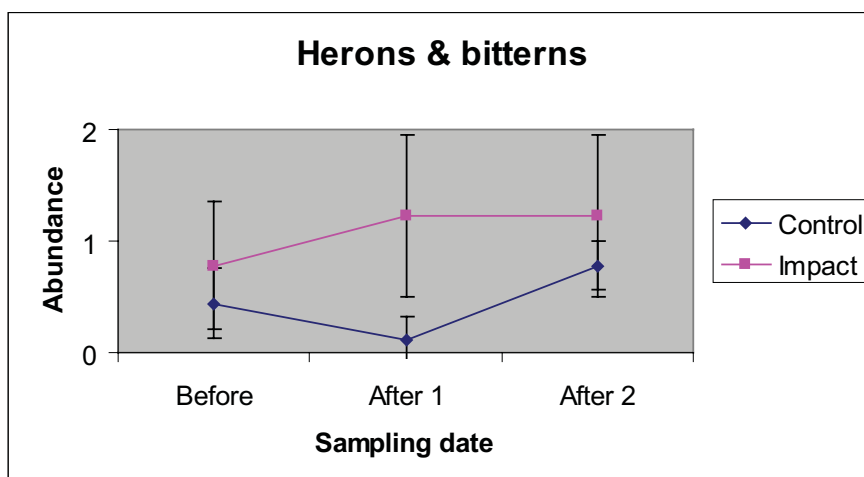
Figure 8: The mean of the total abundance per section of herons & bitterns in the control / impact sites across the three surveys. Whiskers denote 95% confidence interval.
