Former Fannie Bay Gaol

Improving thermal comfort

February 2017

A report for
NT Department of Tourism and Culture

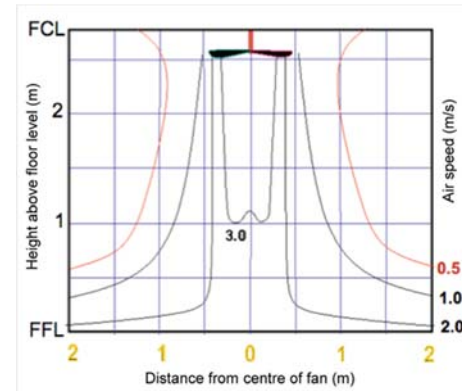
Fig.02 – Air velocity under a ceiling fan.
Reproduced from Ballinger 1992.

Ceiling fans, and to a lesser extent wall, pedestal and desktop fans can be effective for cooling on a room-by-room basis and can provide inexpensive air movement within a room on calm days when ventilation from prevailing breezes is inadequate. Fans cannot lower the air temperature but provide cooling due to the movement of air across the skin and the evaporation of moisture. They are most effective for people located directly under the fan. Figure 02 adjacent shows the typical distribution of air velocity under a ceiling fan.¹

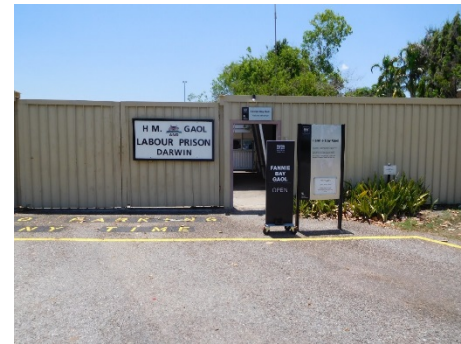
Fig.04 - Western facing perimeter wall showing the vehicle entrance gates and pedestrian entrance gate. The wall dates from ca 1976.

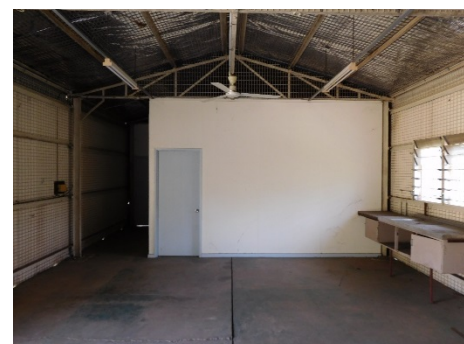
Fig.20 - Interior looking north. The CMP recommends removal of the later internal partitioning, removal of later louvre windows and reconstruction of the ventilation openings at the base and top of the external walls.

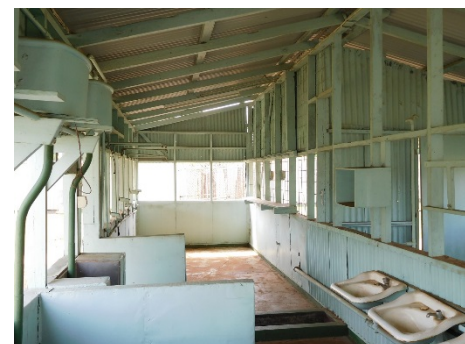
Fig.31 – Open interior of the Ablutions block. Note the open external walls and cladding to sill height only.

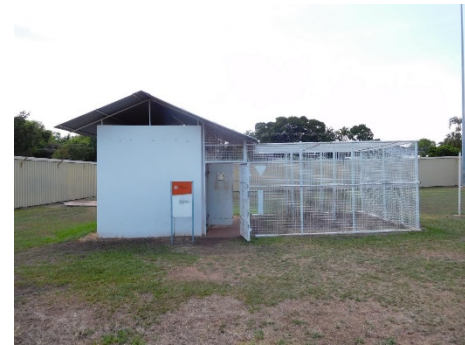
Fig.33 - West facade of the Separate Confinement block and exercise yard.

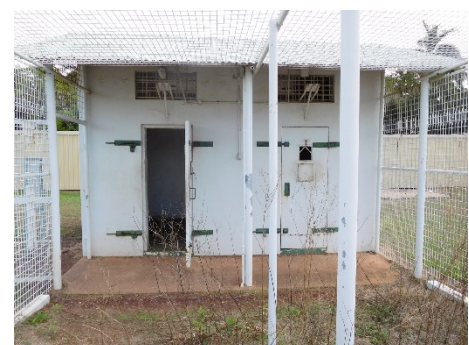
Fig.34 – cell doors from the exercise yard. Pedestal fans, directed into the cells, were fixed to the brackets seen in front of the two high level windows.

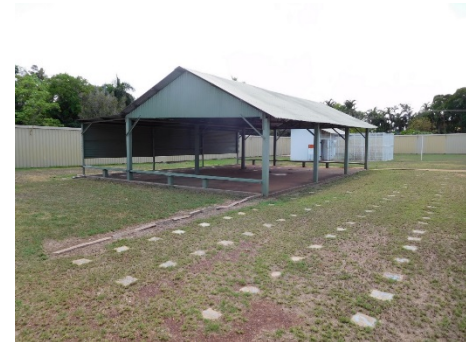
Fig.36 - West facade of the Muster shelter. Note rows of numbered tiles in the yard. Similar numbered squares are painted on the floor slab of the shelter.

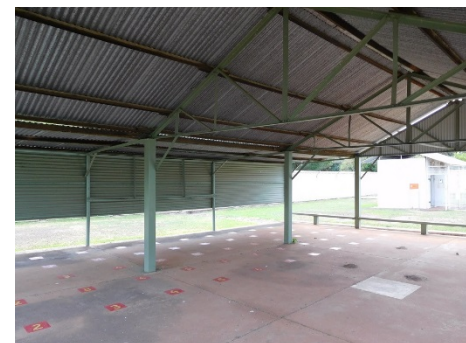
Fig.37 - Interior looking north-east.

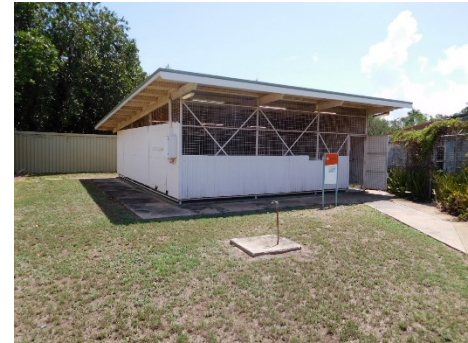
Fig.39 - South facade of the Children's section. The perimeter wall can be seen in the distance.

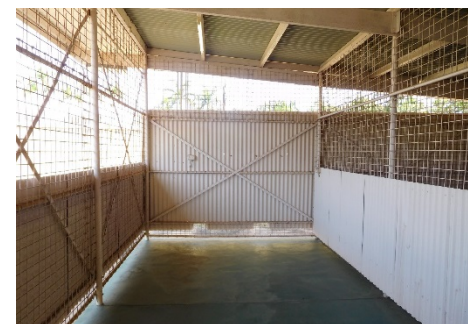
Fig.40 - Interior looking west. External walls to the north and south are weld-mesh above sill height. End walls are single skin with open gables.

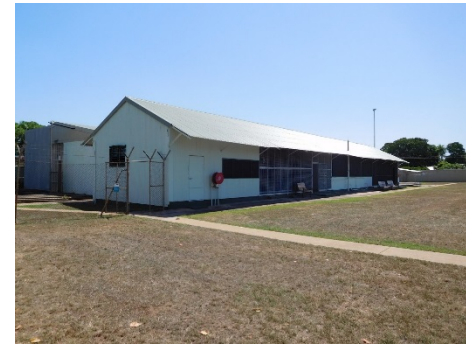
Fig.42 - South and west facade of the Kitchen and mess.

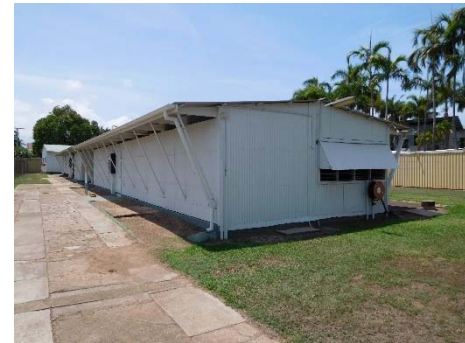
Fig.45 - North and west façade of the Stores building.

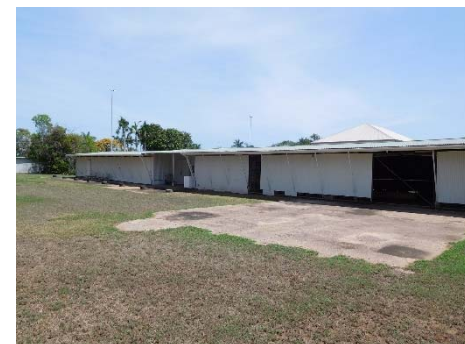
Fig.46 - Southern façade of the Stores building. The large opening is a door into the workshop

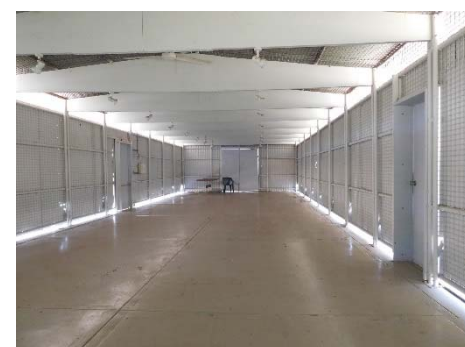
Fig.47 - Interior of the gallery space looking east. Walls are open top and bottom for ventilation. Ceiling fans are installed between truss members.

Two spaces could potentially be air conditioned: the Gallery space (110 m²) and the Office (33 m²). One constraint in air conditioning the building is the low height of the roof structure. The bottom of the roof trusses are at 2550mm above the underside of the floor, rising to the ridge at 3150mm. Trusses are clad both sides resulting in a series of baffles along the length of the building. This effectively precludes running ductwork in the space.

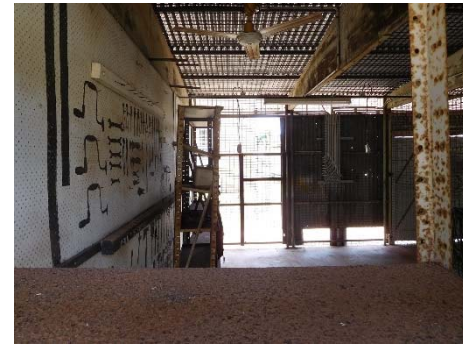
Fig.48 - Interior of the store area in the eastern side of the building. This area has weld mesh openings in the external walls and is well ventilated. Air conditioning outdoor units could be located within this space effectively concealing them from view.

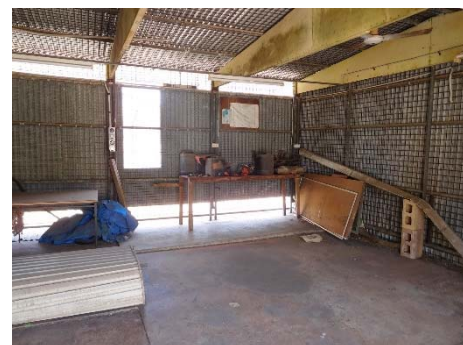
Fig.49 - Interior of the workshop in the eastern side of the building.

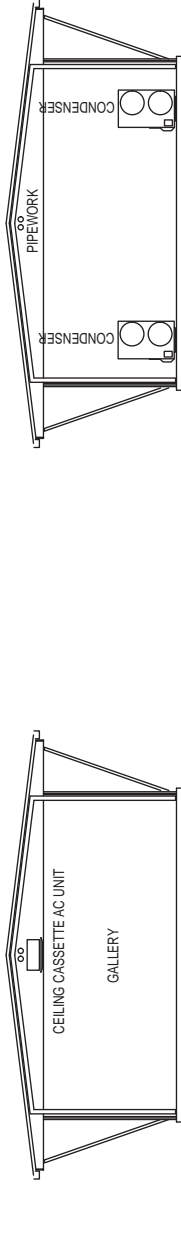
SECTION - 1 SITE 04 - STORES
SCALE 1:100 @ A3

SECTION - 2 SITE 04 - STORES
SCALE 1:100 @ A3

AIR CONDITIONING

The recommended air conditioning system for the Gallery is 3 commercial ceiling cassette type air conditioning units installed between roof trusses with a nominal capacity of 8kW each. Note that additional, smaller, units may be selected for aesthetic reasons.

The recommended air conditioning system for the Office is a single commercial ceiling cassette type air conditioning unit with a nominal capacity of 3.5kW.

This option assumes a concession is pursued for a maximum occupancy of 20 persons in the Gallery at any time with outdoor air delivered by way of the cassette air conditioning units. Ventilation to the Office will be provided by way of the cassette air conditioning unit for an occupancy of 3 persons

- ACU - Outdoor air conditioner unit
- C-ACU - Ceiling cassette AC unit

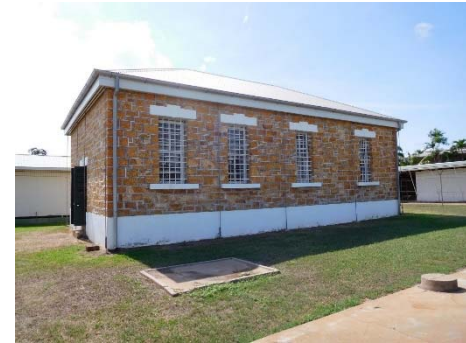
Fig.51 - West façade of the Infirmary.

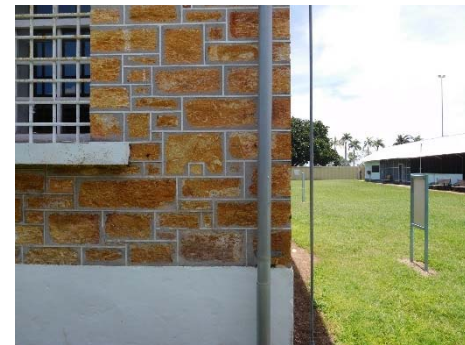
Fig.52 – Refrigerant pipework could be concealed in ducts matching downpipes.

Refrigerant pipework would run through the ceiling and drop down the eastern side of the Infirmary in two galvanised risers matching the existing downpipes. Pipework would then run underground in conduits from the base of the Infirmary wall to the condenser unit.

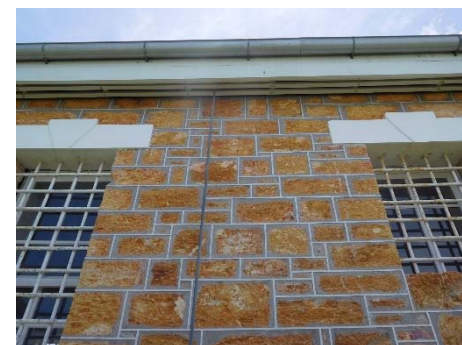
Fig.53 – External wall showing possible location for air conditioning refrigerant pipework running up to the roof space

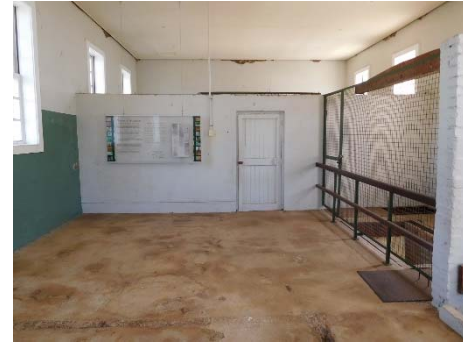
Fig.54 - Interior of the building with the gallows on the right.

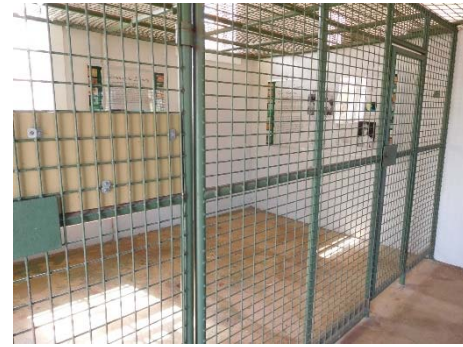
Fig.55 – Cell area with open weld-mesh cells.

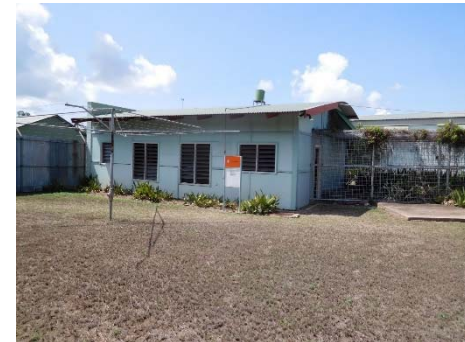
Fig.57 - North façade of the Women's section. The exercise yard enclosure is to the right. The roof to the left is the Muster shelter (Site 13).

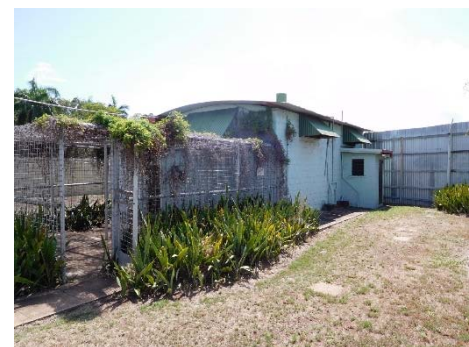
Fig.58 - Southern façade showing mesh exercise yard.

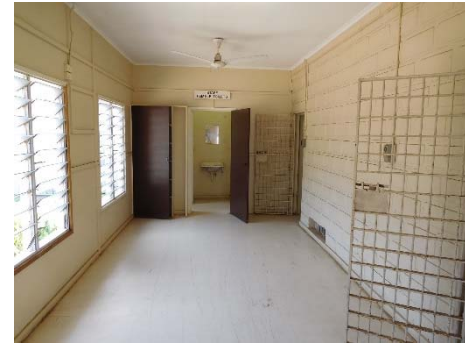
Fig.59 - Interior of the Annexe looking towards the toilets.

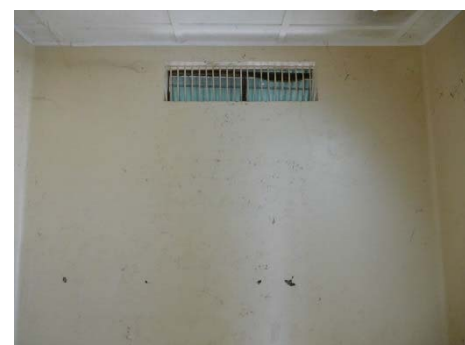
Fig.61 - Interior of the cell looking at high level barred windows located in the end walls (east and west facing).

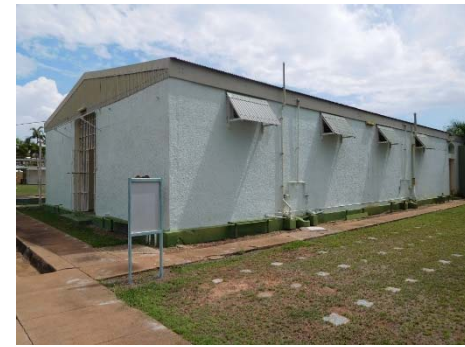
Fig.63 - North façade of Cell block B. The pavers for the muster yard can be seen in the foreground.

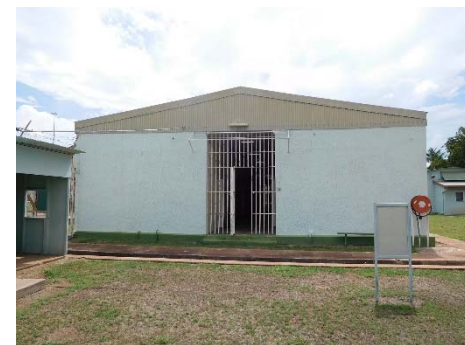
Fig.64 - East façade showing large barred door and screen to the central corridor.

The corridors are fitted with secure, but open barred doors and panels at each end and there are small high level barred windows in each of the cells. Currently there is a large sunscreen blocking the western end of the corridors so little breeze is drawn through these corridors. Ceiling fans are located in each of the cells and create adequate air movement within the small cells.

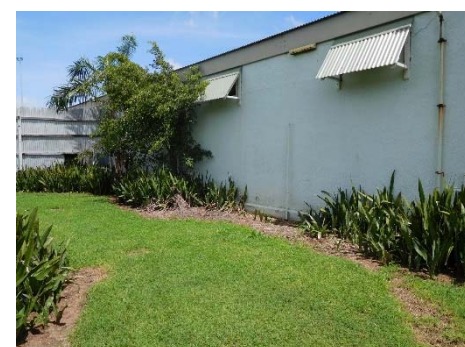
Fig.65 – North façade, western end, showing potential location for the outdoor unit in the yard between Cell block A and the Women's section.

- (i) The preferred option is for the two outdoor condenser units to be located within a screened enclosure immediately outside the northern wall of the Cell block in the space between Cell block A&B and the Women's section.
- (ii) The condenser unit for the Women's section could be located in the same screened enclosure to centralise air conditioning plant.

Refrigerant pipework and cabling would run from the outdoor condenser unit to the base of the Cell block wall on the northern side and run up to the eaves where the pipework and cabling should be able to enter the roof space.

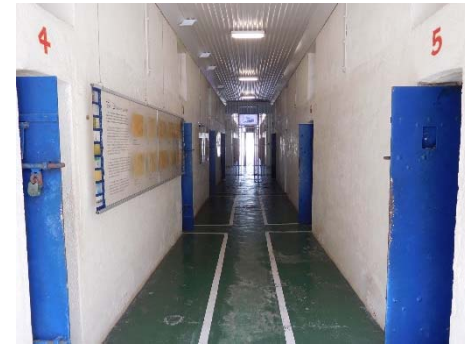
Fig.66 – The corridor looking west. .

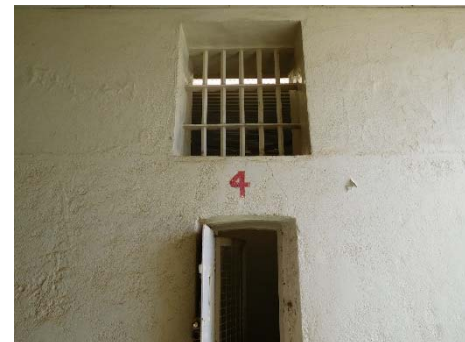
Fig.67 – Cell doors and large permanent ventilation opening above the door in the corridor wall

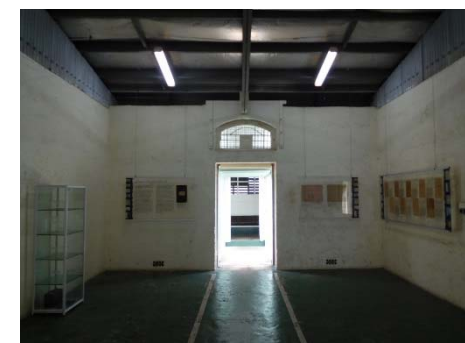
Fig.68 – Central area looking towards the passage to the Kitchen and Mess. A new door and frame is required and the highlight sealed.

A large, low speed fan, could be installed in the common area to promote air movement in the centre of the building.
