Barossa Project

DPD CULTURAL HERITAGE MANAGEMENT PLAN

BAS-210 0208

Darwin Pipeline Duplication Project

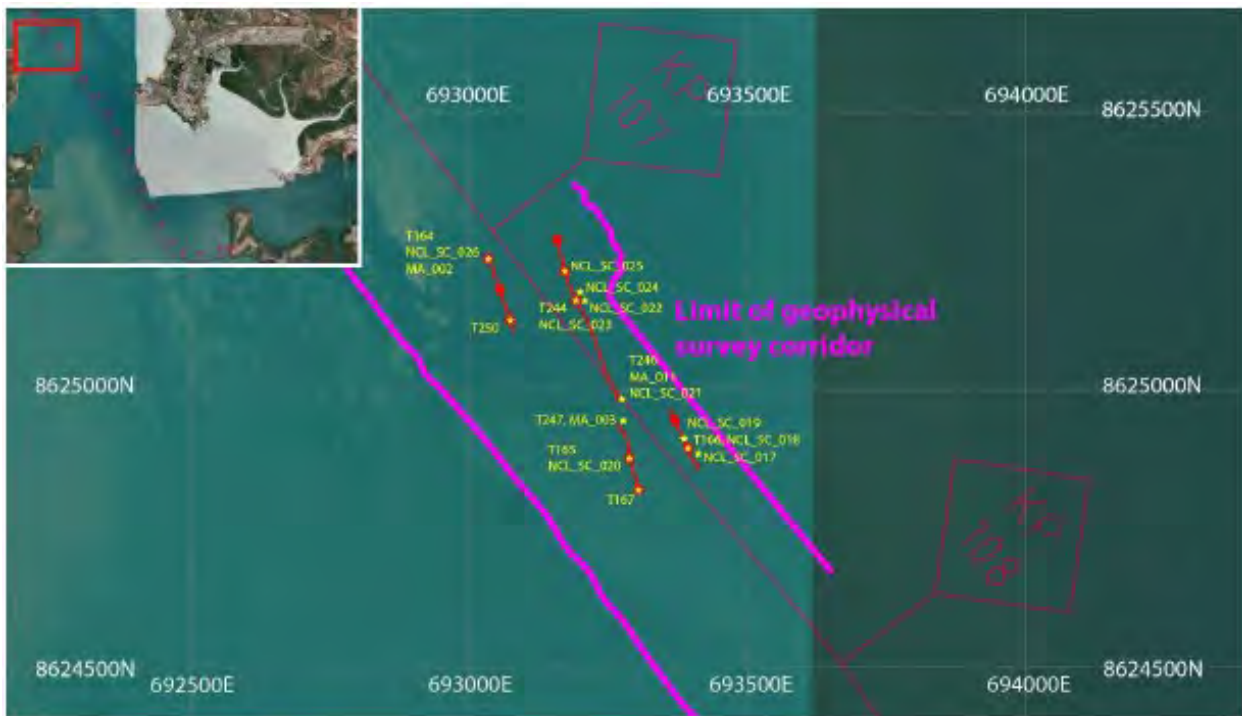
Figure 4-5: Location of anti-submarine net trots identified from ROV surveys (CA 2022: Figure 71)

*Circles represent mooring blocks/anchors, lines indicate chains in between blocks, stars represent geophysical survey anomalies, with IDs.

This assessment revealed that three such Trots (16, 17, and 18) are present within 50 m of the DPD Project Area. Trot 17 directly crosses the path of the DPD corridor, while elements of Trot 16 are 37 m away, and those related to Trot 18 are 25–32 m away. As a result, recommendations were made in both CA 2022 and 2023 that efforts should be made to realign the pipeline to avoid Trot 17, but that if this was not feasible, then the item could be relocated, and the new location recorded in consultation with NT DTFHC.

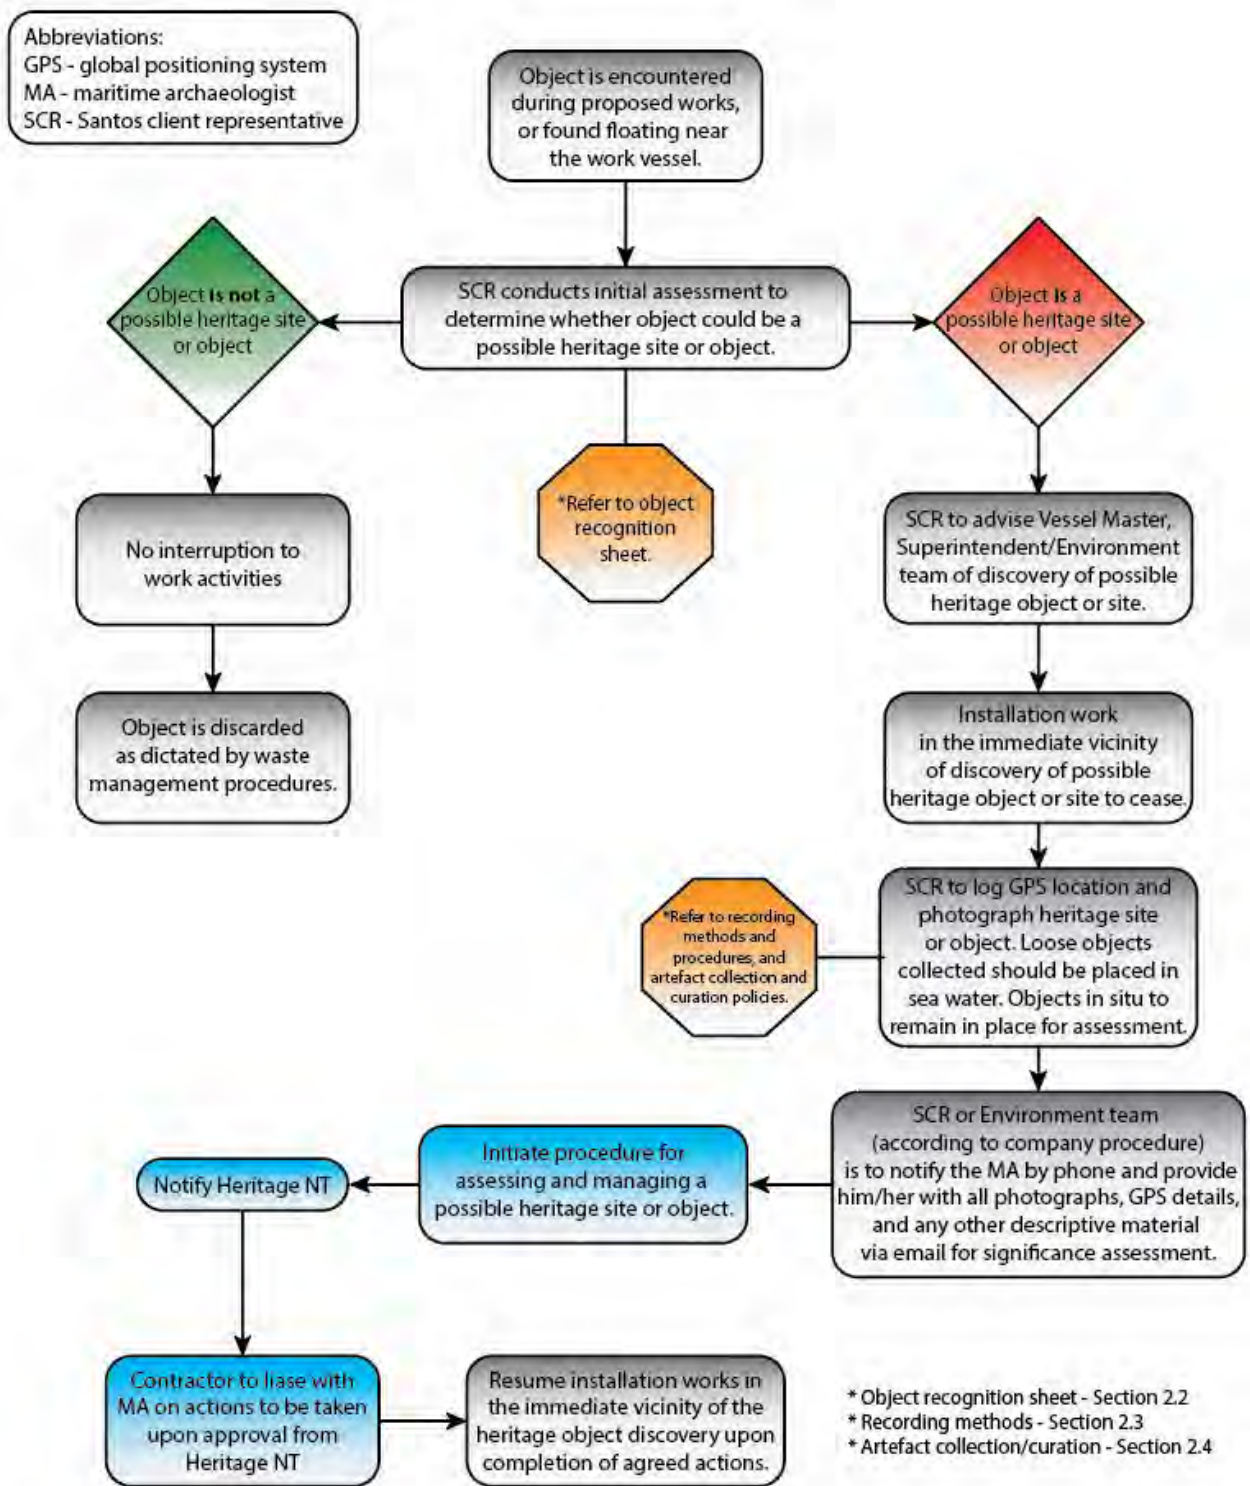
Figure 1: Flow chart detailing the heritage response process upon encountering unexpected finds.

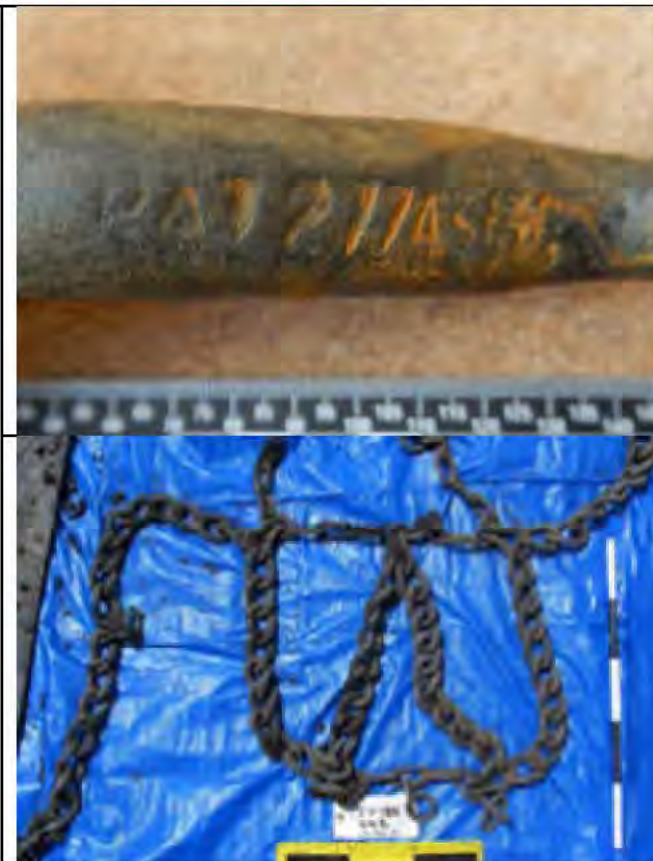
Ferrous chain and hooks

It has been observed during ROV surveys that the mooring trots for the WWII anti-submarine boom nets were connected by heavy grade chain. During ROV survey, it was noted that some lengths of chain were broken and displaced. Broken links and lengths of these chains may be present across the proposed GEP route.

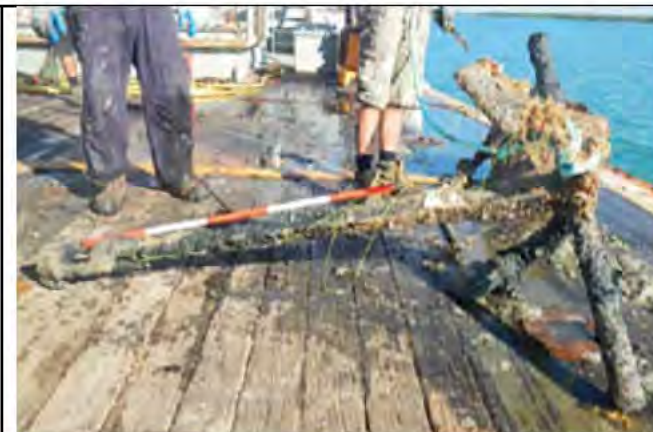
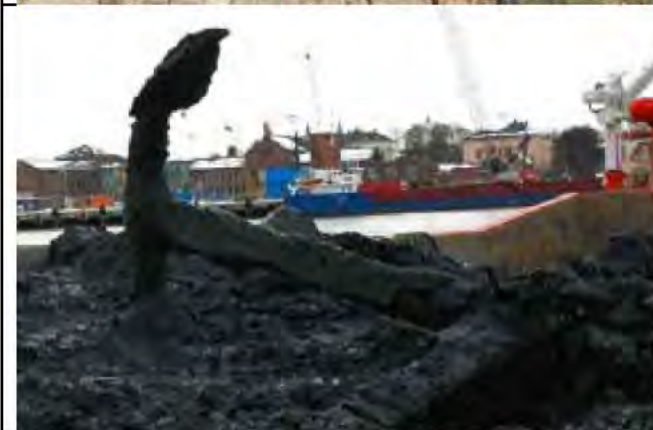
Anchors

One anchor was identified during ROV surveys for the Barossa GEP. This was a large ship's anchor that had been repurposed for use as a mooring for the anti-sub net. Other anchors associated with flying boats, shipwrecks, or discard may be present.

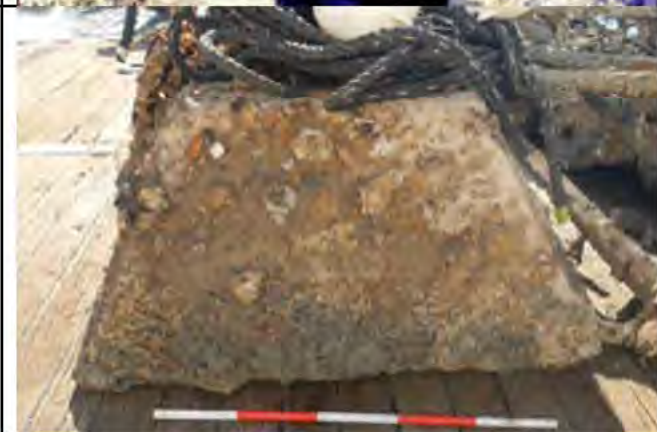
Concrete moorings were extensively used throughout Darwin Harbour during WWII, including those used to anchor the anti-submarine boom nets. ROV surveys identified numerous mooring trots still extant within the vicinity of the proposed GEP route. However, some moorings that would have originally been in the area were not found. These may have been moved and could be within the proposed works.

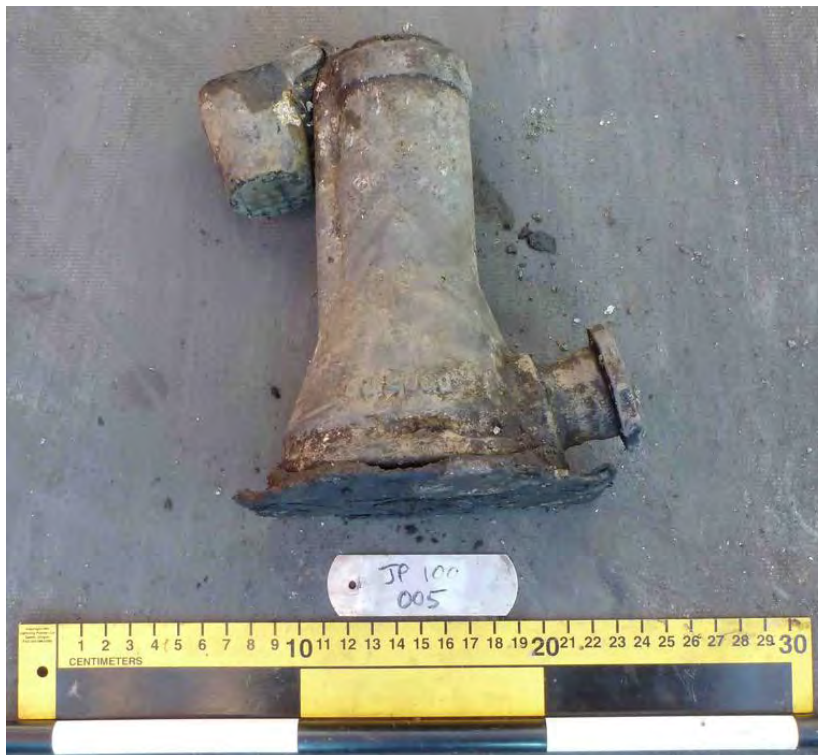
Figure 2: photograph of artefact recovered during excavation works. Note ID tag with unique number and scale in photo.

- **Unique Identifying number** (this number is to appear in any photographs of the object)
- **Date and time of recovery**
- **Location of find** (to be expressed as general area description and GDA94, MGA zone 52 coordinates)
- **Description** (Include broad dimensions, such as width, length, depth, and diameter where relevant, as well as a description of the material)
- **Photographs** (All photos **must**, when possible and practical, have a scale and ID number – see Figure 2)

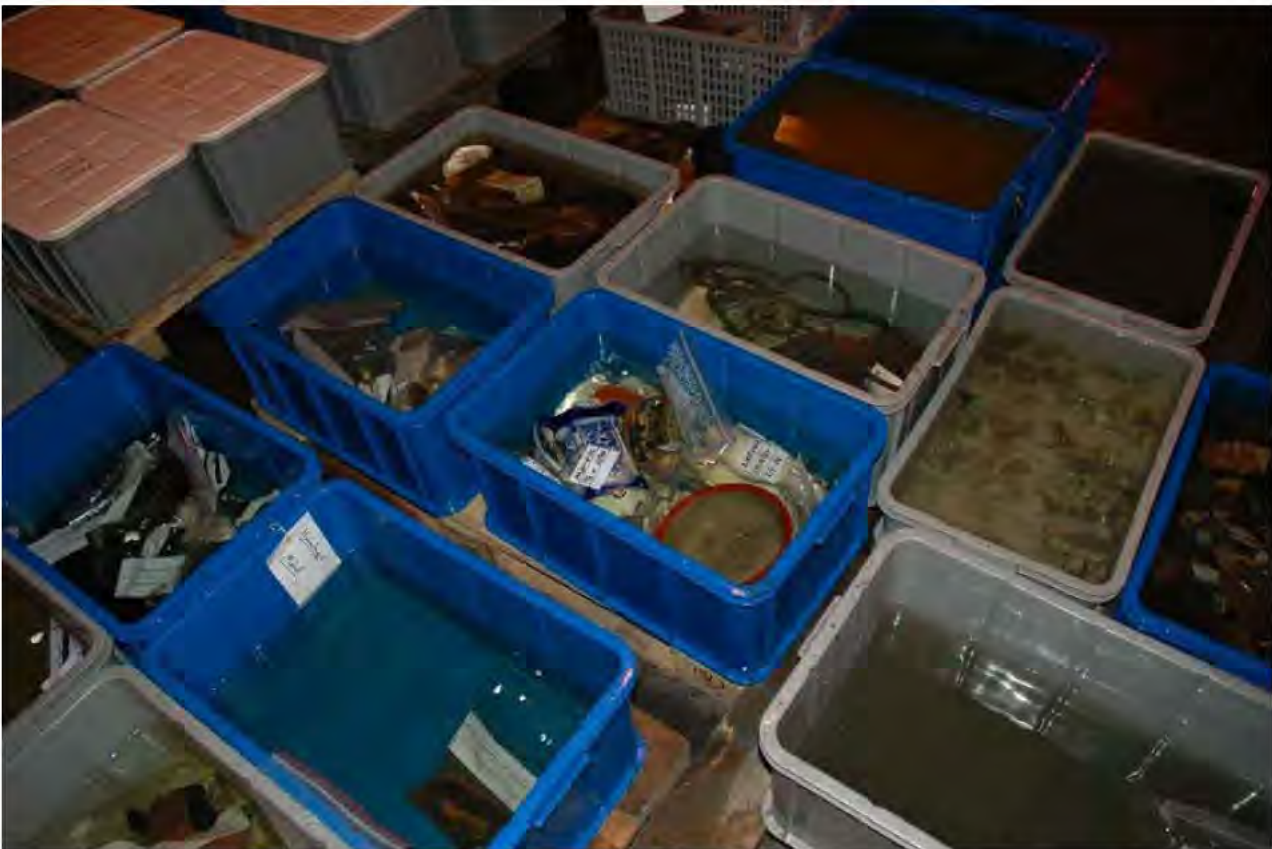
Figure 3: Small objects should be kept in tubs filled with seawater and labelled. Large objects should be wrapped in hessian and kept wet.

Objects that are encountered on the seabed might need to be collected and assessed by a maritime archaeologist to determine their significance. If archaeological objects are recovered from the seafloor/marine environment, they are to be stored in containers with salt water and covered from sunlight where possible (Figure 1). If the object(s) are too large to be stored in containers (i.e. timber planking), they are to be kept wet by spraying down with salt water at intervals so the object does not dry out. These large objects also need to be covered and stored out of direct sunlight.

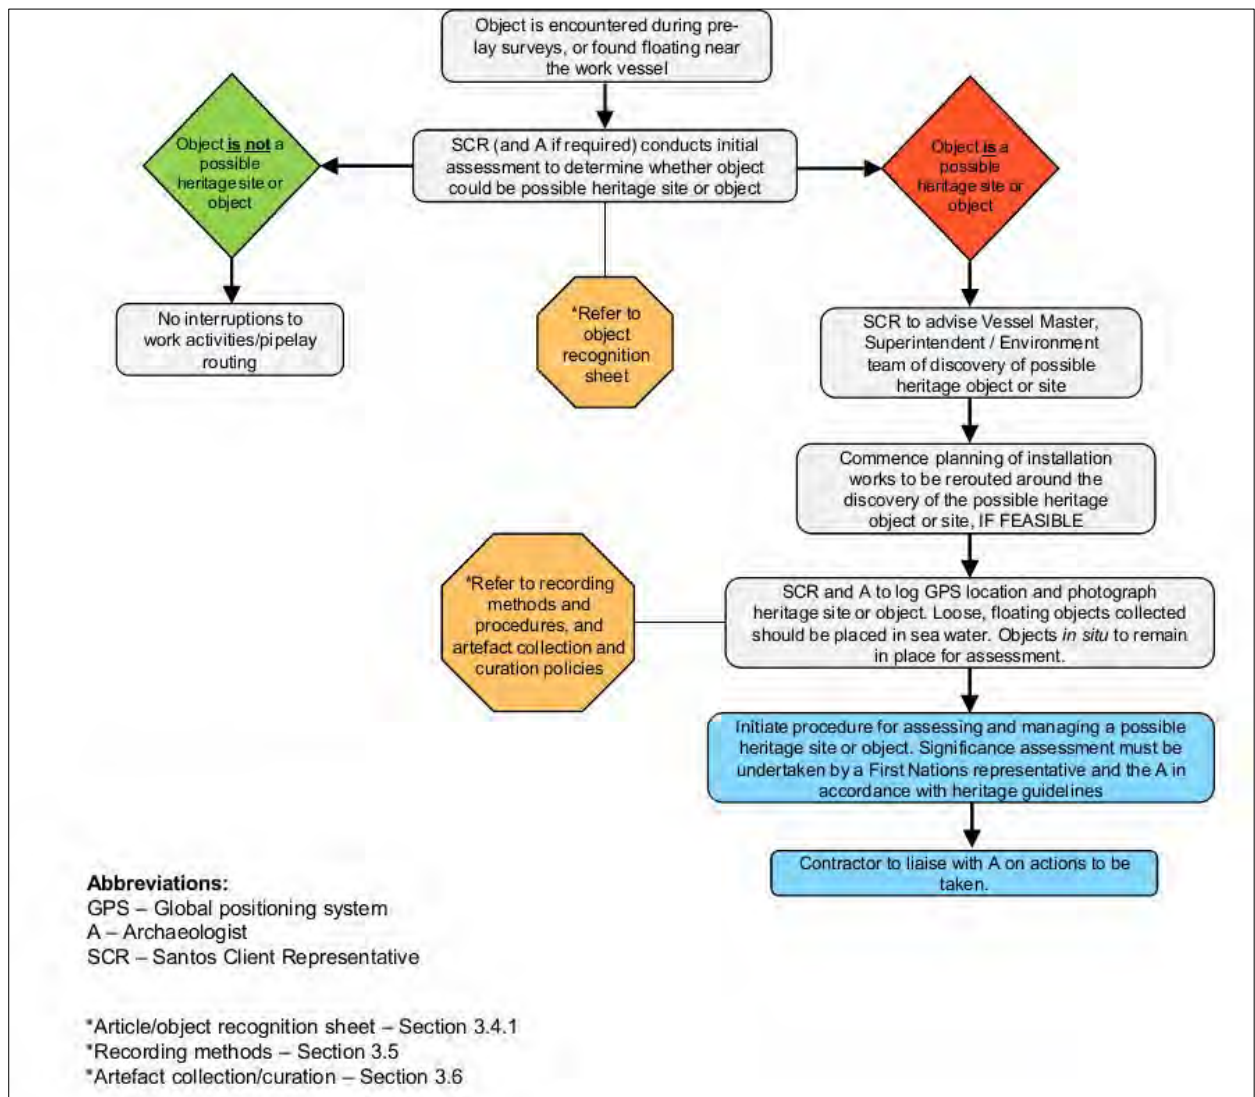
Figure 3-1: Flow chart detailing the Phase 1 heritage response process upon encountering unexpected potential heritage finds during the in-survey and pre-trench and pre-lay surveys.

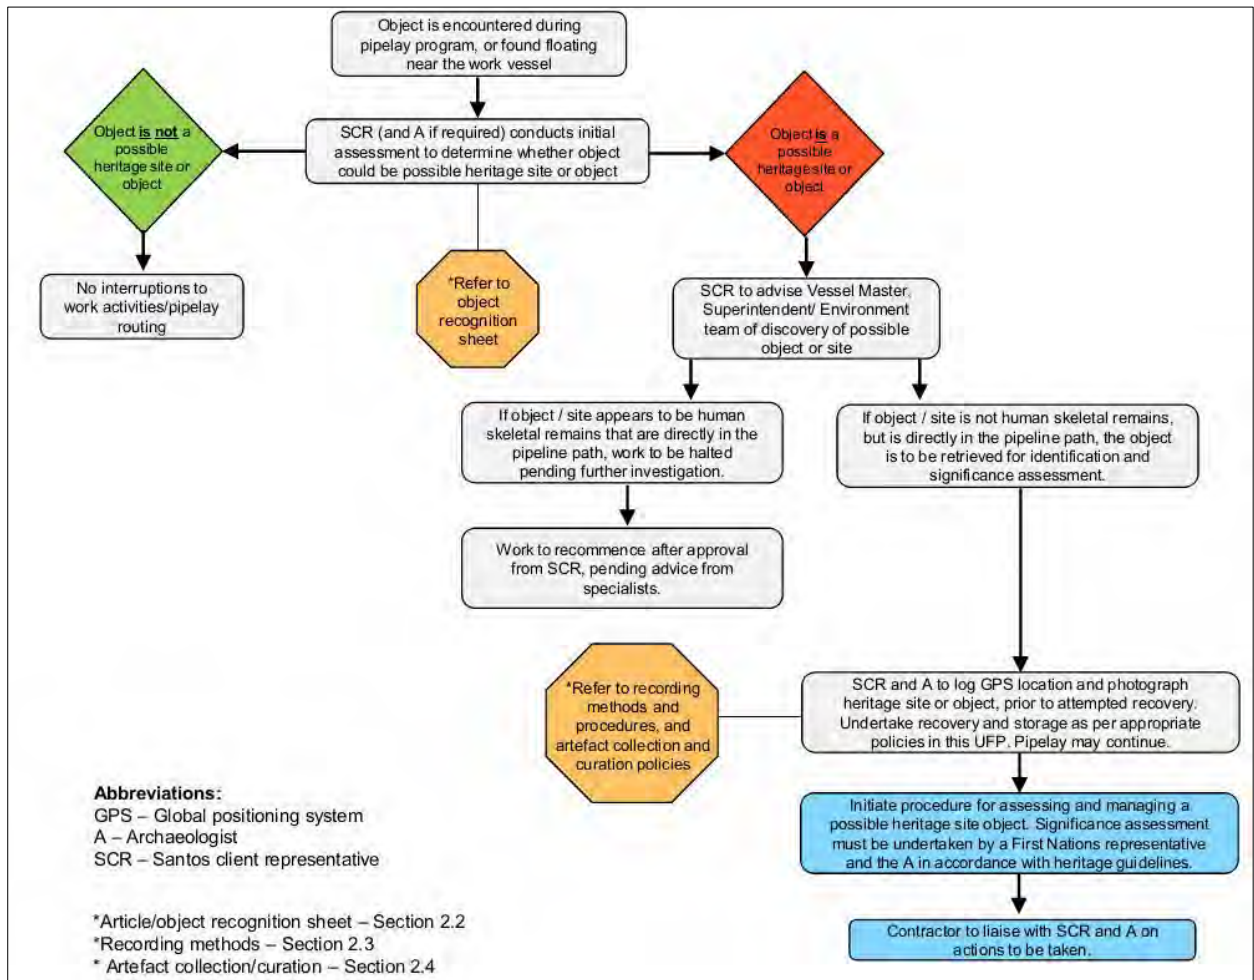
Figure 3-2: Flow chart detailing the Phase 2 heritage response process upon encountering unexpected heritage finds during the pipeline laying program.
