Shoal Bay and Howard River freshwater and marine water quality

Buffalo Creek estuarine water quality

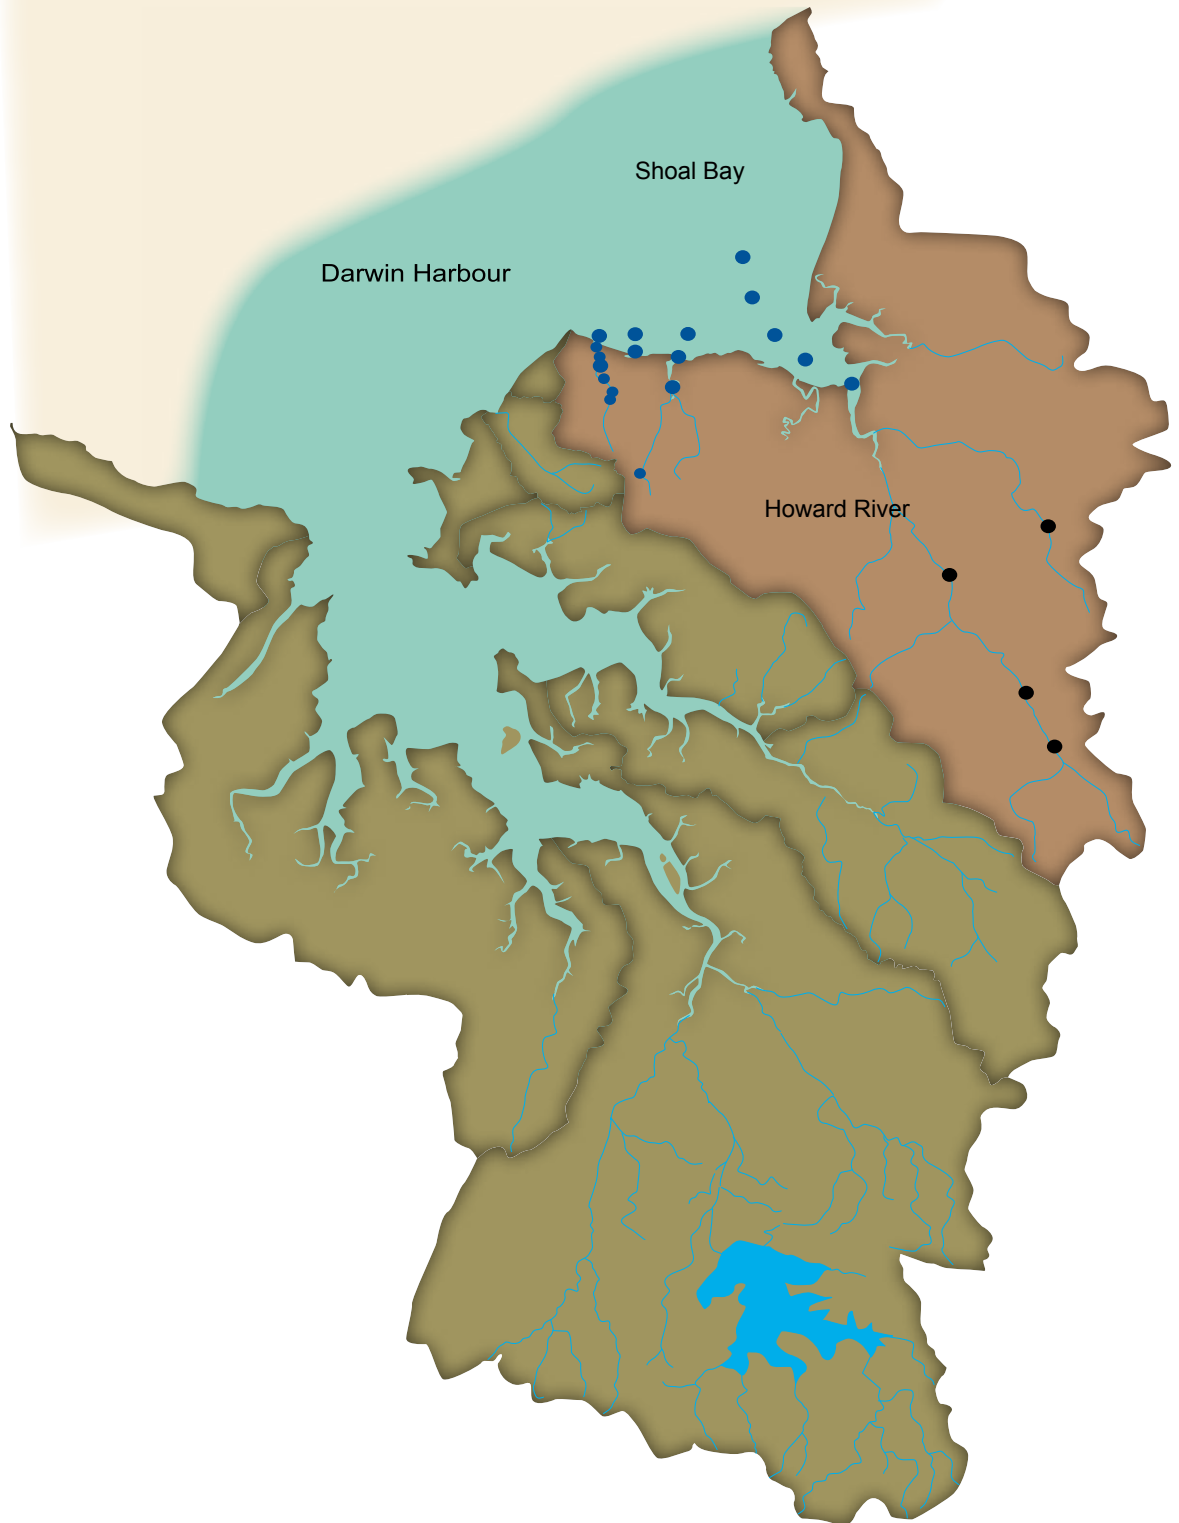
- Marine Monitoring Sites
- Freshwater Monitoring Sites
